Revision 1 February 2020

Safety Recall W03 / NHTSA 20V-043 Transmission Valve Body

**2019 - 2020 (DJ) Ram 2500 Pickup
(D2) Ram 3500 Pickup**

NOTE: This recall applies only to the above vehicles equipped with a 6-Speed Automatic 68RFE Transmission (sales code DG7).

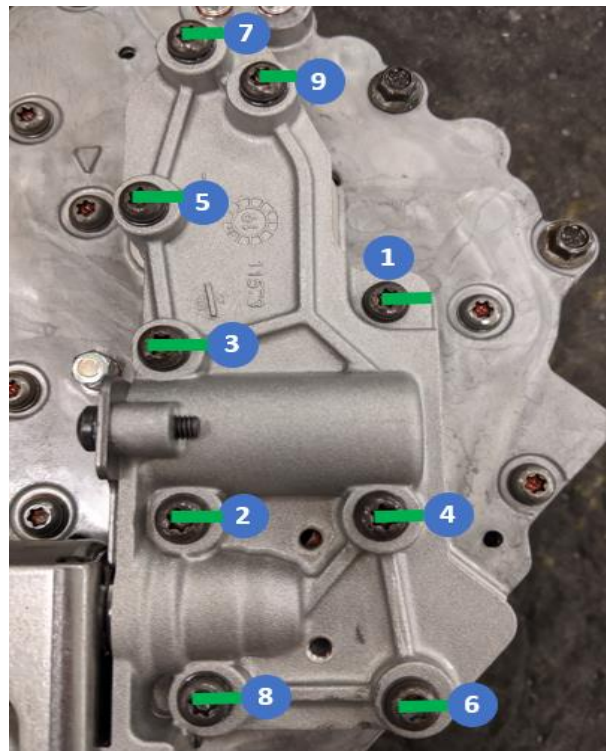
Figure 10 – Tightening Sequence

IMPORTANT: Tightening sequence procedure **MUST** be followed to assure correct lower valve body mounting, failure to follow the tightening sequence may result in transmission malfunction.

19. Re-install Lower Valve Body to main Transmission Valve Body, hand starting and seating all of the fasteners then tighten to 7.3 N·m (64.6 in. lbs.) according to specified pattern illustrated in (Figure 10).

21. **Important:** Repeat tightening the 9 Lower Valve Body fasteners to 7.3 N·m (64.6 in. lbs.) using the sequence illustrated in (Figure 10).

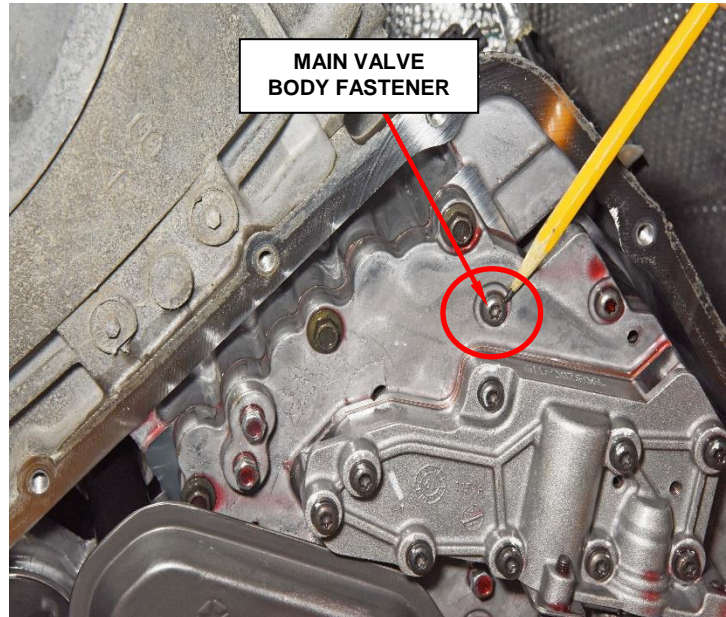
Figure 11 – Main Valve Body Fastener

NOTE: Tightening of the fastener is to improve sealing between main valve body and lower valve body.

20. Tighten the main valve body fastener to 7.3 N·m (64.6 in. lbs.) (Figure 11).

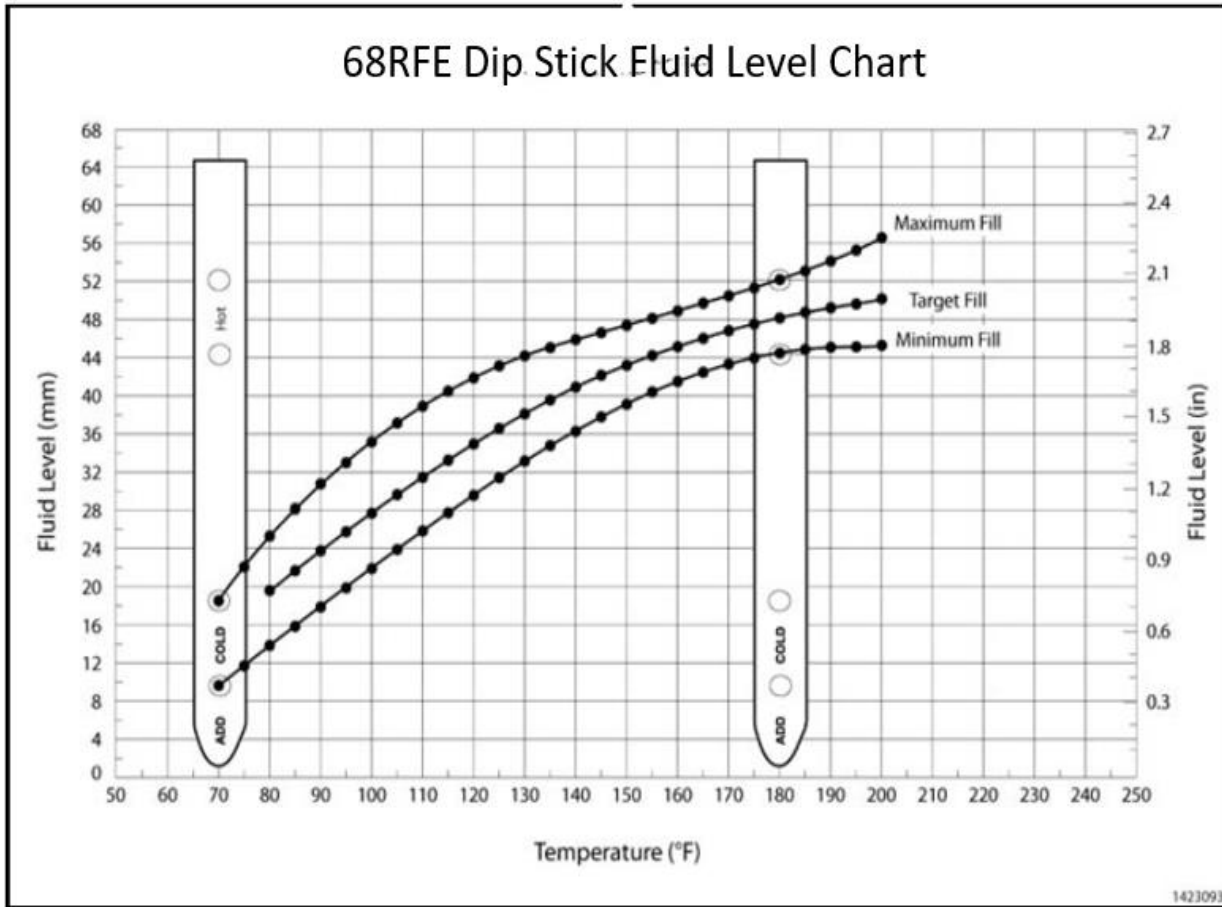
Figure 13 – Fluid Level Chart

NOTE: Transmission fluid temperature must be at least 160°F (71°C) to set fluid level. This may take up to 20 minutes' idle time in Park.

29. Add approximately 5 Quarts of MOPAR® ATF+4 Automatic Transmission Fluid.
30. Start vehicle and allow the transmission to reach operating temperature then check transmission fluid level, adjust the fluid level according to the specified procedure and using the 68RFE dipstick fluid level chart (Figure 13).
