ATS or BD.....you decide.

The products that I'll be discussing are two competing sets of compound turbos, both installed on 2006 Dodge Ram's with Cummins Turbo Diesel engines. One set was from ATS, which included the Aurora 3000 and Aurora 5000 turbos and the other was from BD Power, which included the SuperB and R700 turbos. Both are advertised as towing / race setups.

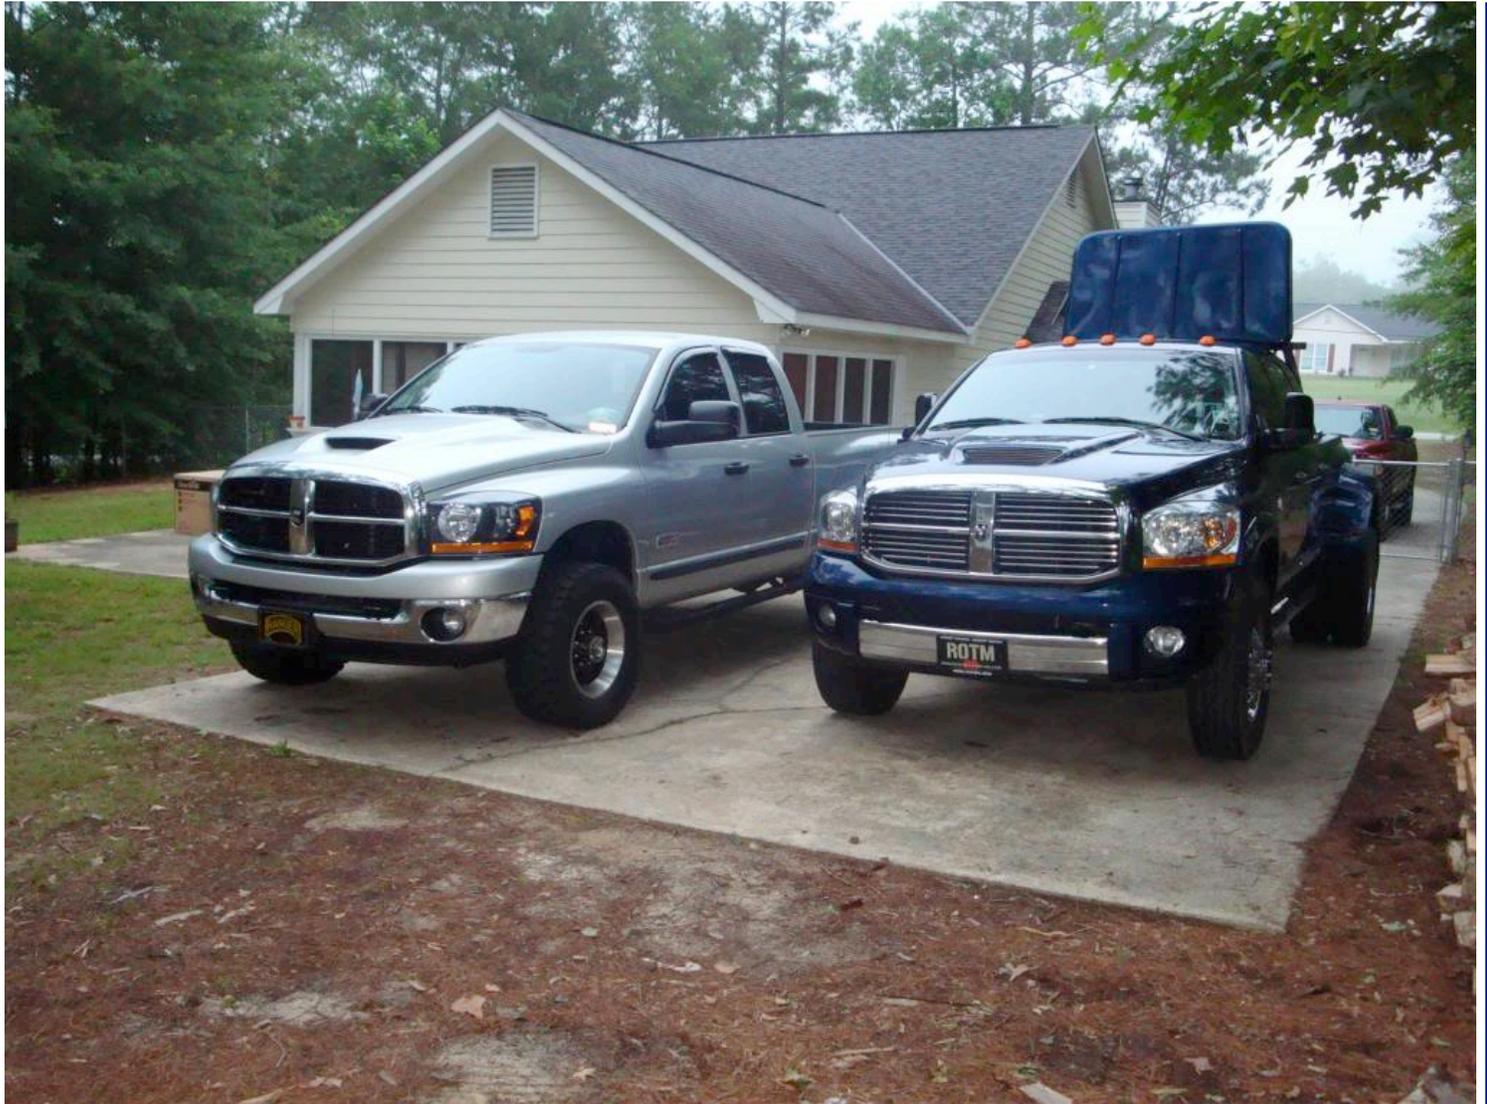
The two vehicles that the products were installed on:

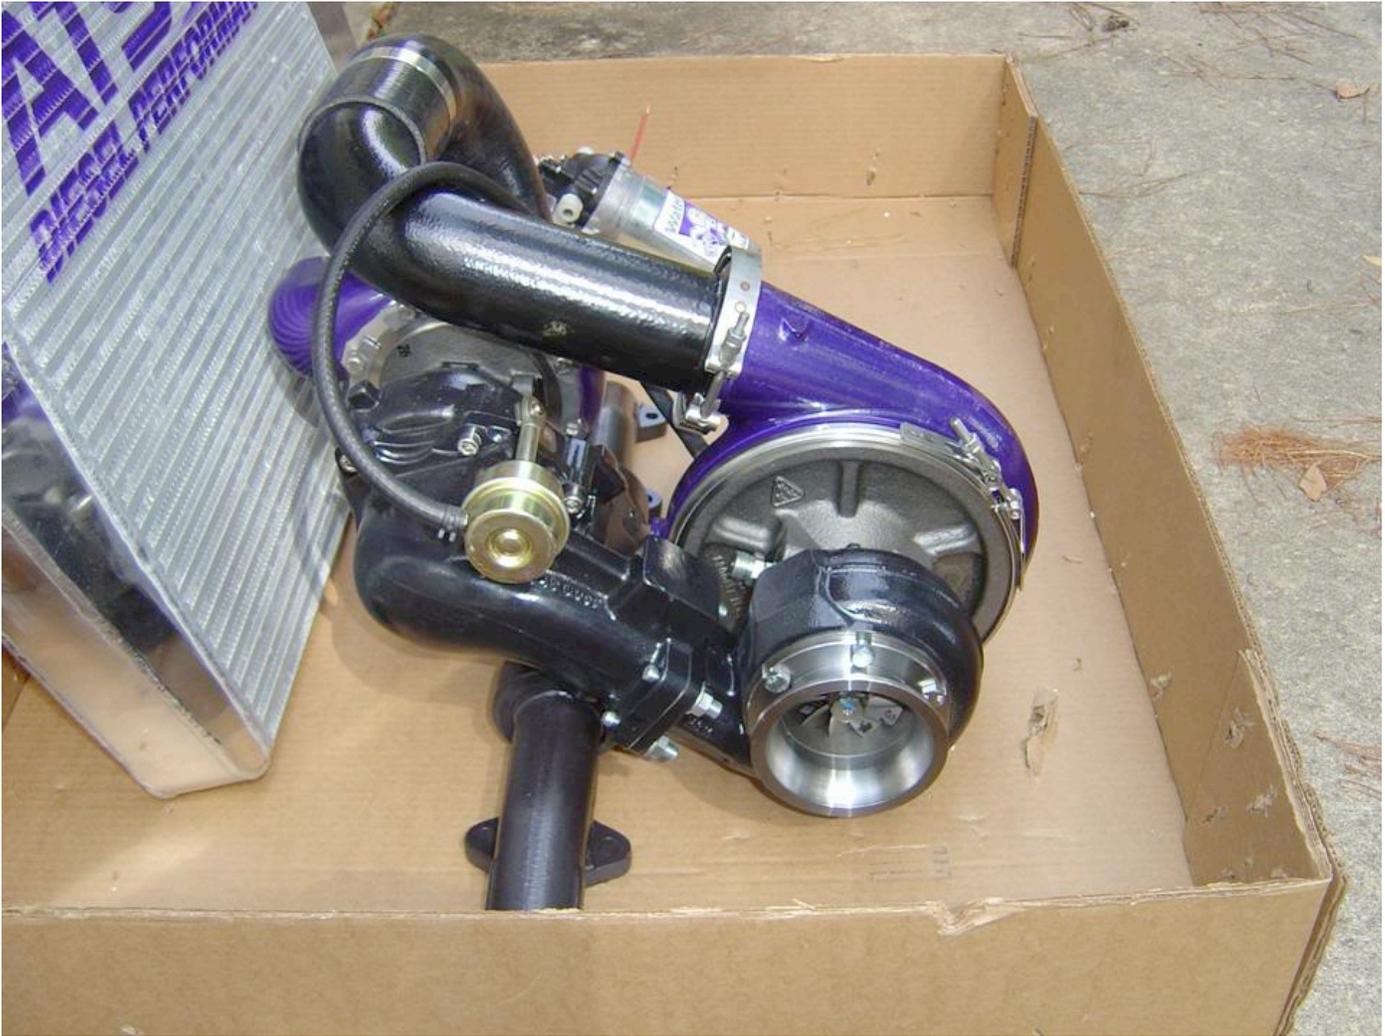
When the parts arrived, they were in very different conditions from each other. The ATS kit came completely assembled and made for a very easy install. You had the finished product to look at prior to installation.

The parts arrived complete, free of rust and corrosion and clocked correctly for the application.

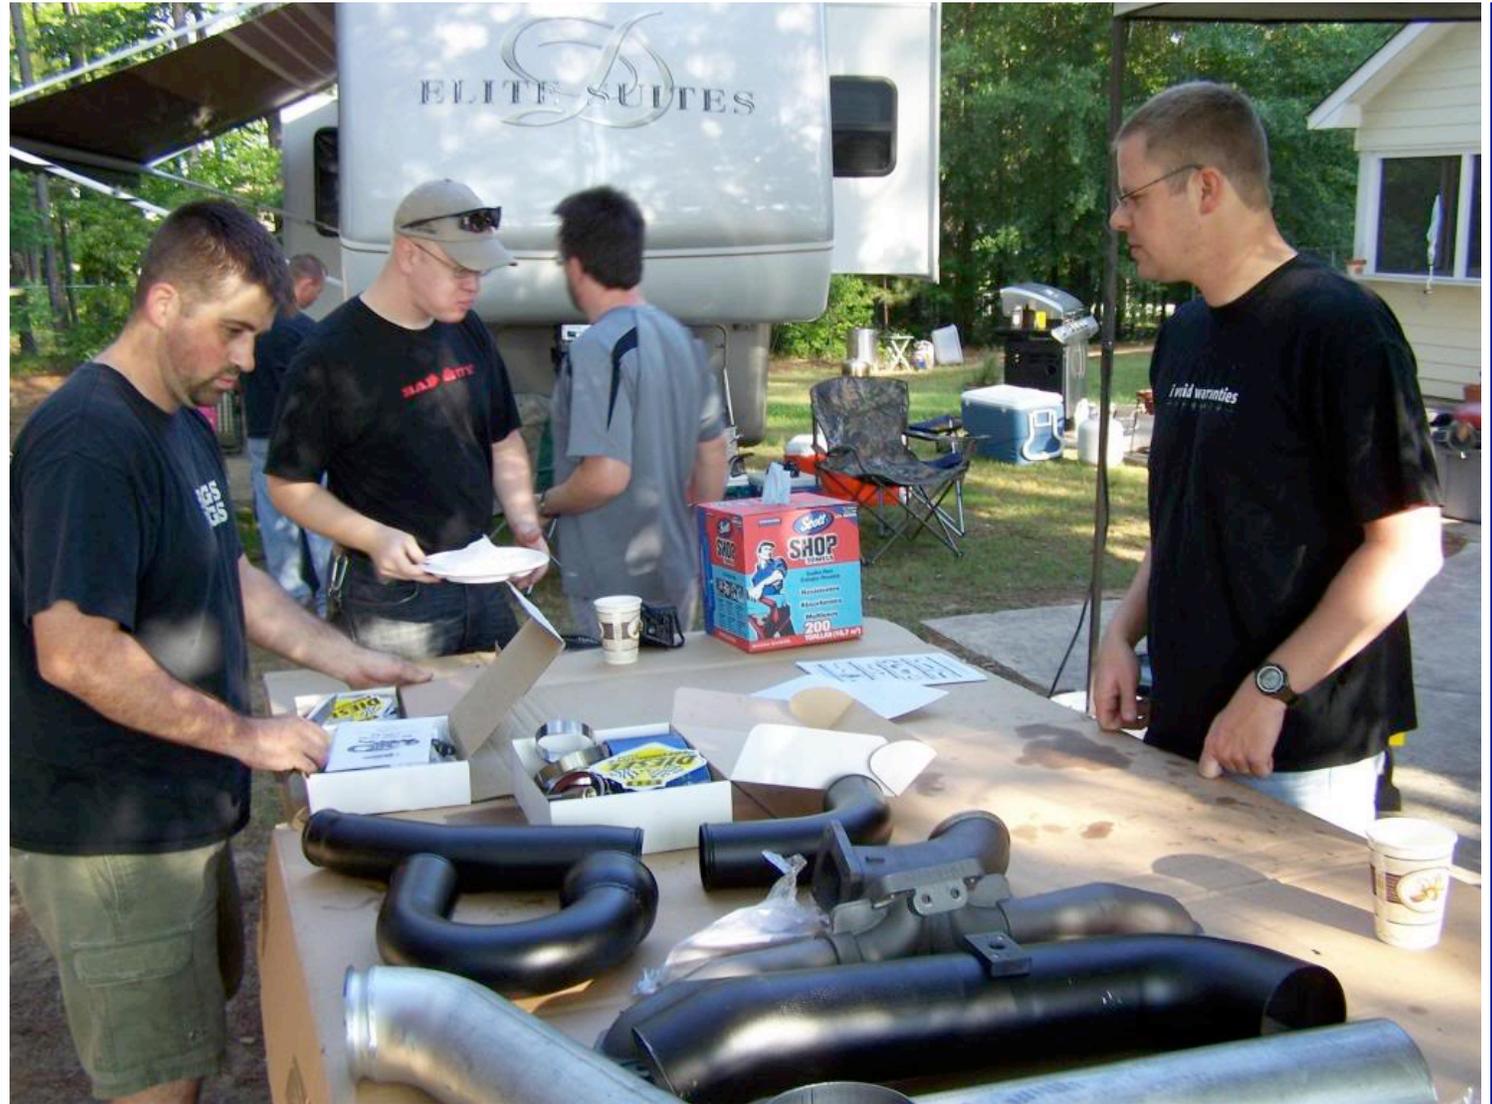
The BD kit arrived in multiple boxes and unassembled. Upon initial inspection, there were numerous parts missing (as noted previously) and there was considerable rust and corrosion on and in the turbine housing.

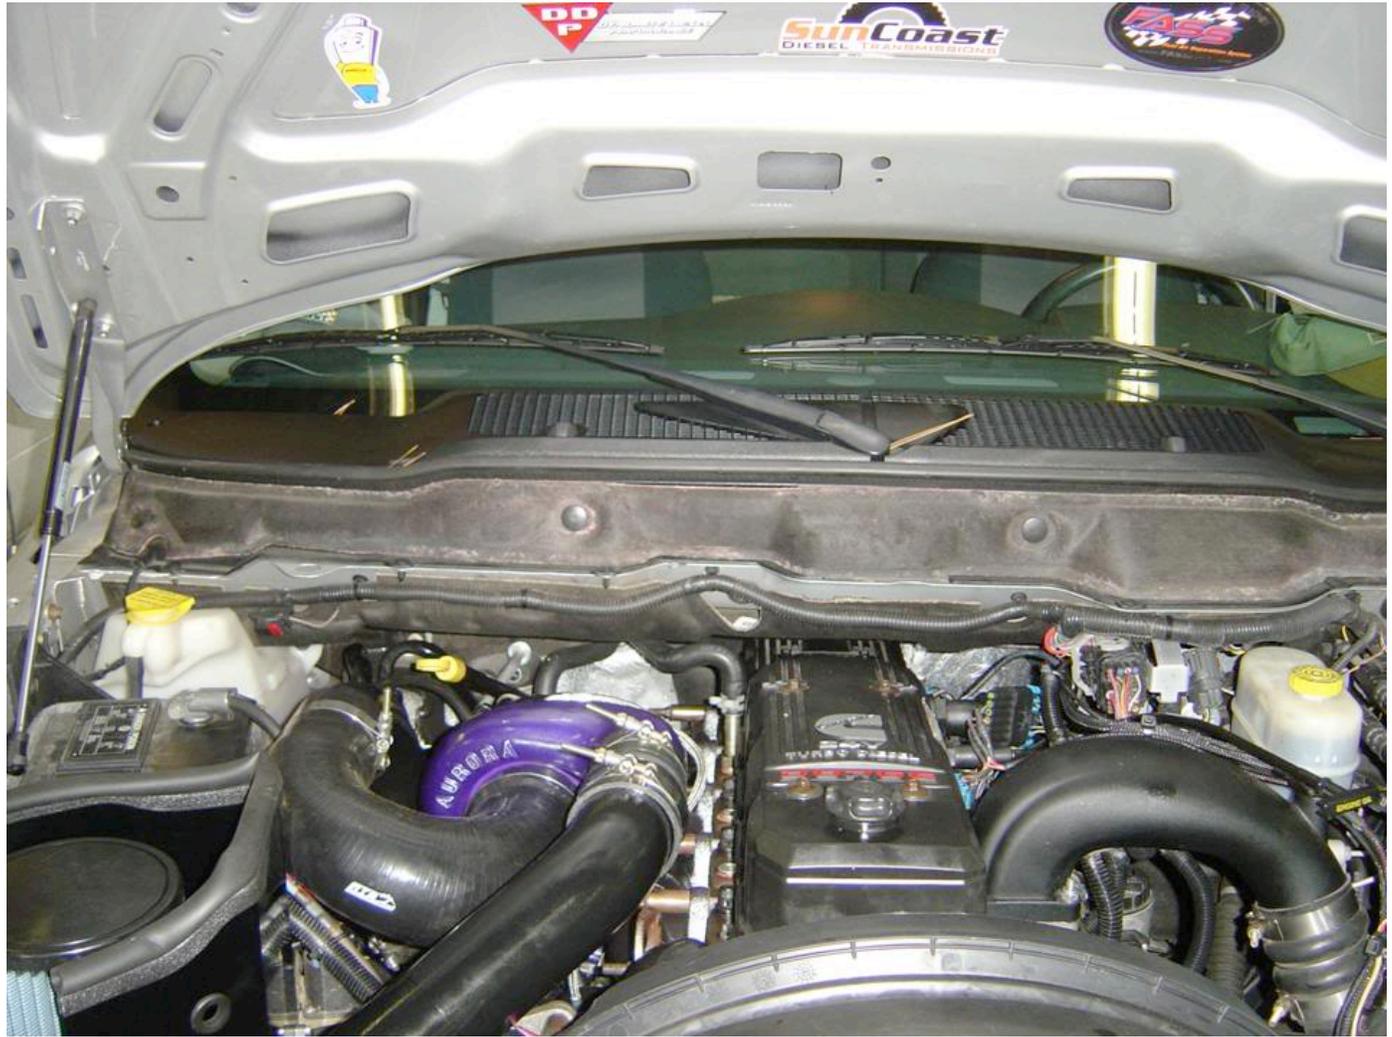
Now from this point, the installations were vastly different. For the ATS setup, I was done in a single day (minus the fix for the AC line and getting the new boost boot for the ATS intercooler). I began this install at 11 am and was finished and running by 6 pm, including putting the stock intercooler back on. I did this install by myself with no help other than having my neighbor help lower the primary turbo into position.

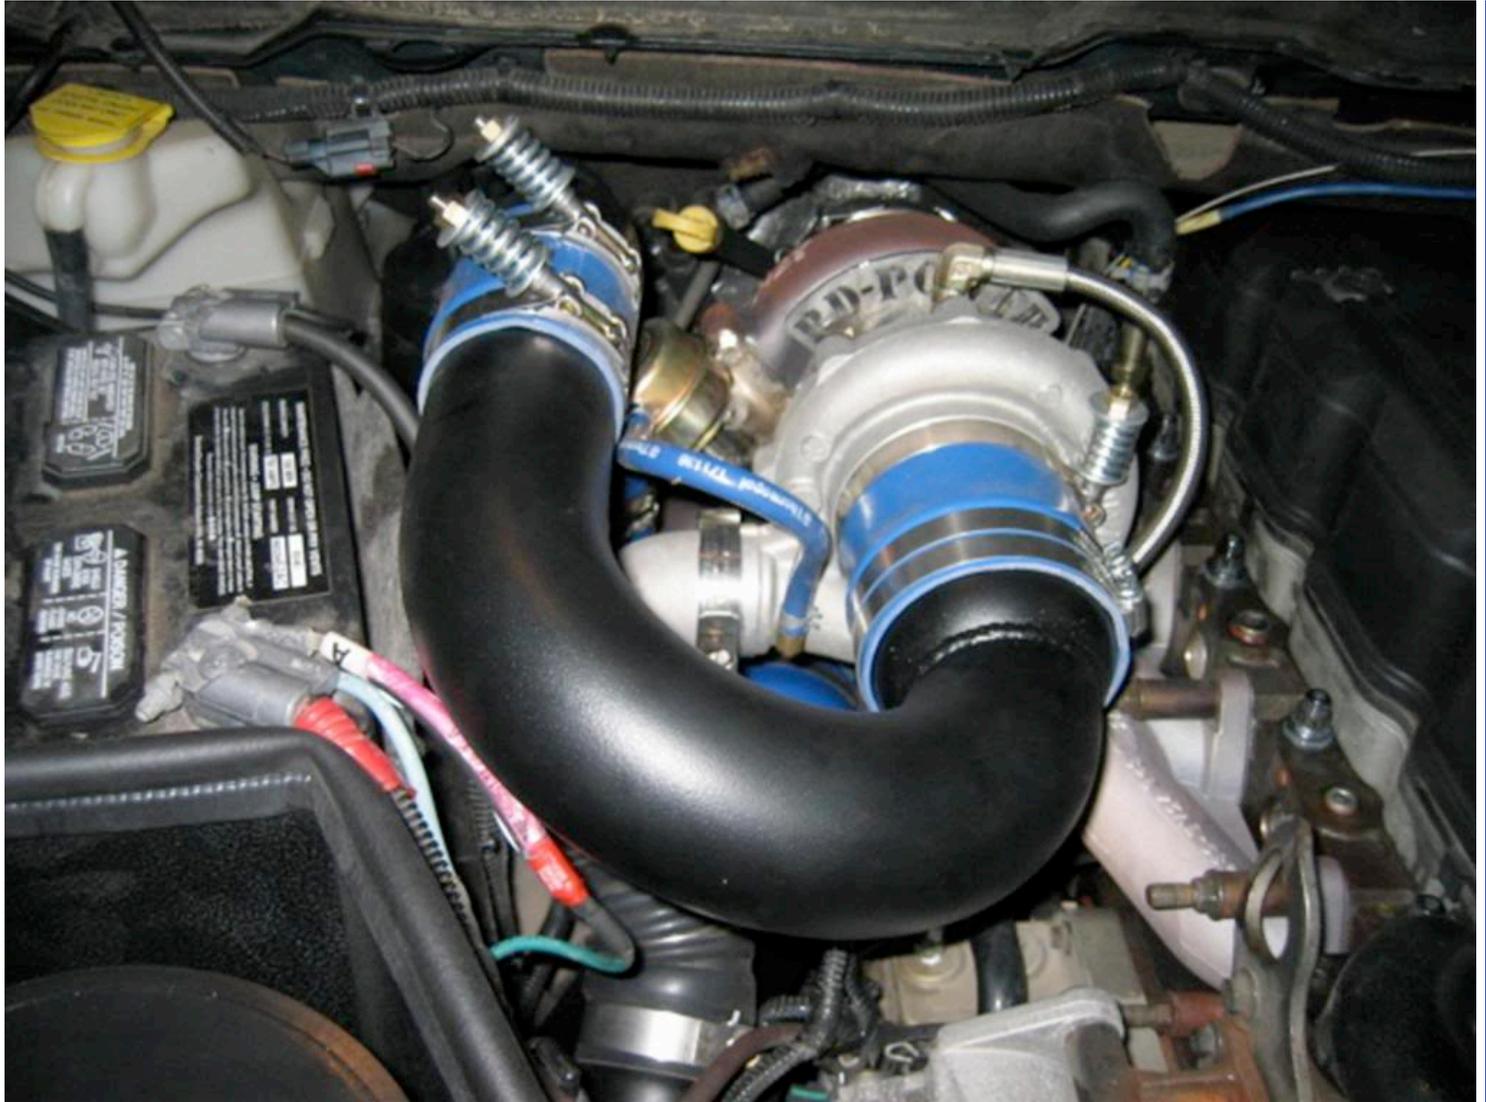
The BD kit, too 2 days to complete. This was done with 5 people assisting at various stages of the installation. We began Day 1 at 8 am and worked until 1030 PM. The next day we began at 8 am and finished at approx 3 pm. The experience of the crew that were present for this install included myself, a factory trained Dodge parts / service manager, a diesel bus fleet manager and several others with considerable time turning a wrench.

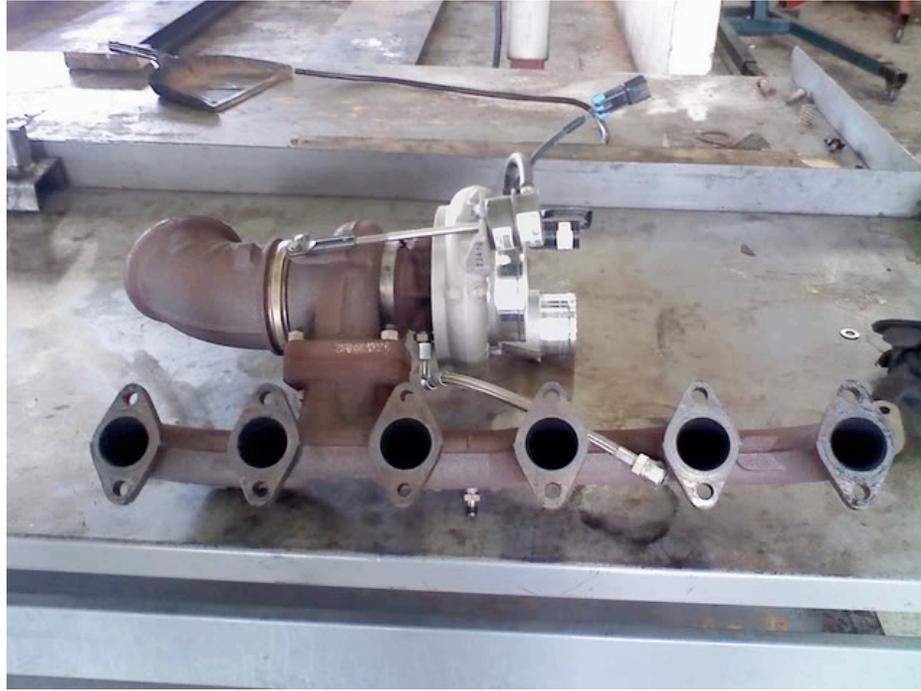
Silver 2500:

To begin, obviously all the original parts had to be removed. Both of the trucks had OEM manifolds and turbos, both had AFE Stage II intakes, both had 5" exhausts installed. The blue 3500 had a Pac-Brake that had already been disconnected and posed no additional labor to remove.

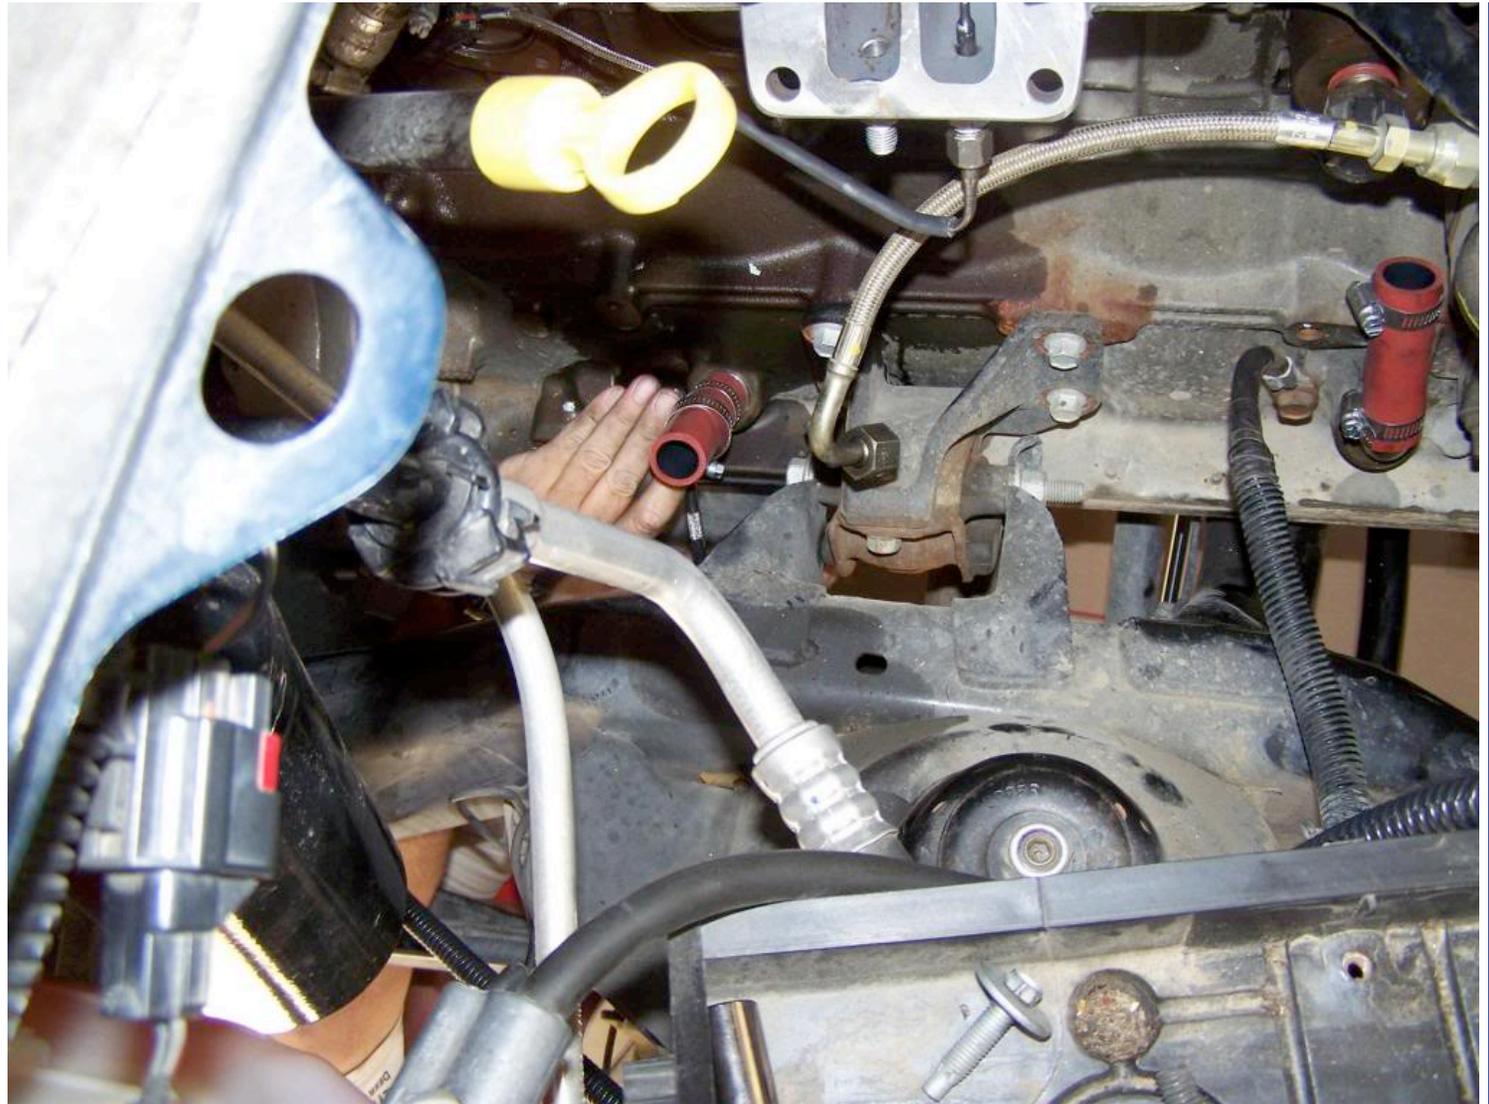
Once the old intakes, manifolds, turbo's and passenger side batteries were removed, we can now start doing a few things were common to both kits, but became uncommon very quickly. Both kits require pulling out a frost plug leading to the oil pan for the drain on the secondary charger.

The picture below shows where the OEM return is (rear of engine) and the new secondary drain is located (front of engine)

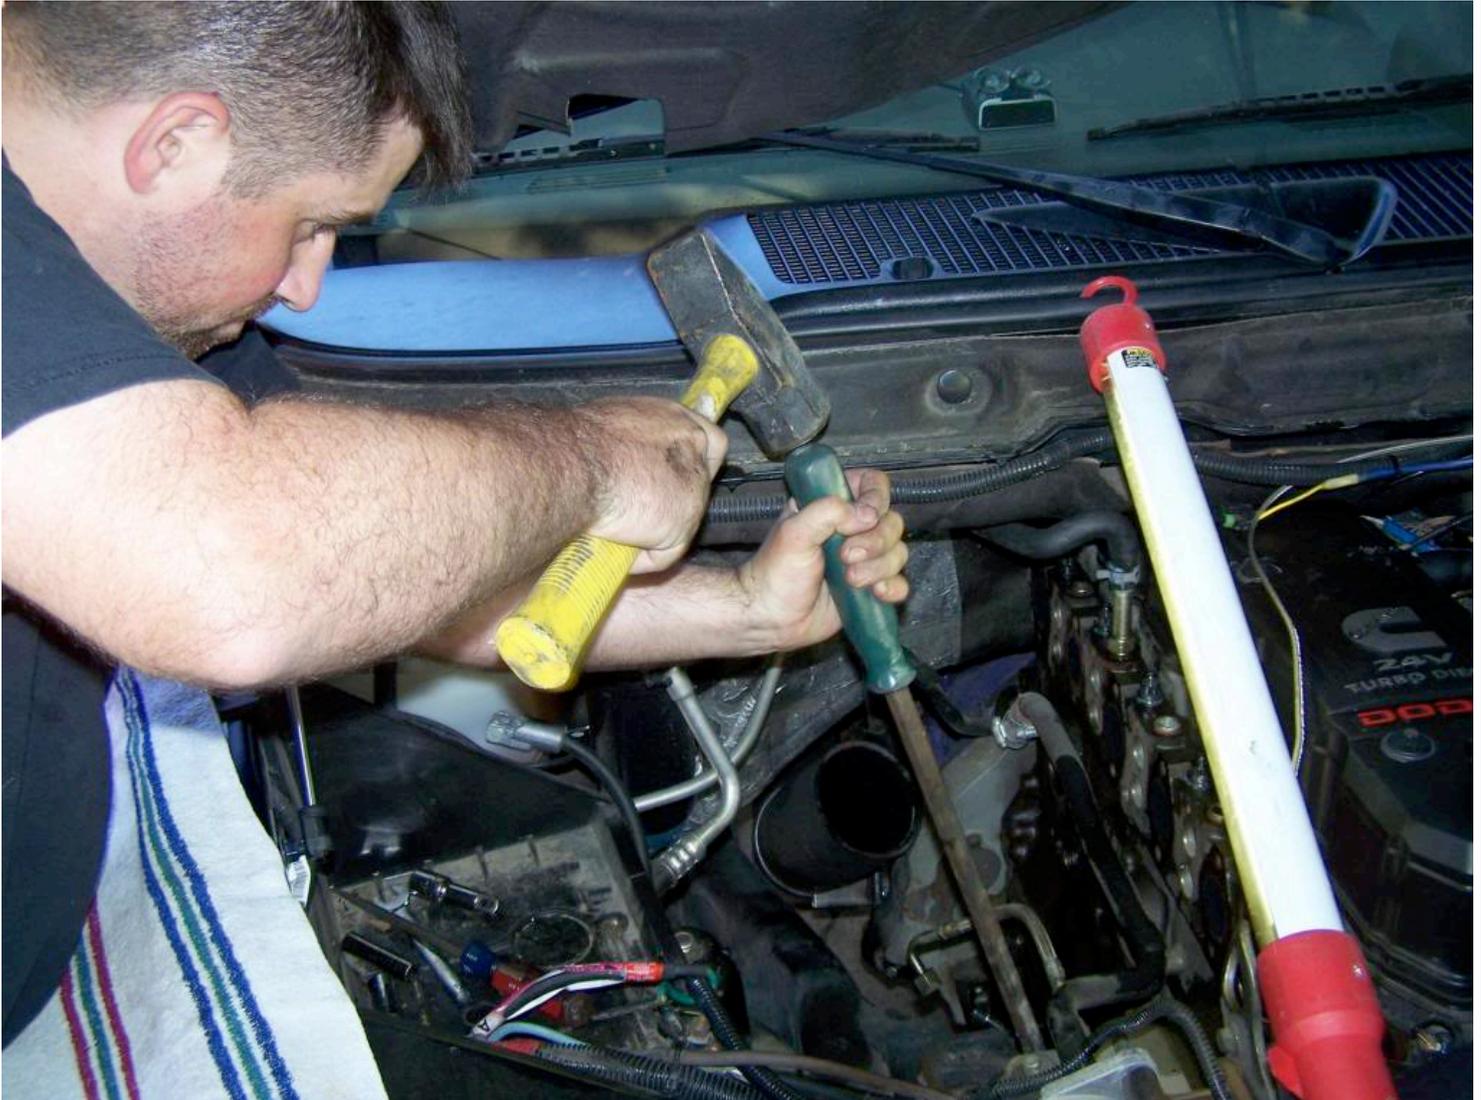
The secondary turbo also required a steel adapter to go in the frost plug hole. This adapter did not fit. The instructions said that you may have to use a punch to get it to fit....this was a mild understatement.

I tried brass and steel punches, using a reasonable amount of force and it would not even seat. I ended up need to use a pry bar and a mallet to mark the adapter where it was oversized so it could be re-sized with a die grinder.

Once it was chamfered and resized, the secondary adapter was installed. The picture below is of those two components and their associated hoses and clamps installed.

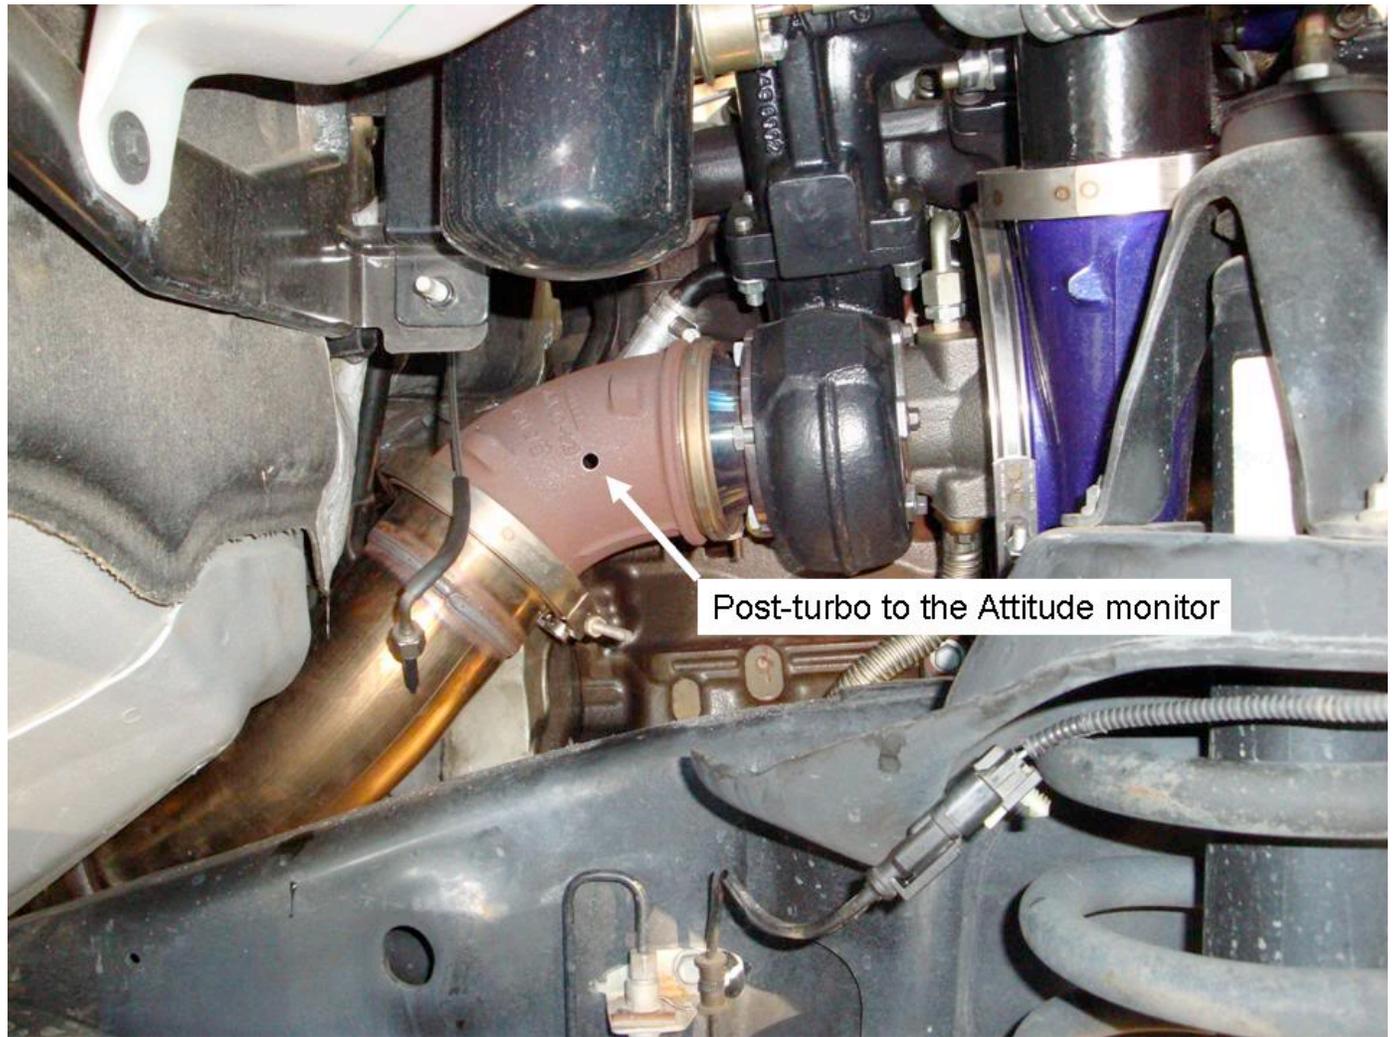
Now, from here, the ATS primary was attached the OEM exhaust elbow by removing the locator roll pins in the elbow and loosely attaching it to the existing down pipe for alignment and attachment to the secondary.

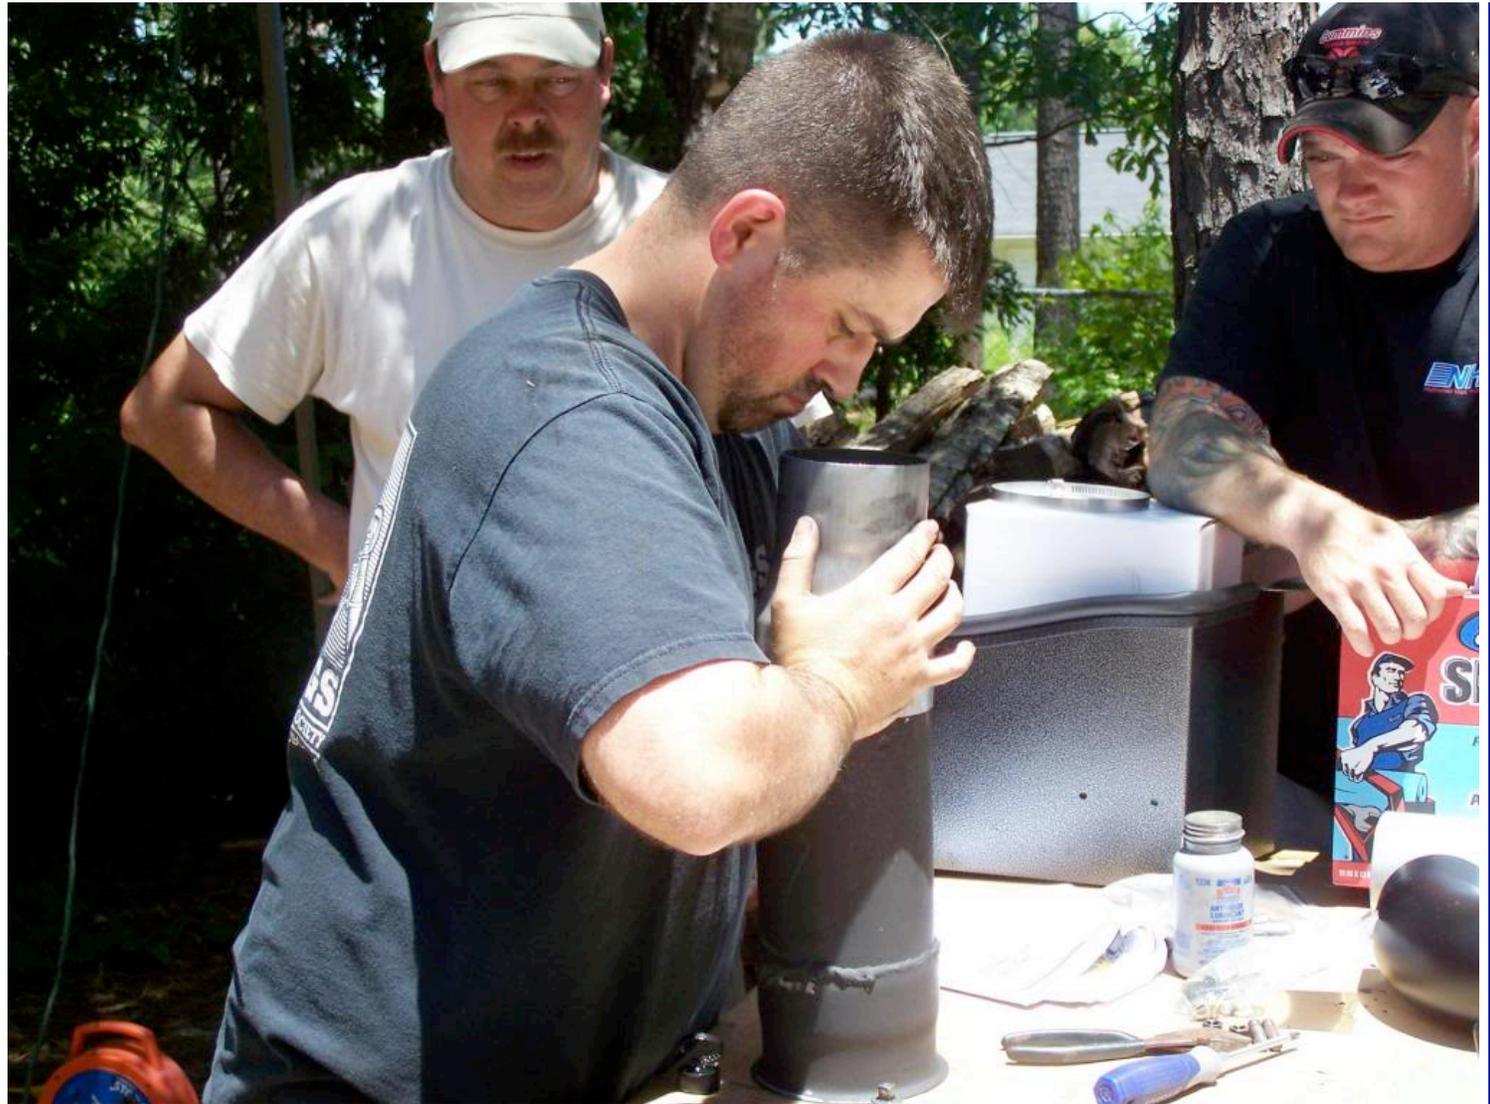
The BD kit does not sit in the OEM location and cannot reuse the existing elbow or down pipe. This presented a problem as both trucks had 5" exhausts and the BD downpipe that comes with the kit is 4", which required getting an adapter to mate the two. This also eliminated the possibility of using the existing exhaust elbow and the post-turbo pyrometer used to monitor the exhaust brake.

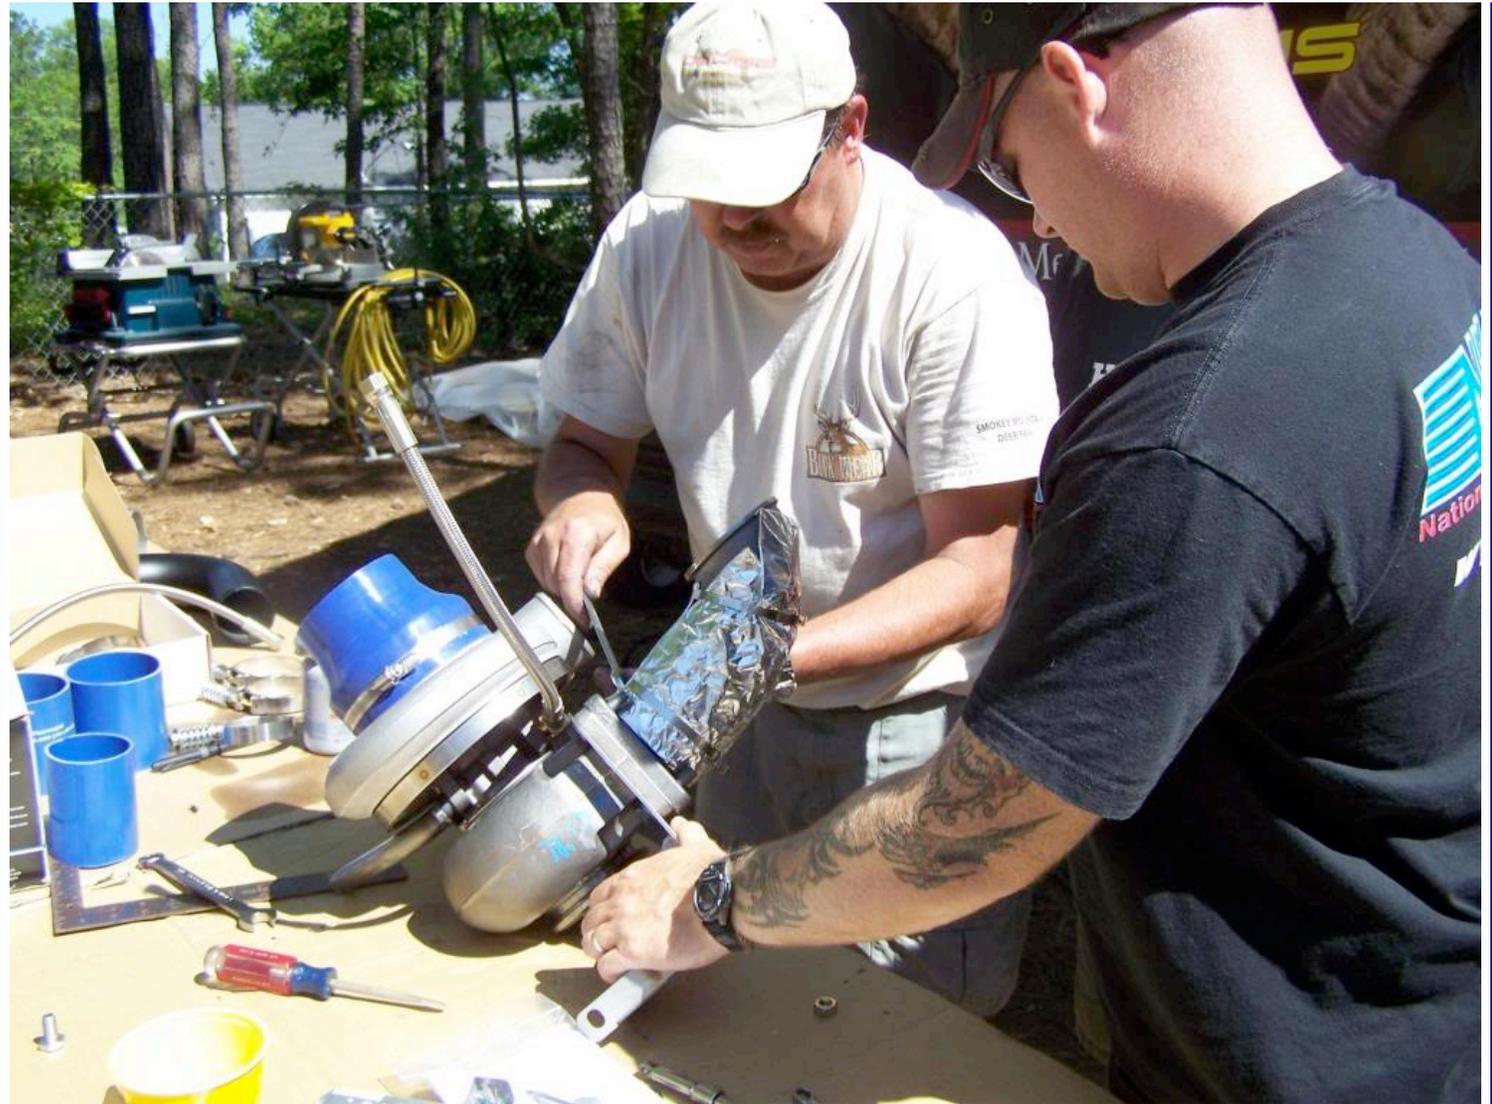
From here, you must fit the exhaust adapter from the secondary to the primary on the BD compound. This again presented a problem. The studs supplied with the kit were incorrect in thread pitch, count and coarseness. We had to run to the hardware store to get fasteners of the correct type to bolt the adapter to the primary.

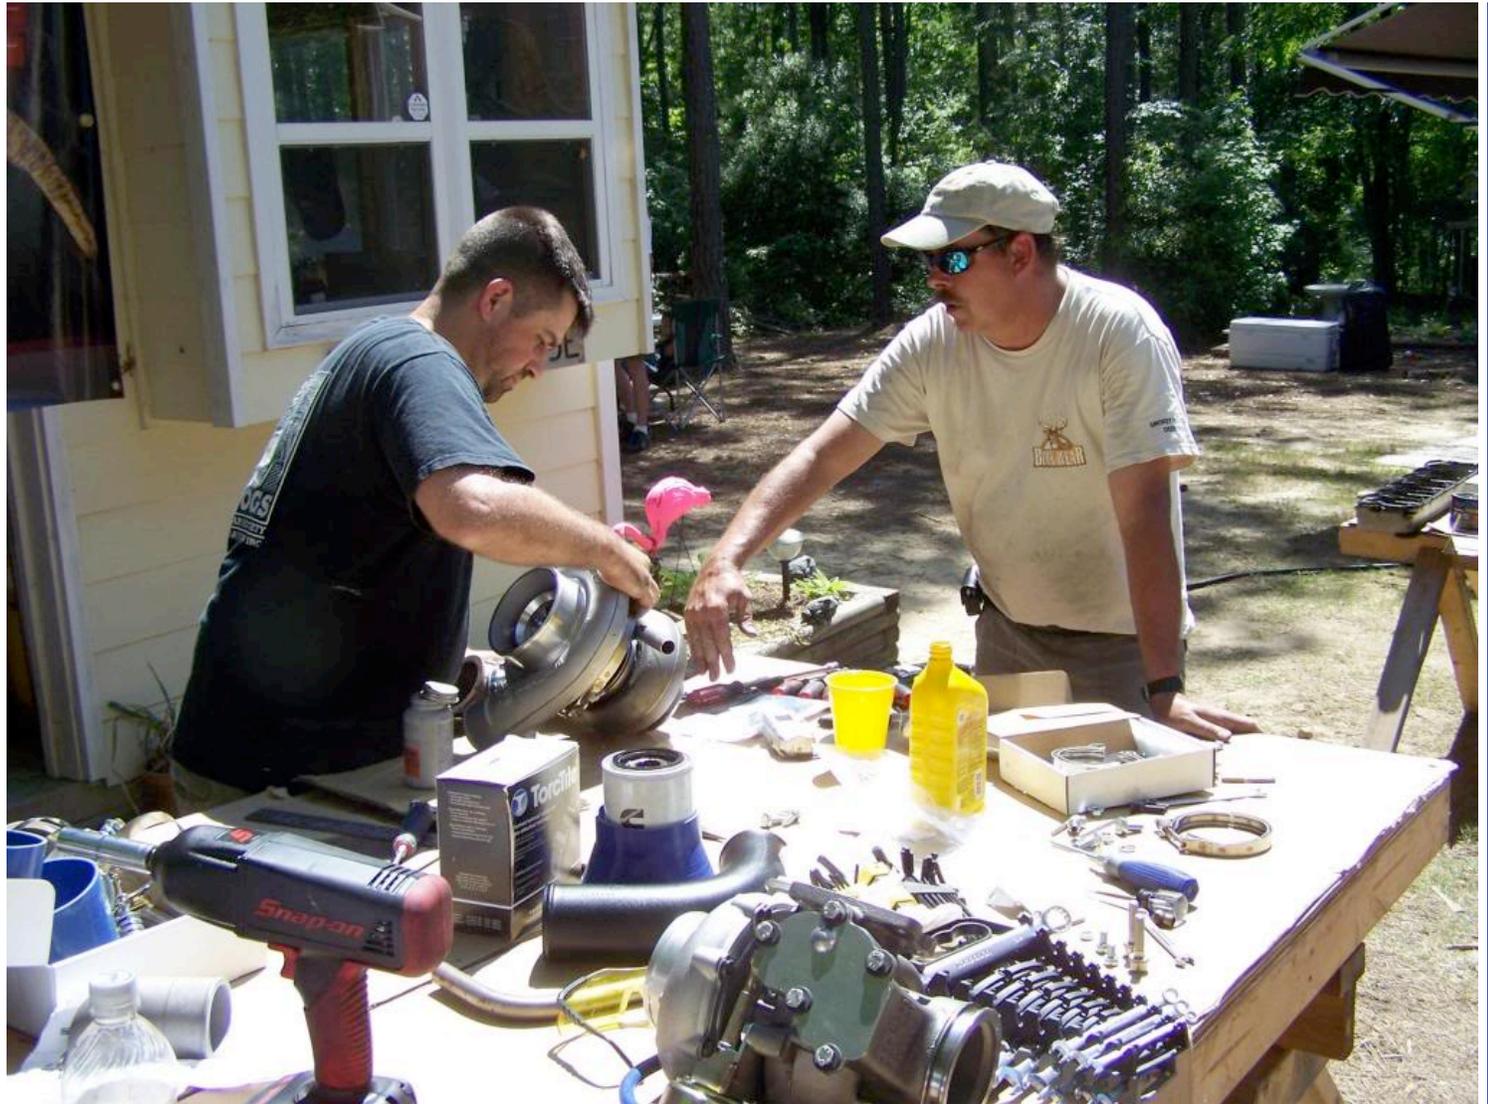
Once the primaries were positioned, we found the clocking that was called for in the BD directions was incorrect, so this was adjusted.

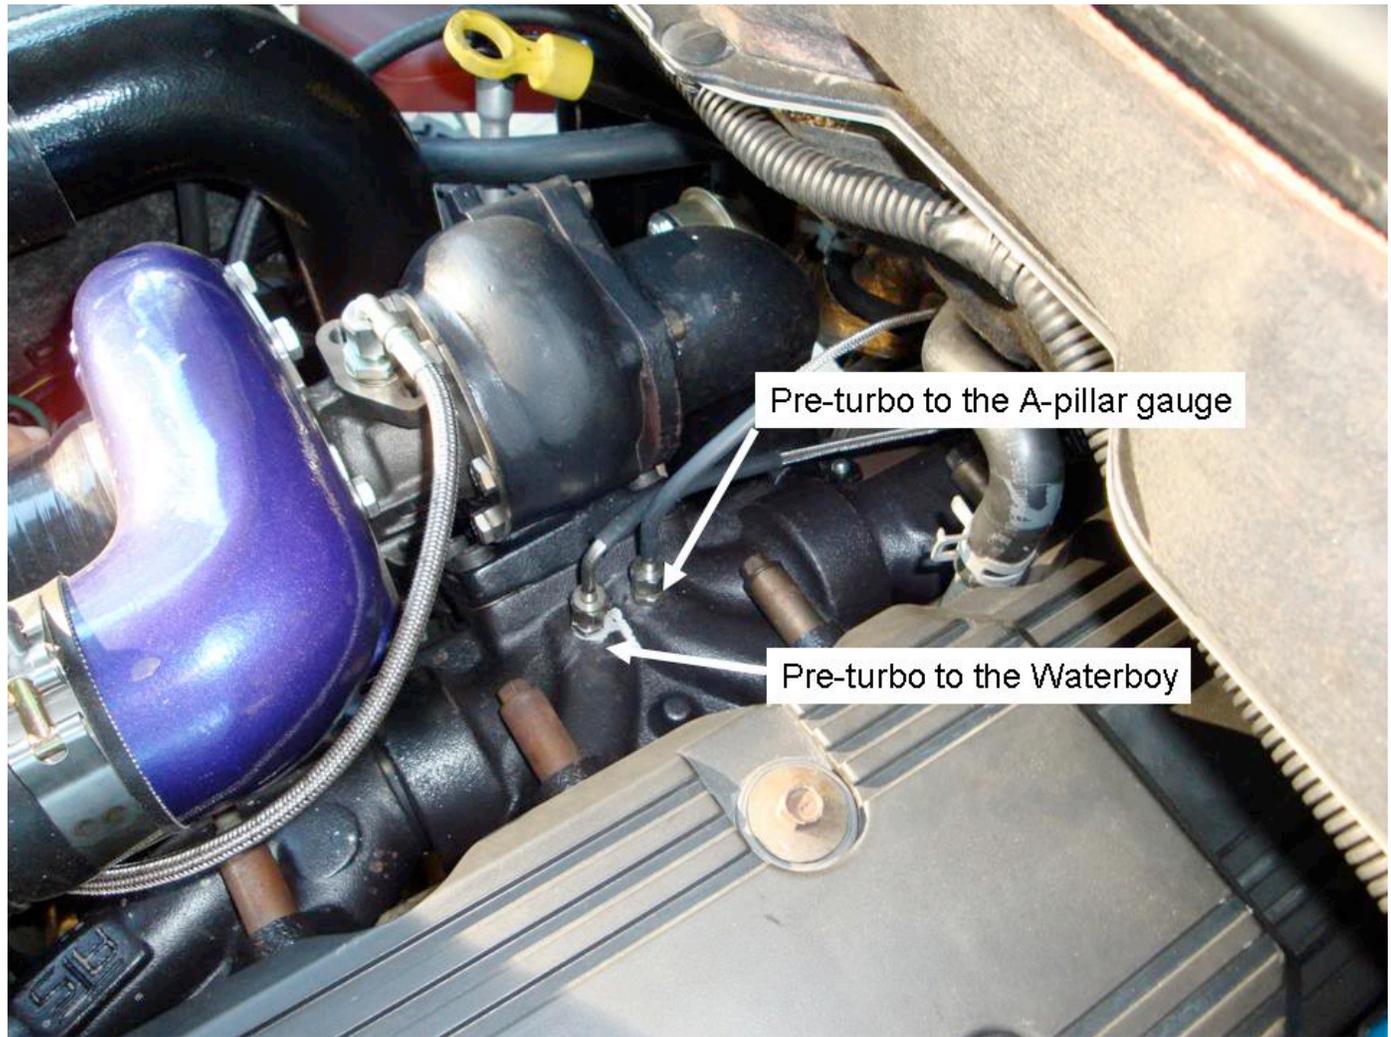
The ATS manifold came pre-drilled and tapped with four 1/8 NPT ports. Two on top and two on the bottom. These ports were in the correct locations for the application and were correctly tapped.
