ATS or BD.....you decide.

The products that I'll be discussing are two competing sets of compound turbos, both installed on 2006 Dodge Ram's with Cummins Turbo Diesel engines. One set was from ATS, which included the Aurora 3000 and Aurora 5000 turbos and the other was from BD Power, which included the SuperB and R700 turbos. Both are advertised as towing / race setups.

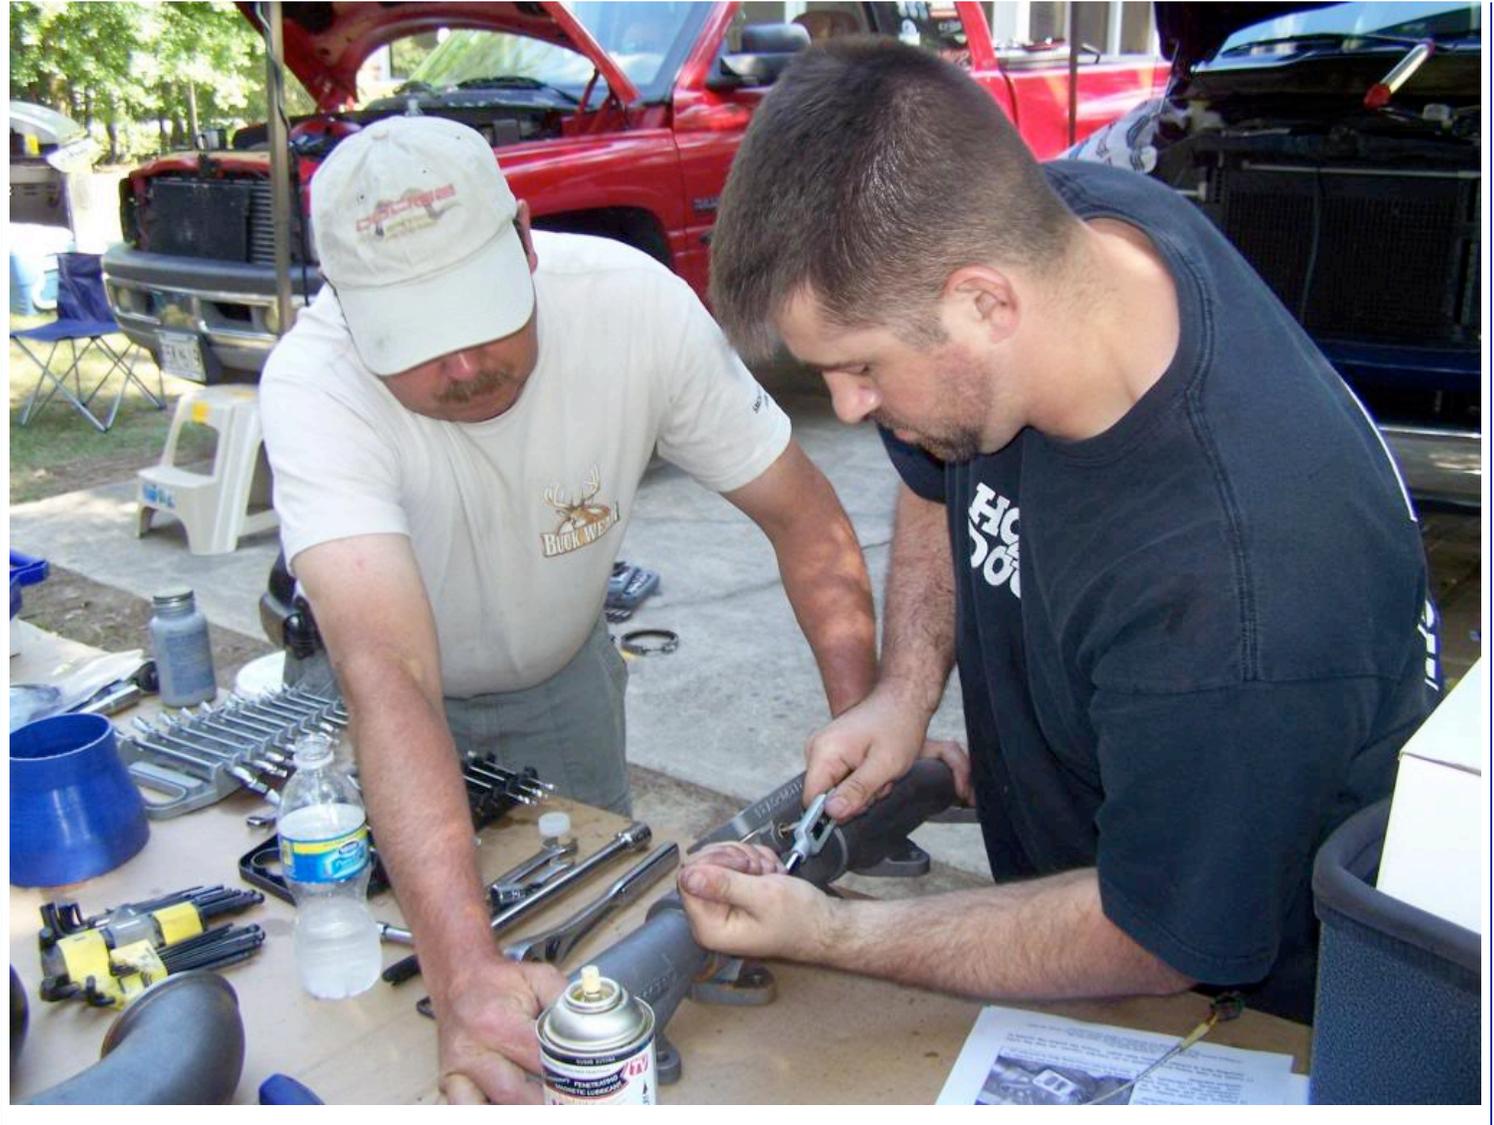
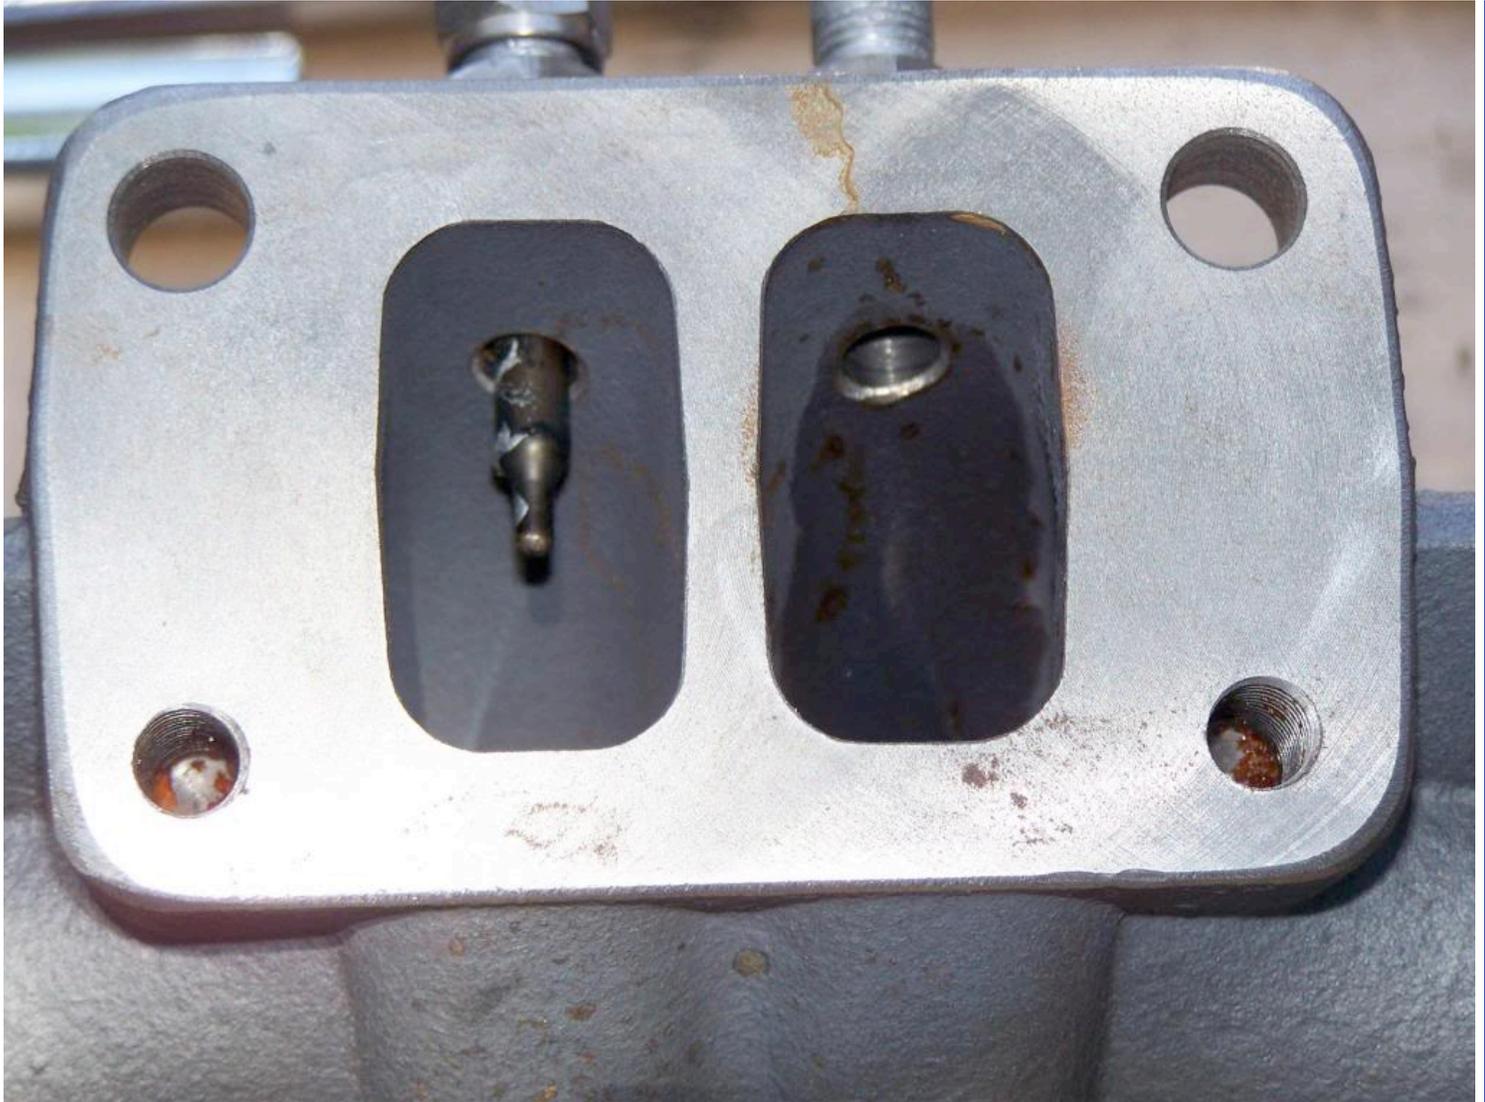
The BD kit came with two pre-drilled and tapped ports. The ports, as the manifold was to be installed, were located on the bottom of the manifold. They were also not tapped deep enough to properly seat a 1/8 NPT fitting. We could only get 2 threads of the probe fitting in before it stopped. This required tapping the manifold further to allow proper EGT probe function.

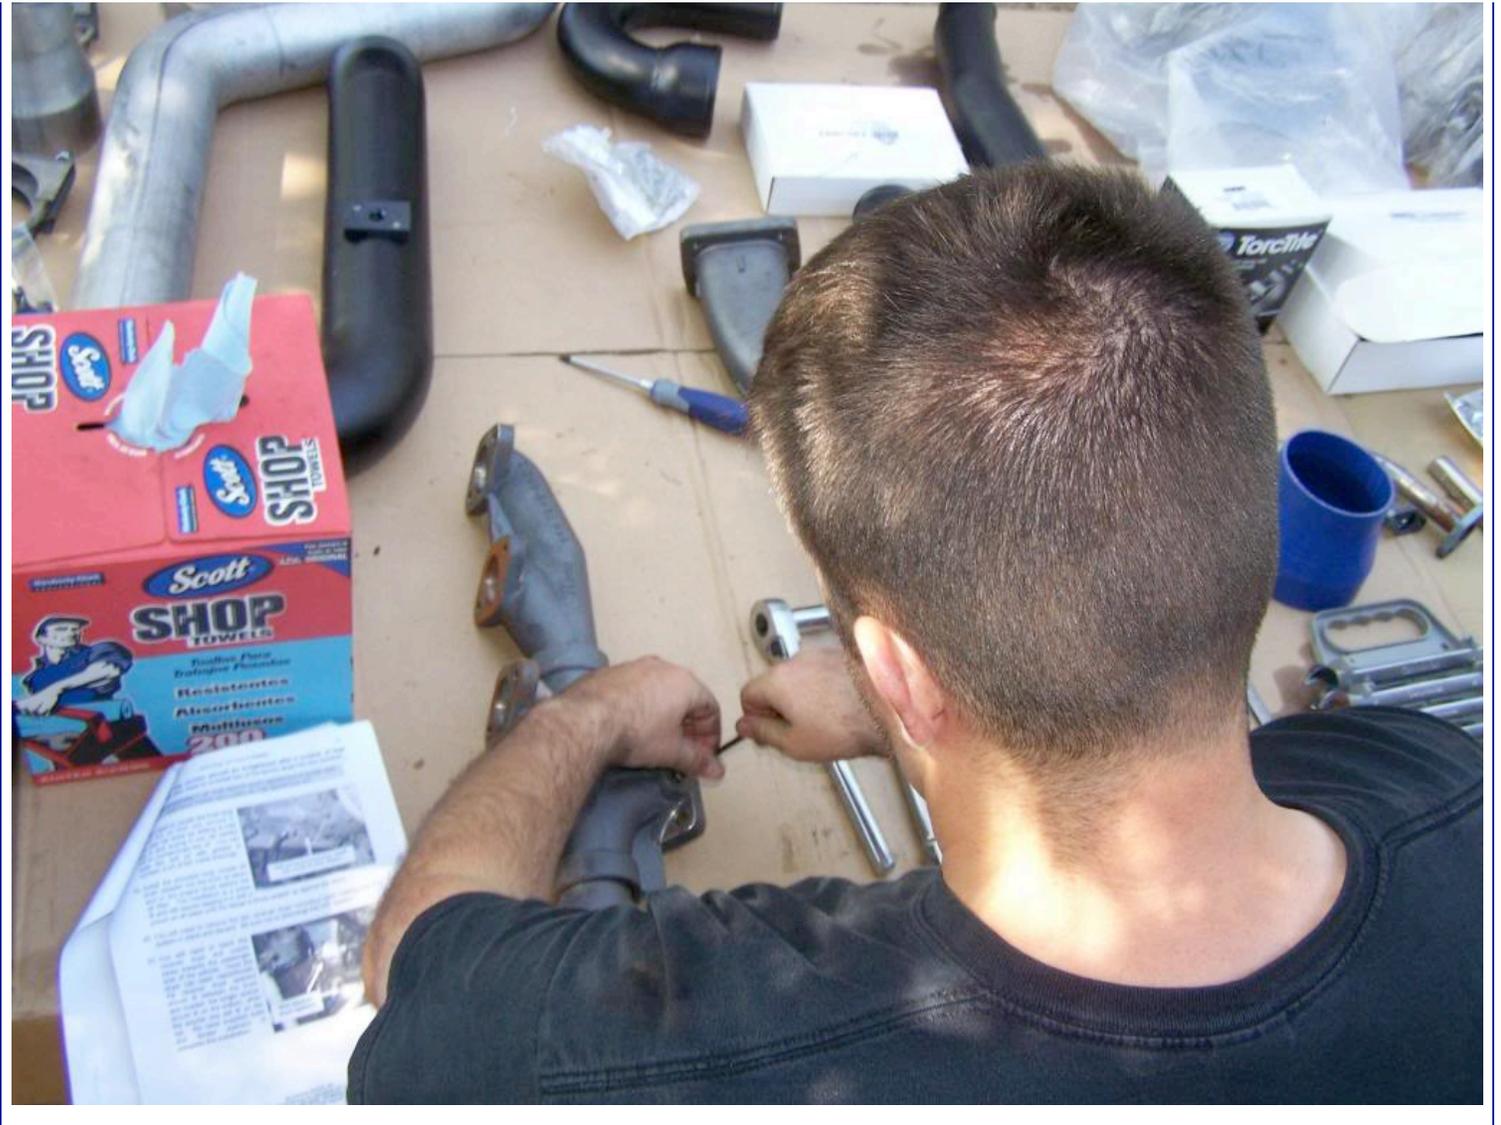
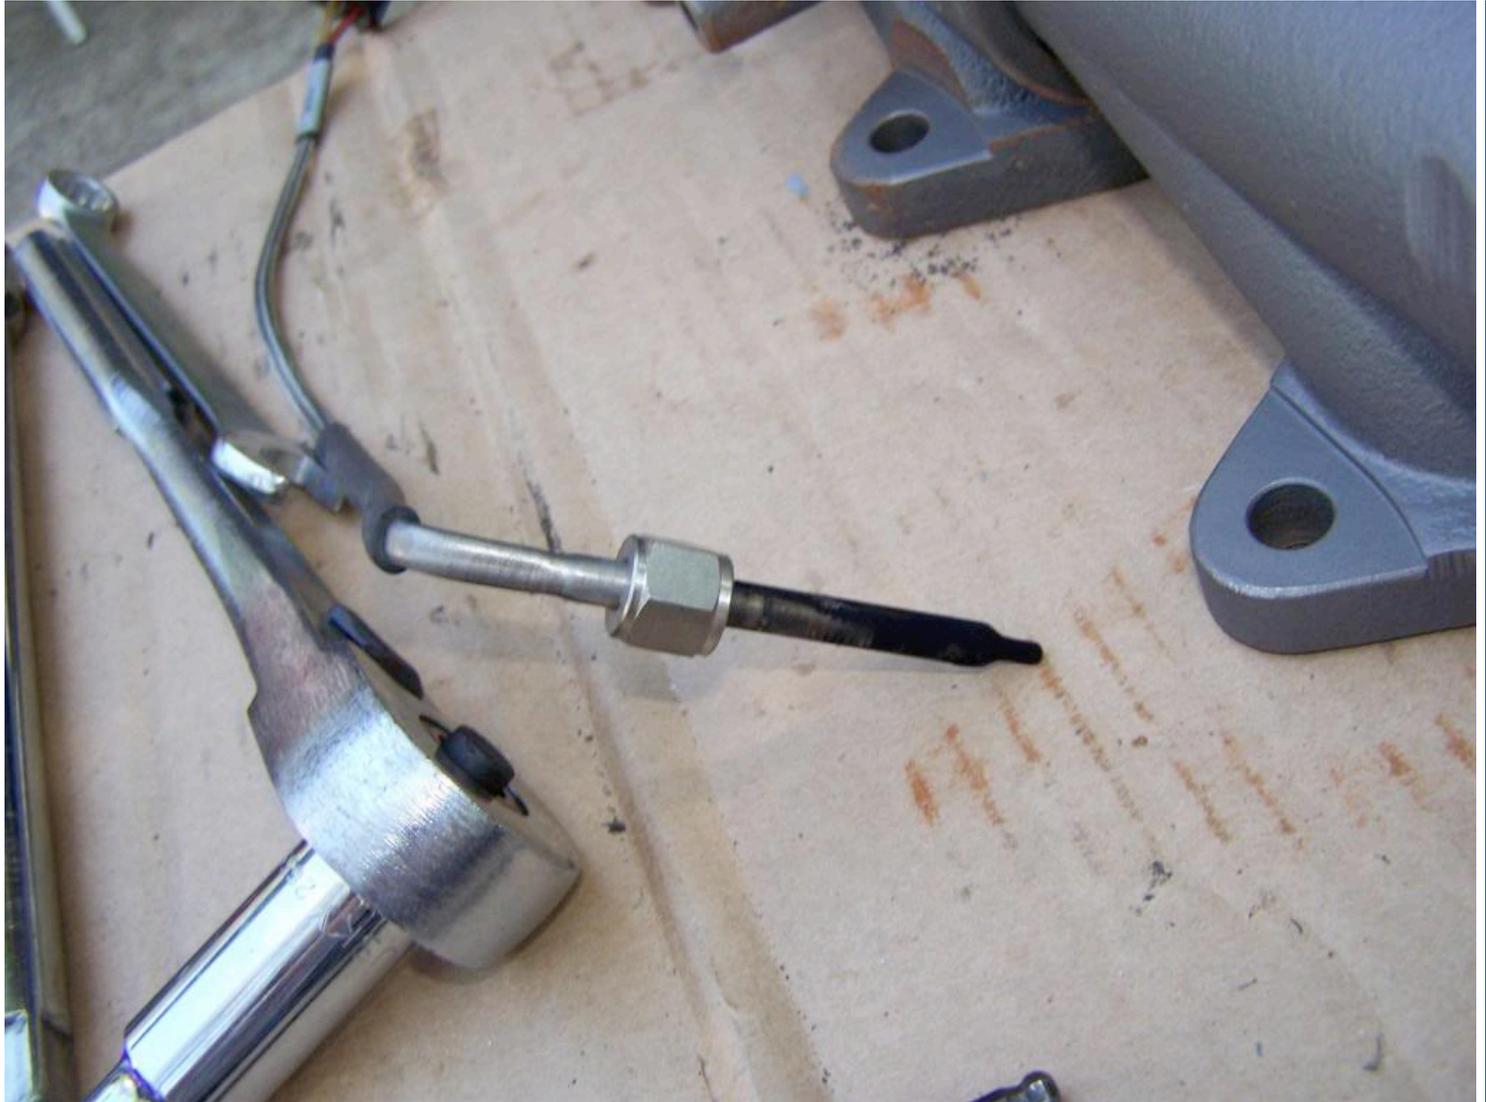
Once this was done, we installed the EGT probes and found another problem. The location of the ports on the bottom of the BD manifold did not allow enough clearance for straight type EGT probes. The probes ran directly into the side of the SuperB compressor housing. We ended up taking two 90* probes off of another truck to make them fit.

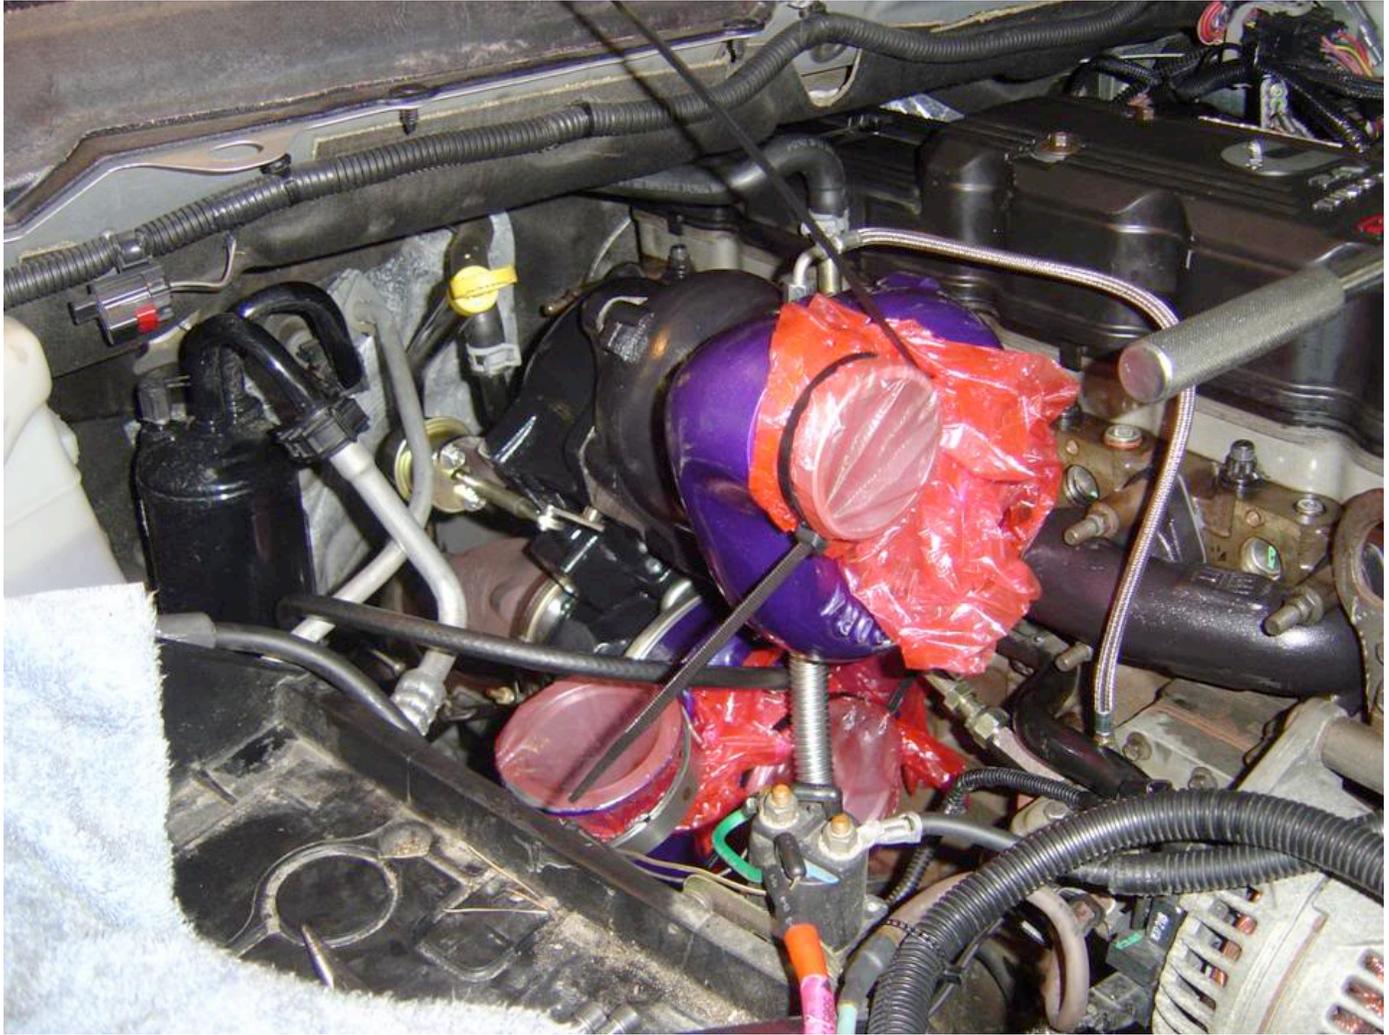
The ATS kit already had the secondary attached to the manifold, so all I had to do was check for proper torque specs on the fasteners.

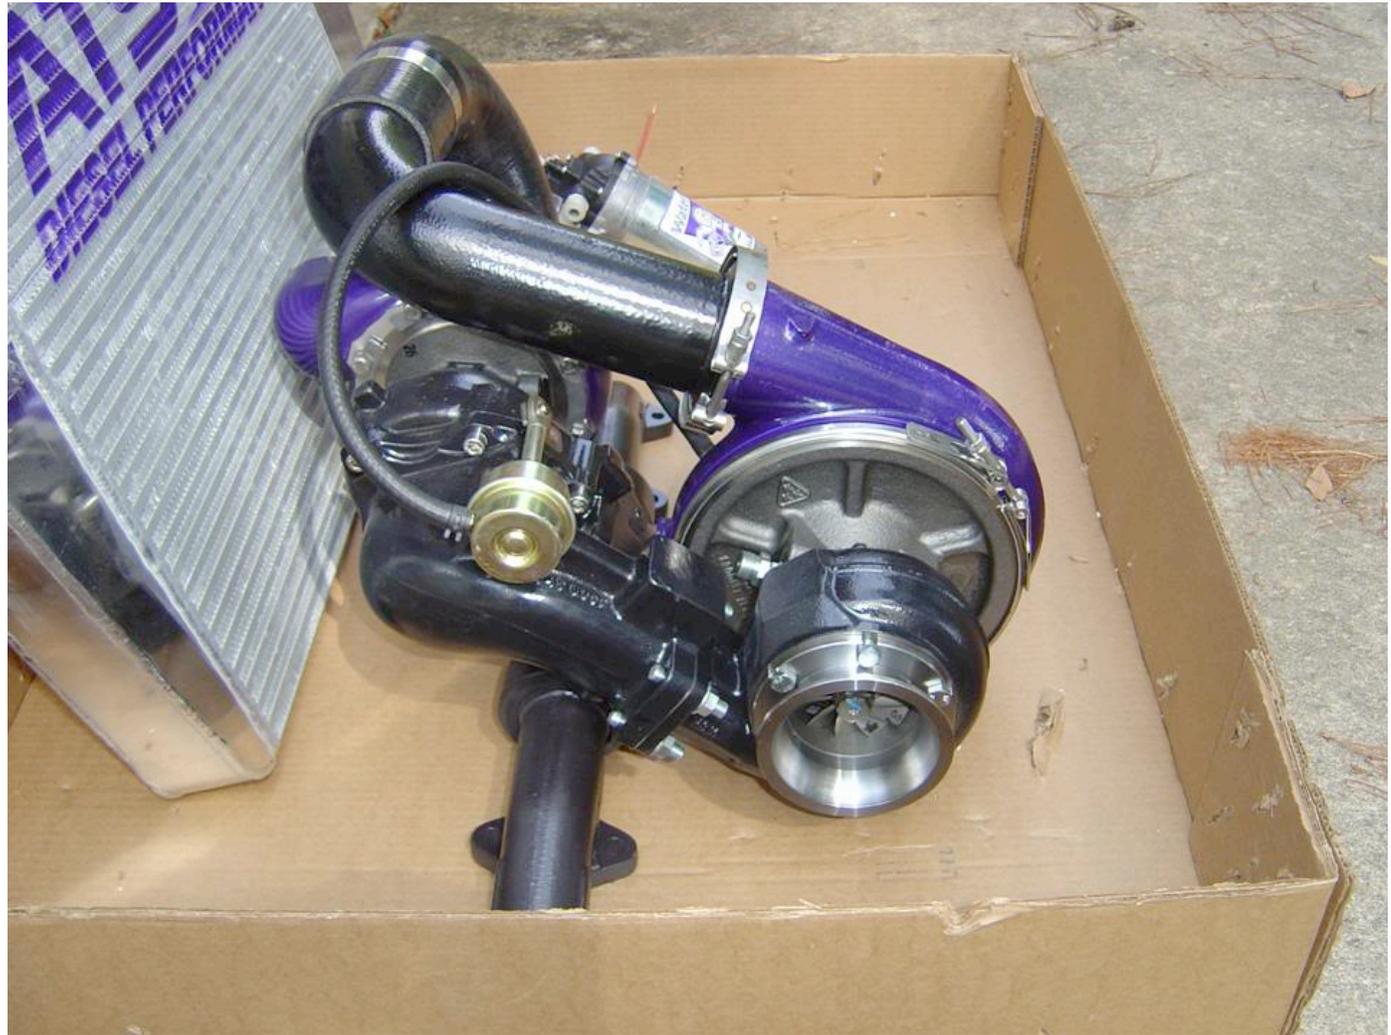
From here, the ATS kit requires attaching the exhaust adapter to the turbine housing of the secondary. This was simply a matter of lining up the holes and attaching the bolts. Using a ratchet wrench is essential here, otherwise you'll be making minute turns on two of the hard to reach bolts. The picture below shows the ATS exhaust adapter and where it fits to the secondary.

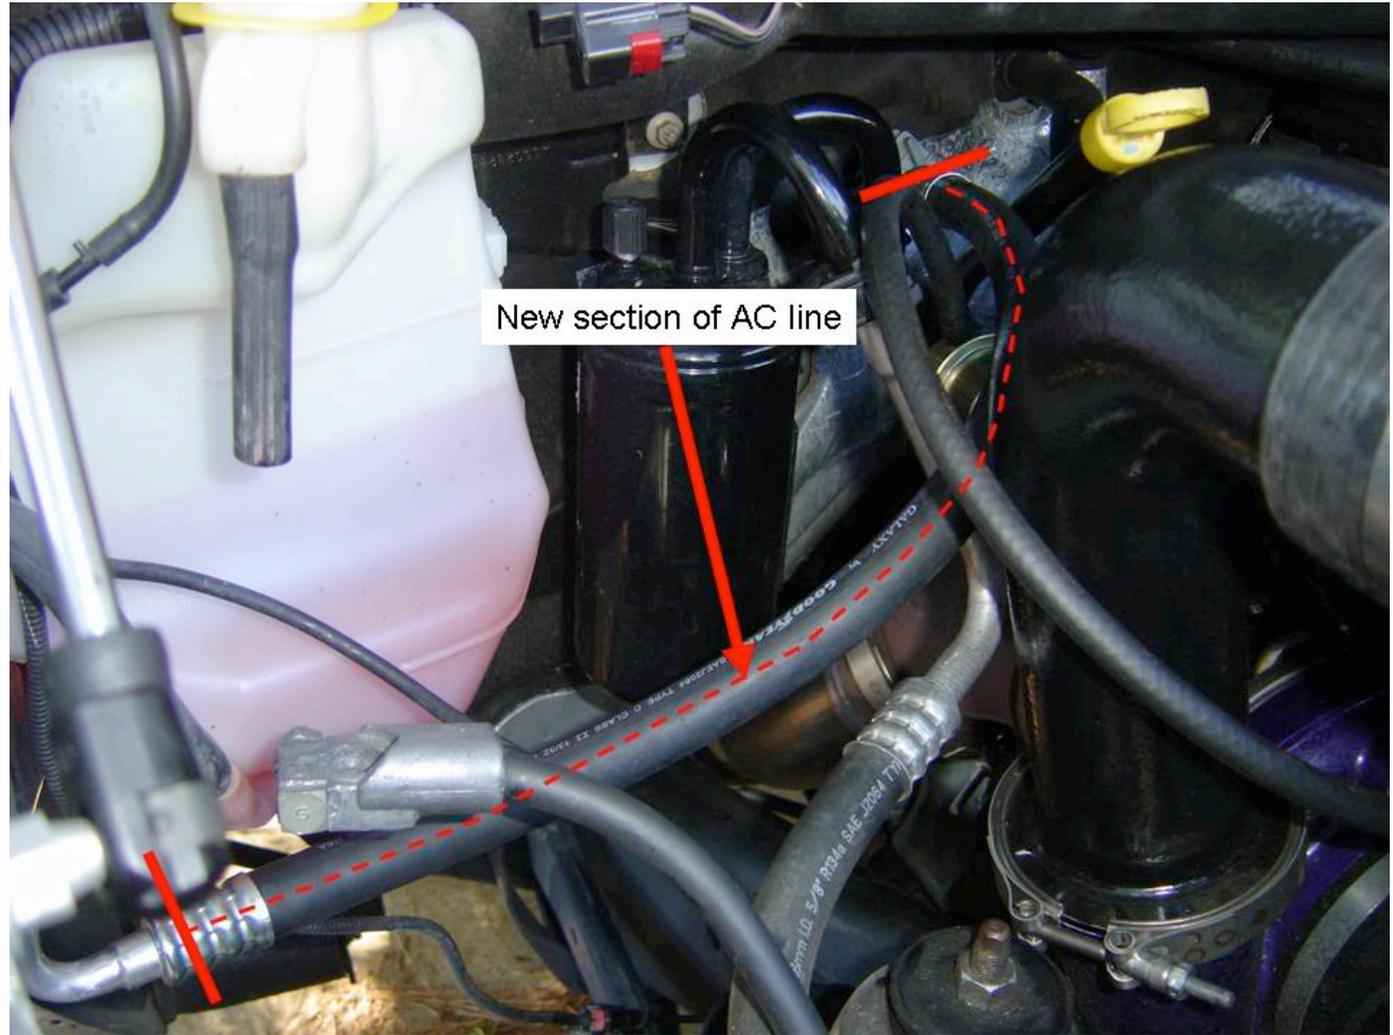
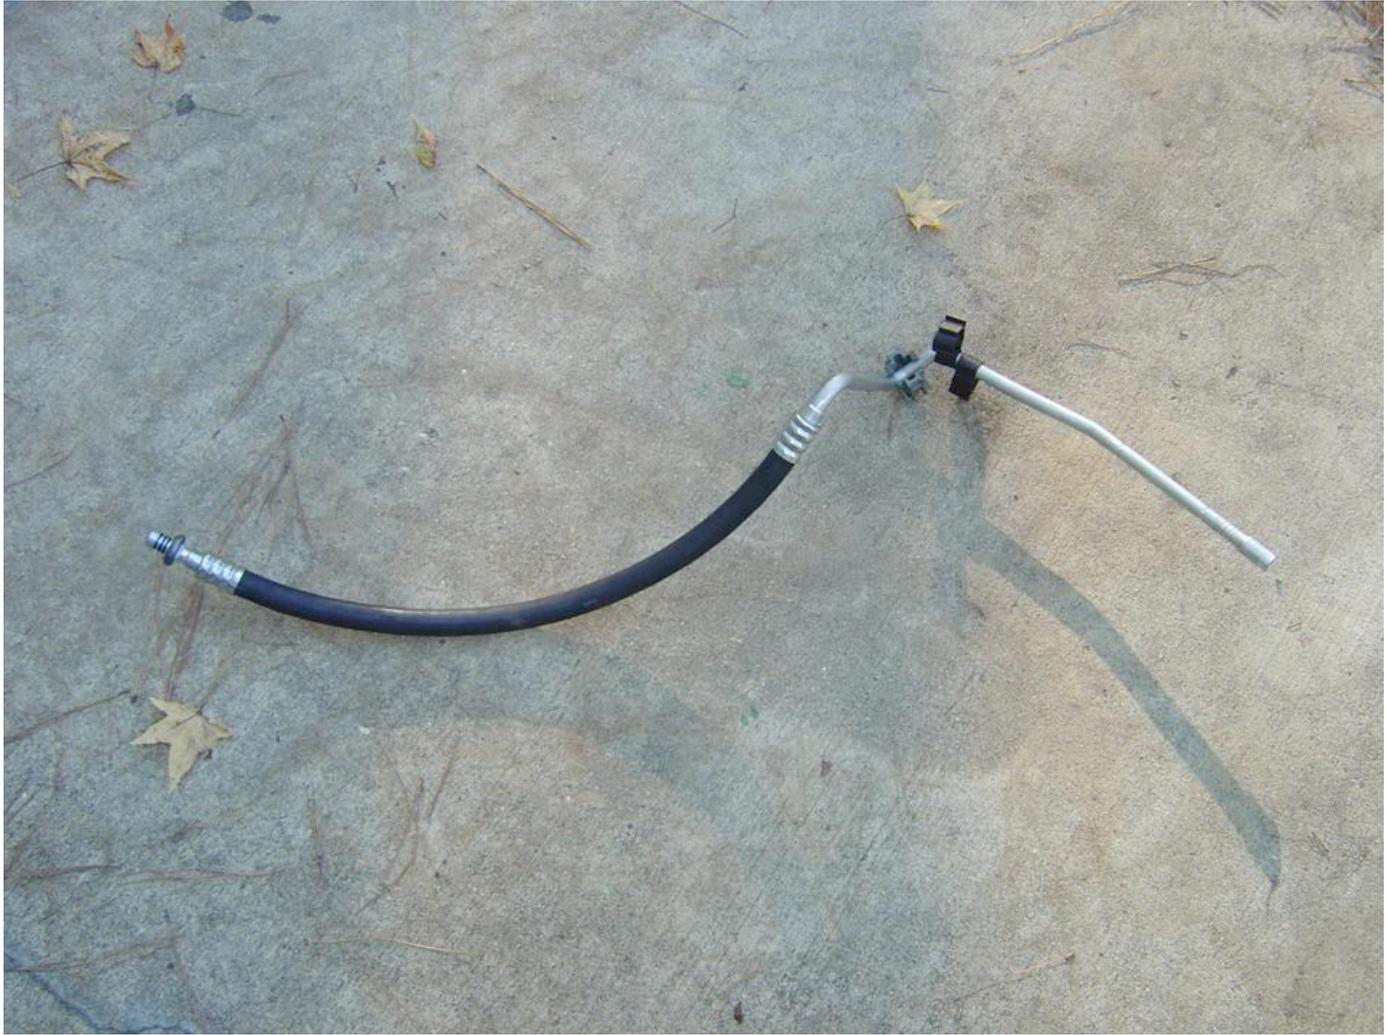
Now this is where we ran into a problem with the ATS setup. The location of the wastegate head was trying to occupy the same space as one of the AC lines. This required evacuating the AC system and removing the AC line until I could get a custom one made at a local shop. Here is the line I had to remove and the one I had had made to clear the wastegate head.

I contacted ATS regarding this, sent them the pictures and was reimbursed the \$45 that it cost me to have a new AC line made.

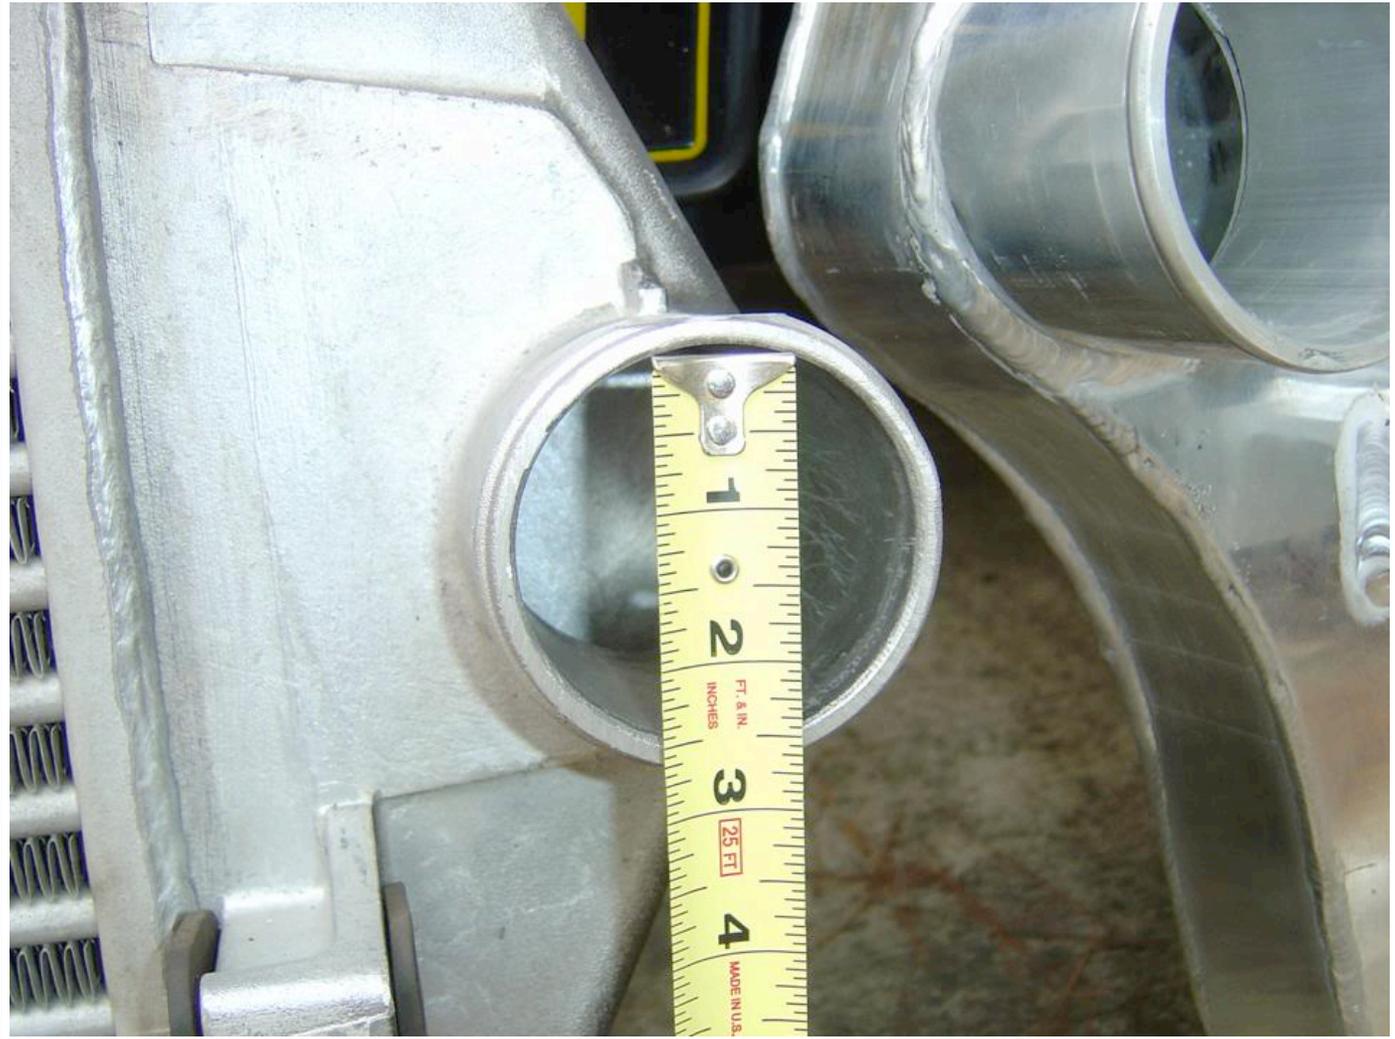
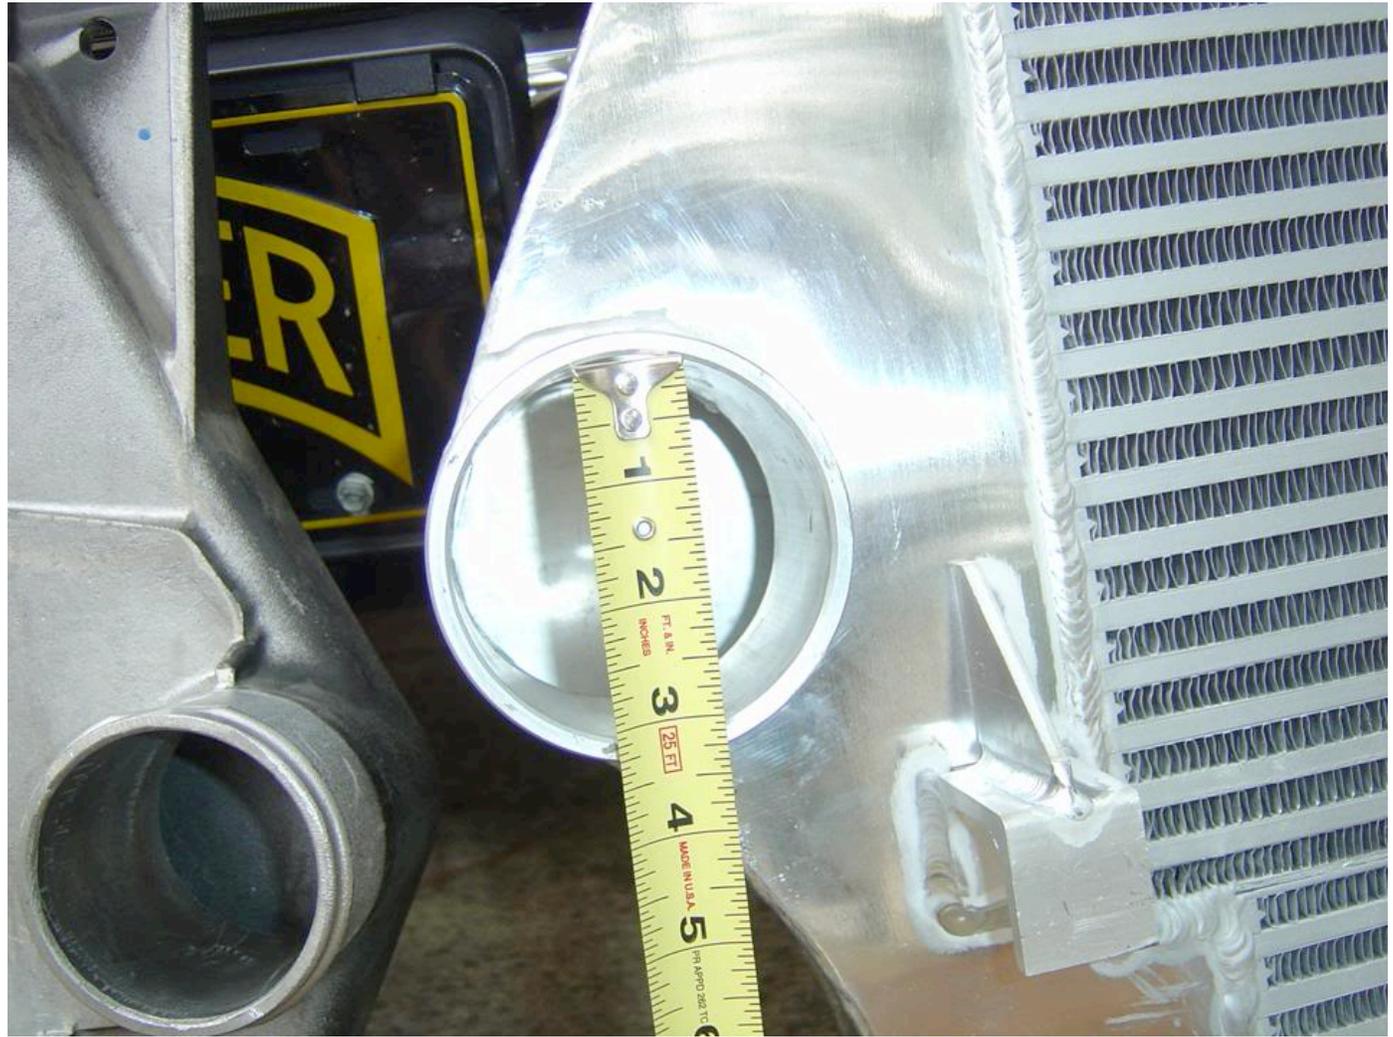
The ATS kit presented me with one final problem here. The kit comes with a 90* boost boot to go from the secondary boost tube to the intercooler opening. This boot is sized for a stock intercooler and I had the ATS intercooler that had a larger opening.

This required removing the ATS intercooler and re-installing the stock intercooler until the new one from ATS showed up, which was sent overnight.

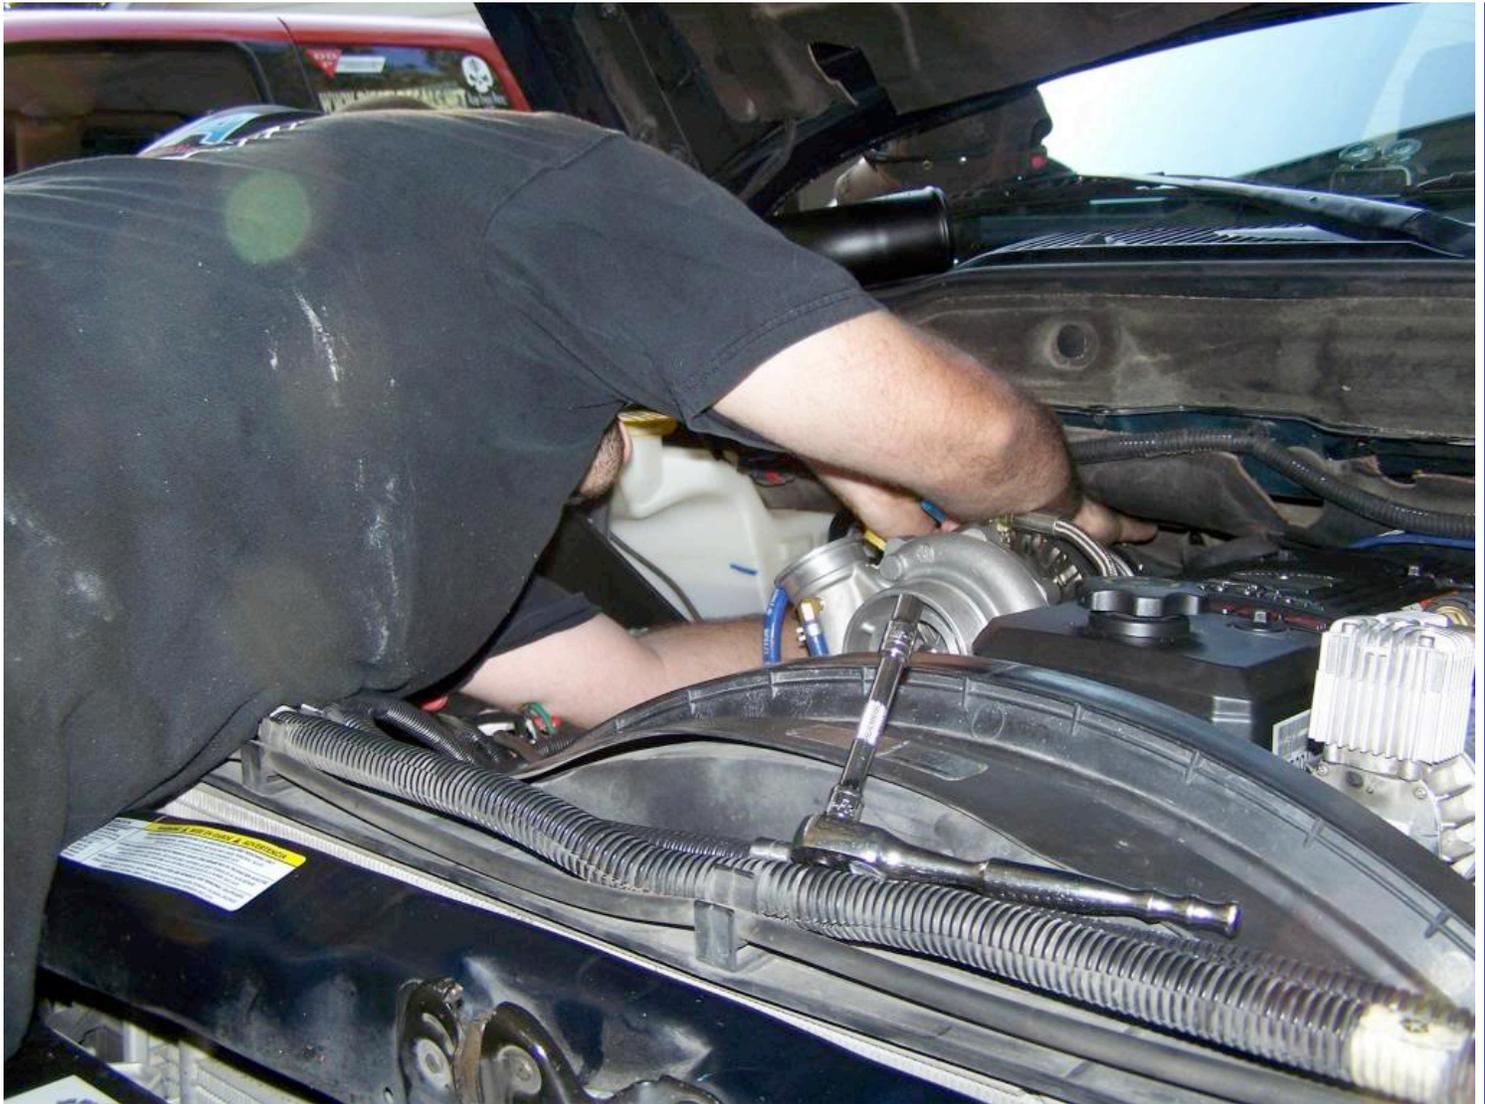
As we began routing the piping, we found that the compressor outlets still needed some tweaking to line up. Other than it being a pain to reach all the hold down bolts at this point, we found that the location of the wastegate head made it impossible to turn the compressor outlet to the correct position. You could go toward the engine, as it would hit the manifold and you couldn't go toward the battery as you hit the wastegate head. So, we had to remove the wastegate head, clock the compressor housing and then re-install the head. Now, the location to the wastegate head and it's 3 bolts make this a task for a contortionist. This took us a little while and increased our vulgarities count significantly.
