# **1045880 INSTALL MANUAL HE451VE/HE400VG TURBOCHARGER**

**1045880 HE451VE/HE400VG Turbocharger for ISX15**

## Prevention of Turbocharger Damage After Engine Mechanical Issue

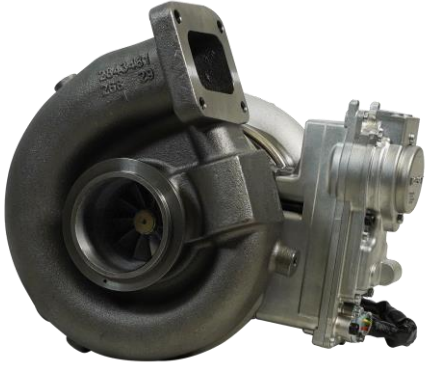
HE451VE/HE400VG Turbocharger	T4 Flange Gasket	Oil Drain Gasket

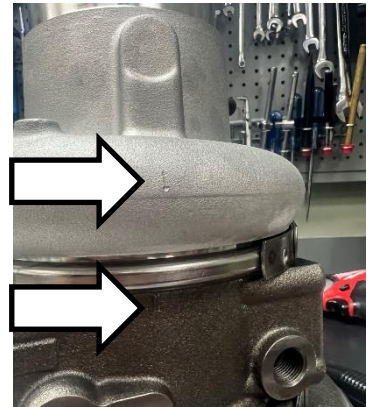
This turbocharger has the capability of being clocked in two different ways. From factory it is clocked in the HE451VE (Holset #2882112) orientation. To use the turbo as a HE400VG (Holset #3796351), loosen the v-band on the compressor cover and rotate cover until the stamp marks match. To retain original clocking, align the compressor stamp mark to the speed sensor. Torque the nuts to 160in/lbs.

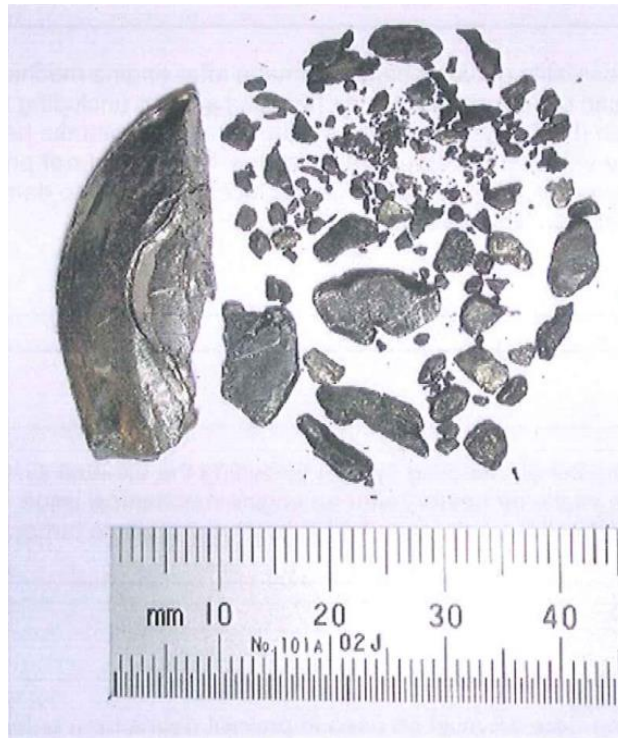
Figure 1 – Example of exhaust valve debris

If an engine experiences a piston, intake valve, or exhaust valve mechanical issue, it is important to understand that the small size of the debris particles could possibly allow them to travel through the air handling system and become lodged in various components (See Figure 1).

**NOTE:** Some debris pieces are large, however, particles as small as 0.70mm [0.030 in] could damage a turbocharger.

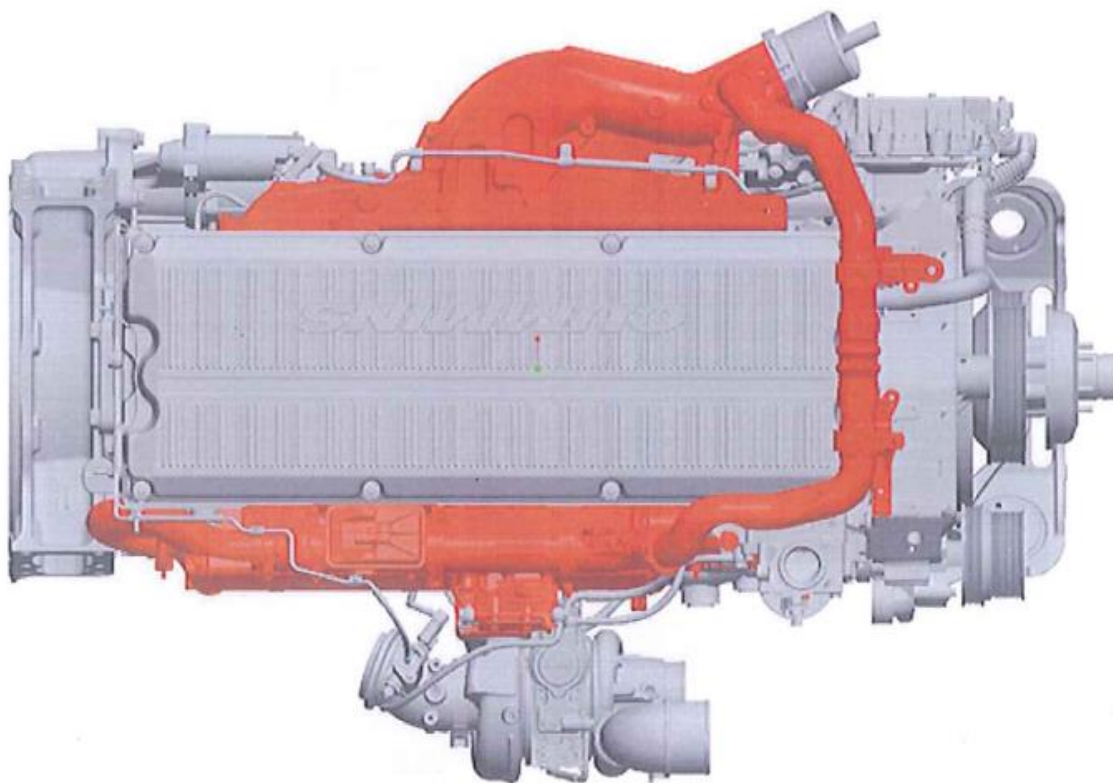
Figure 4 – Components to be inspected and cleaned or replaced are shaded darker. Shown is the ISX15 CM2250/CM2350

1. Replace the EGR cooler.
2. Inspect the interior of the following components. Flush the air passages in the components using safety solvent. Rinse and dry with compressed air. (See Appendix A for component location reference. **Not** all engines are shown)
  - a. All EGR air plumbing
  - b. EGR measurement venturi (ISM and ISX engines)
  - c. Air intake connection (Including intake air heaters where applicable)
  - d. Intake manifold and cover
  - e. Exhaust manifold (for multiple piece manifolds, remove sections and clean)
  - f. Intake and exhaust passages in the head (if the head is to be reused)
  - g. EGR valve
  - h. Charge air cooler (CAC) **must** be cleaned per original equipment manufacturer (OEM) guidelines
3. Operate the engine without the turbocharger installed at low idle for approximately 3-5 minutes to be sure the system is free of debris.

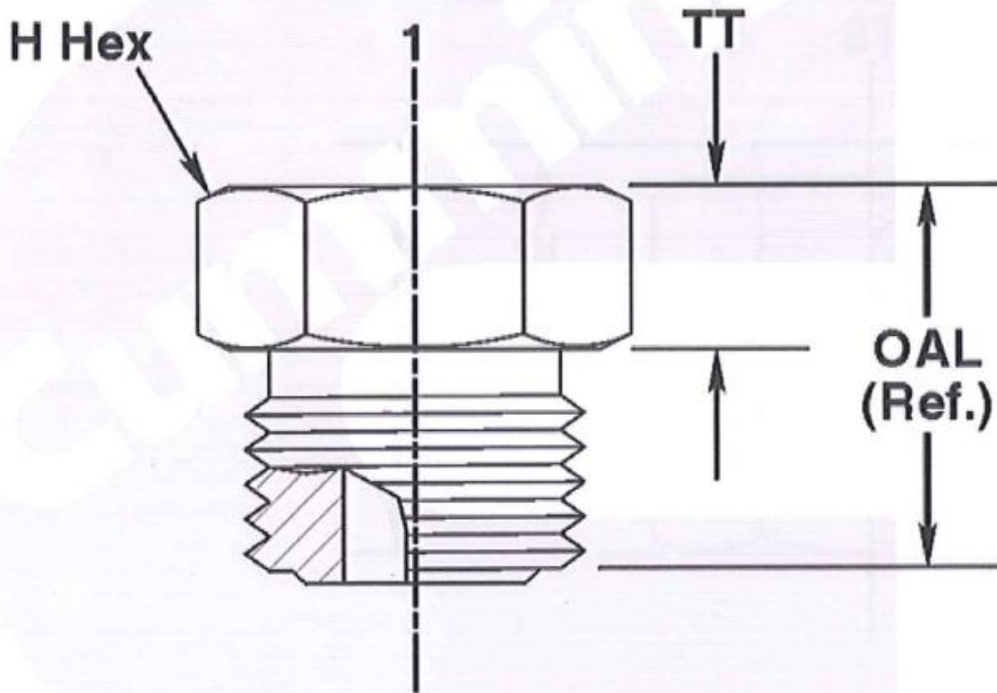
00r00001

O-ring Face Seal Plug dimensions – See Table 1

Table 1 – O-Ring Face Seal Plug				
Parker™ Part Number	Dimension 1 (inch)	Dimension H (inch)	Dimension OAL (inch)	Dimension TT (inch)
6 PNLO	3/8	3/4	0.76	0.32
8 PNLO	1/2	7/8	0.86	0.35

Table 1 lists the required plug sizes for blocking off oil and/or coolant.

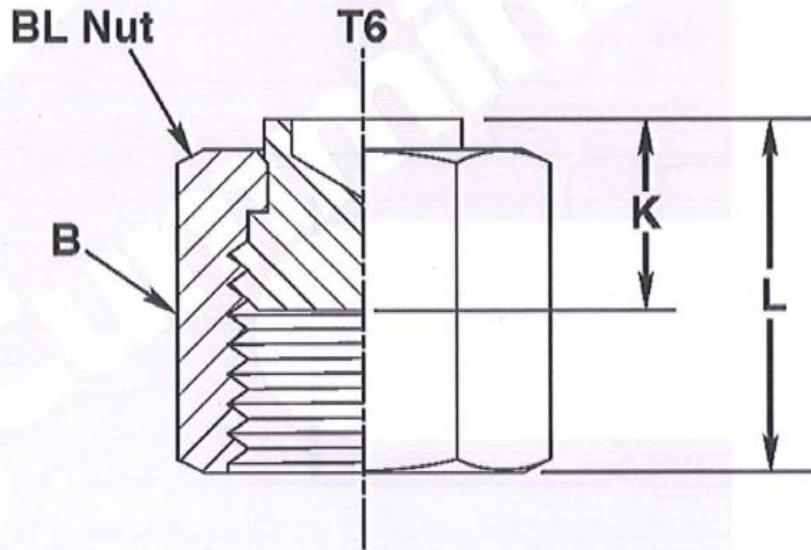
00r00002

O-Ring Face Seal Cap dimensions – See Table 2

Parker™ Part Number	Tube Outside Diameter (OD) (inch)	Dimension T6 (UN/UNF-2B)	Dimension B Hex (inch)	Dimension K (inch)	Dimension L (inch)
4 FNL	¼	9/16-18	11/16	0.34	0.65
6 FNL	3/8	11/16 – 16	13/16	0.39	0.76
8 FNL	½	13/16 – 16	15/16	0.45	0.88

Table 2 lists the required cap sizes for blocking off oil and/or coolant
