68RFE ProTect68 Plate Kit

1030373 | 2007-2018 68RFE Transmission

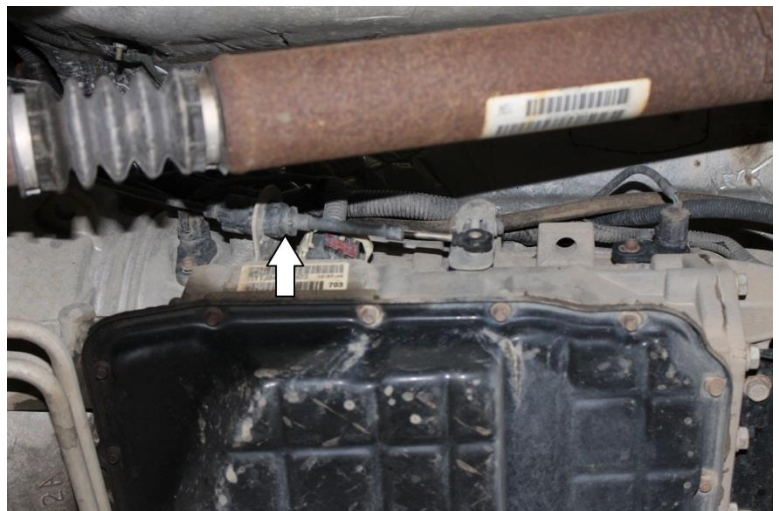
5. Remove shifter cable from transmission for better access to the main electrical connector.

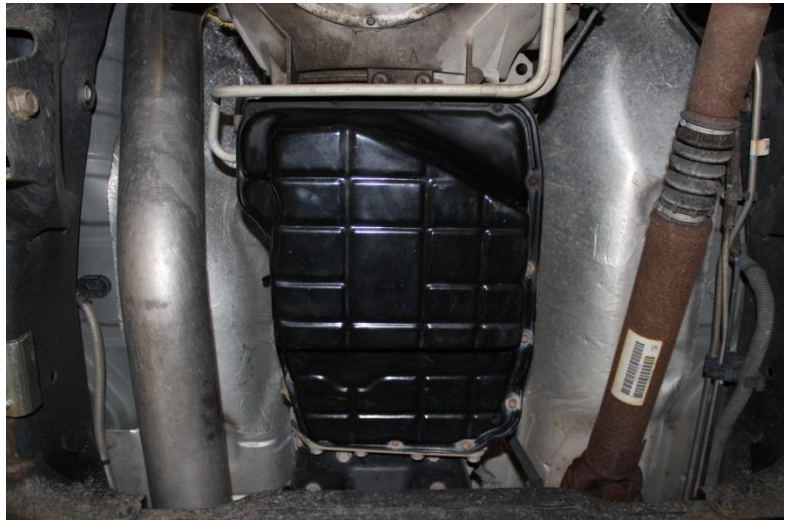
8. Remove 14 of the 15 transmission pan bolts (8mm). Loosen the remaining bolt but leave in place to keep the pan from falling. The transmission cooler lines may need to be moved to access some of the bolts, gently pry them out of the way.

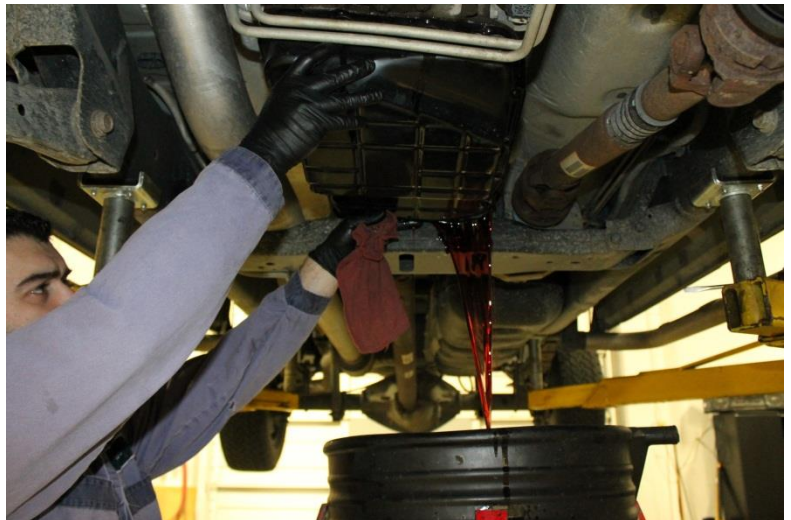
9. Tap pan with a mallet to break the silicone gasket seal. Allow fluid to drain. Remove last screw and drain remainder of fluid.

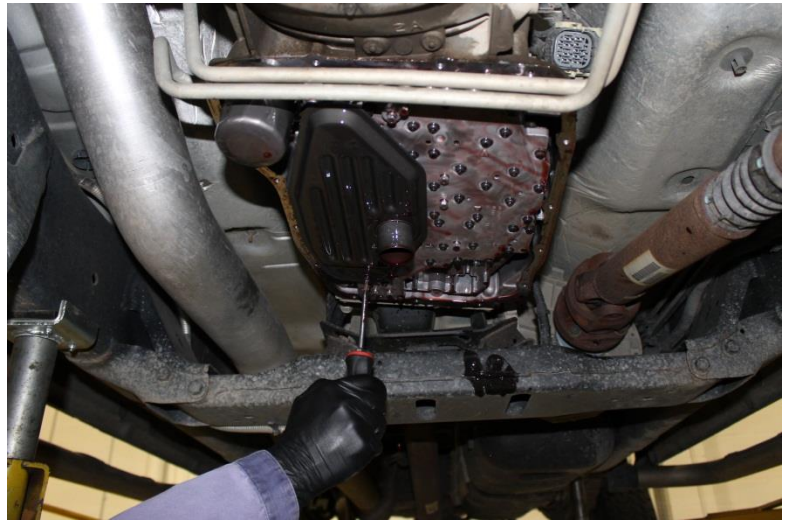
10. Remove transmission filter by removing the one T25 Torx screw.

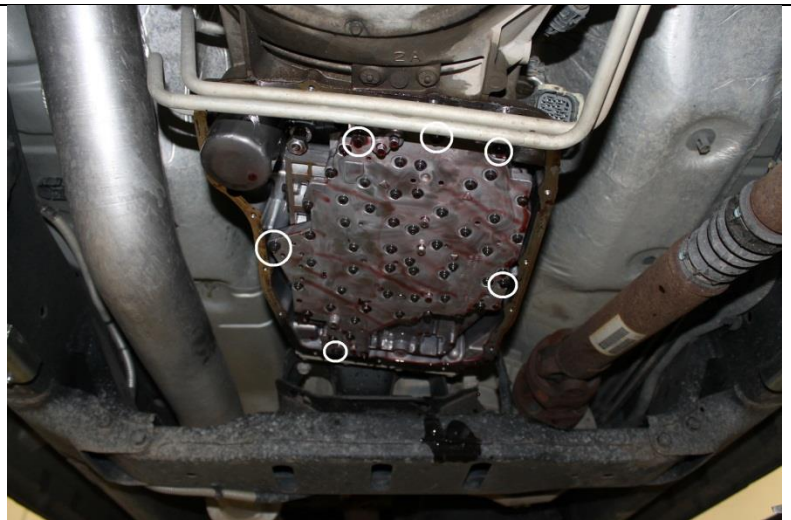
11. Remove the six 8mm bolts securing the valve body to the transmission. Drain valve body of fluid. To remove valve body from transmission, wiggle it while pulling downwards to work the electrical connector through the case.

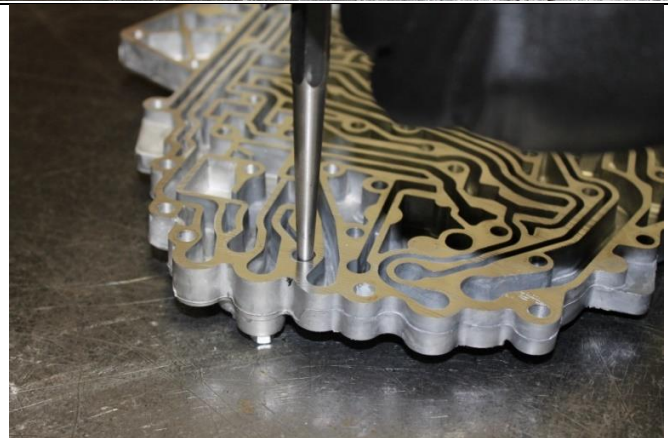
18. Punch center of hole using a center punch.

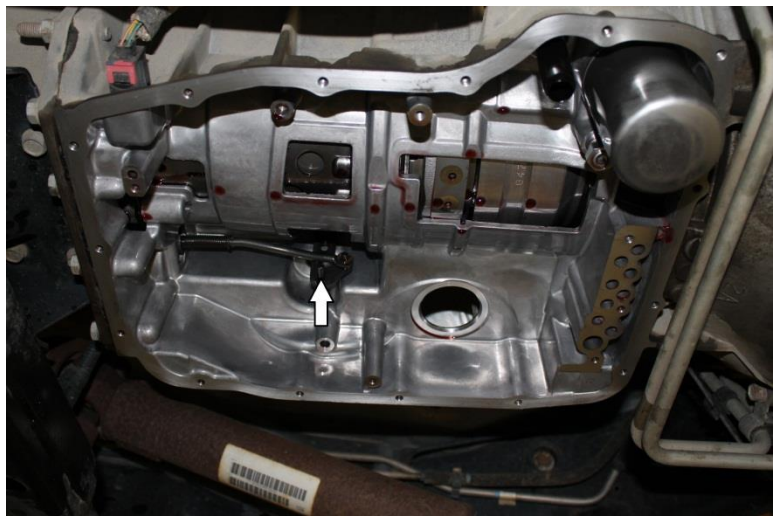
29. Wipe clean the bore on the transmission case around the electrical connector. Scrape all old silicone gasket material (if any) from the oil pan mating surfaces.

30. Check that the shift lever on the valve body lines up with the shift lever on the transmission and lift the valve body back into the transmission. Start the 8mm screws by hand, do not tighten yet. Work the shift lever on the outside of the transmission case by hand to ensure that the lever is making contact with the valve body correctly.

IMPORTANT: Use great care when reinstalling the valve body, the gasket that mates with the front of the case must line up correctly. Do not fold or pinch during installation.

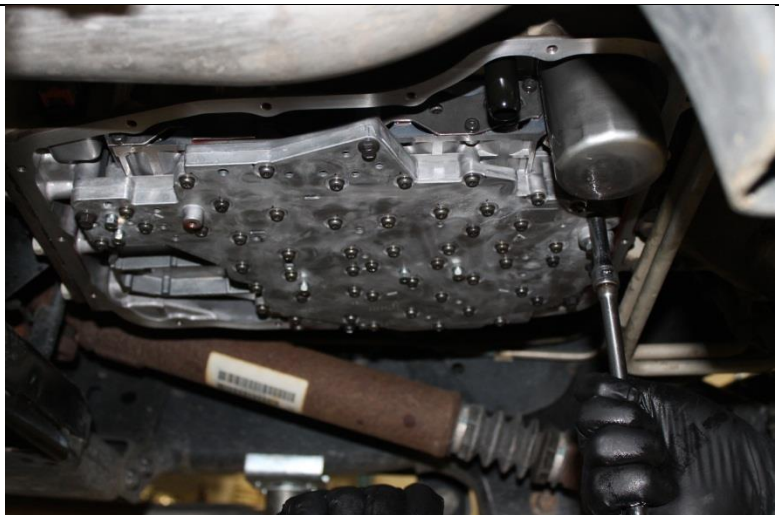
31. Torque the valve body attaching bolts to 105 in/lbs.

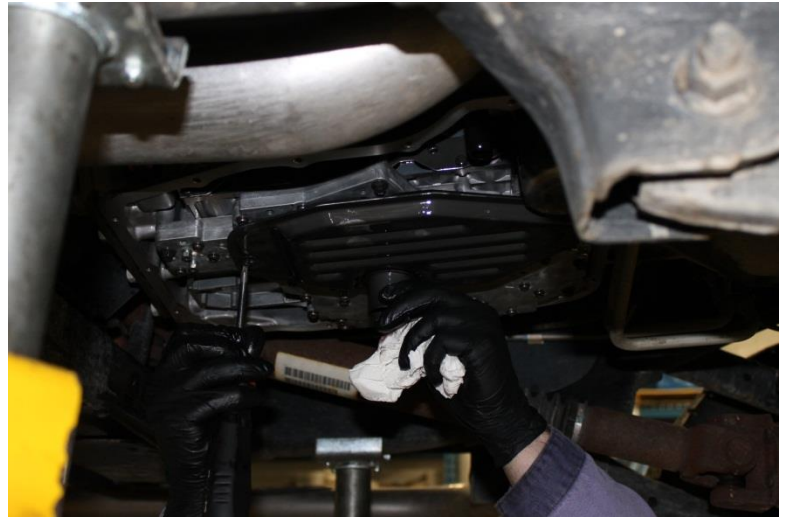
32. If desired, install new filter(s). Otherwise, reinstall the filter/pickup assembly. Torque to 50 in/lbs.

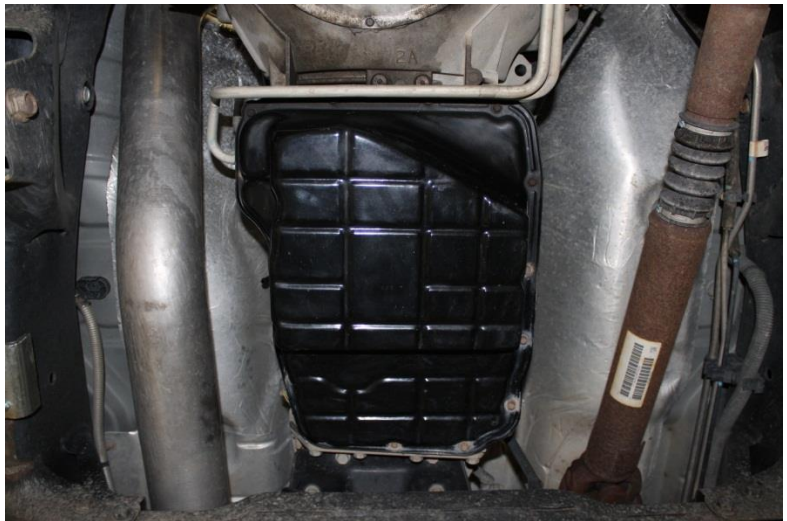
33. Place the supplied gasket on the transmission pan. Hold pan below transmission and install attaching screws. Torque the pan screws to 105 in/lbs.

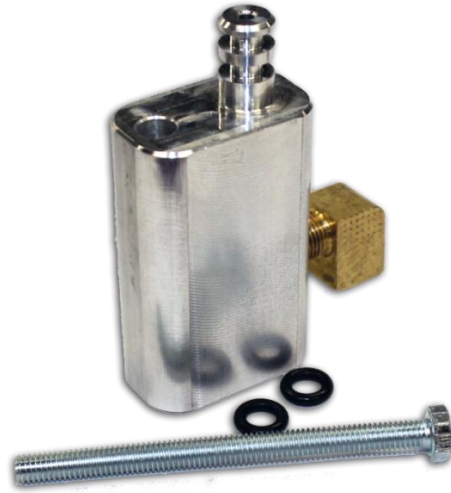
ADAPTER KIT BD# 1061529

40. Note. If you would like to verify the increases in line pressure, use adapter kit (BD 1061529) in conjunction with a 300psi gauge. Pressures at wide open

throttle should be between 240 – 260 PSI with a mechanical gauge.

Use this kit with a 300 psi gauge.
