**GM8428**2015-CURRENT DURAMAX DOWN PIPE 3-BOLT  
FLANGE**MBRP**  
INC.  
PERFORMANCE EXHAUST

21 April, 2016

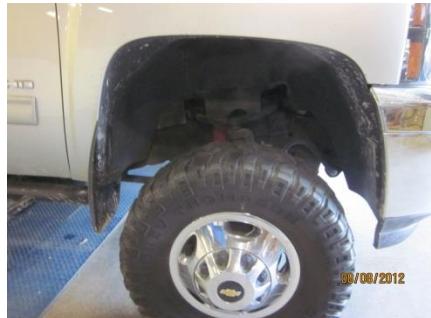
**Figure 1**

1. Remove the passenger-side inner fender.  
**See Figure 1.**  
Note: we also removed the Grille Assembly to prevent damage to it during the removal or installation of the down pipe.
2. The front pipe needs to be temporarily removed. Carefully disconnect all sensors and loosen the four flange nuts on the rearward part of the front pipe. The transmission cross-member will need to be temporarily dropped to remove the front pipe. Remember to support the transmission with a block or jack stand while doing the transmission cross-member removal.  
**See Figure 2.**
3. Remove the hex bolt securing the down pipe to the exhaust manifold. Remove the sensor located just above the hex bolt. The 3 nuts connecting the front pipe to the down pipe can also be removed. Save the hex bolt, nuts and sensor for the installation.  
**See Figure 3.**

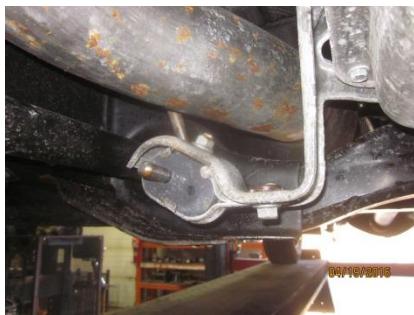
**Figure 4**

4. The front pipe has a hanger mounted to the transmission that will also have to be removed. Remove the bracket from the transmission. **See Figure 4.**

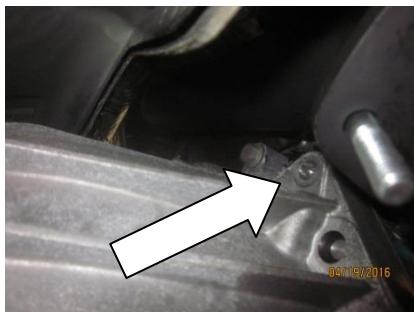
**Figure 5**

5. Remove the combination stud/bolt from the transmission bellhousing just above the locating dowel. It has already been removed in **Figure 5**. This is to allow the clearance necessary to remove the down pipe.

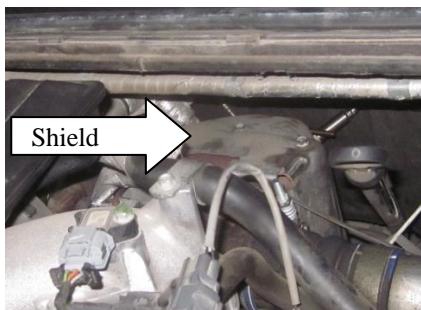
**Figure 6**

6. The heat shield on top of the turbo will need to be removed. The 2 stock sensors on the top of the down pipe need to be carefully removed. Set the sensors aside and save for the installation. The stock V-Band clamp can be removed, save for the installation. **See Figures 6 & 7.**

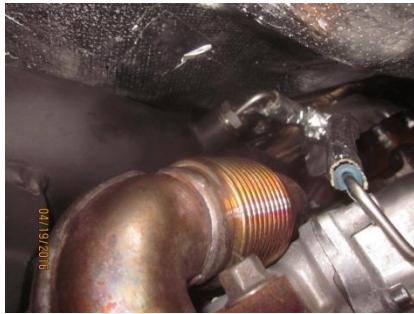
**Figure 8**

4. Install the stock sensors into the **Down Pipe**. One is located along the lower section of the **Down Pipe** (Refer to Figure 8.) The other two sensors are located closer to the turbo.

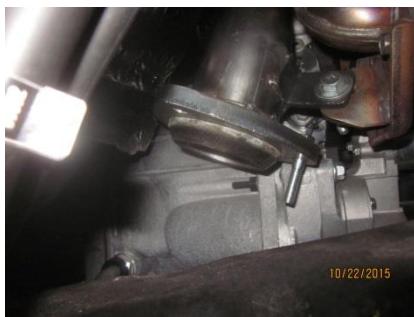
**Figure 9**

5. The front pipe can then be reinstalled using the supplied **3/8" Bolts, Flat Washers, Lock Washers and Nuts**; as well as the factory hardware for the 4-bolt flange. See Figure 9.

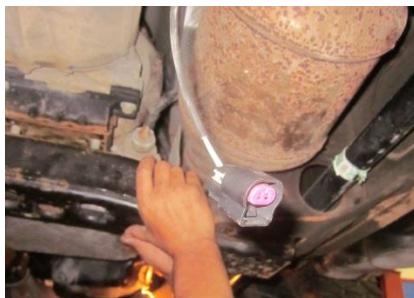
**Figure 10**

6. Reinstall the transmission cross-member. Reinstall the exhaust hanger to the transmission. Reconnect all the sensors to the front pipe. See Figure 10.

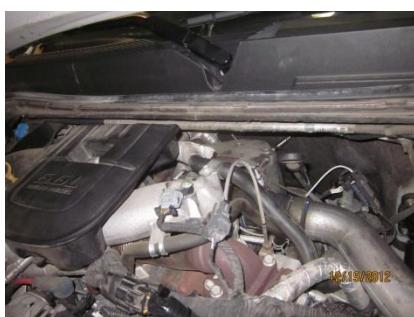
**Figure 11**

7. Reinstall the passenger-side inner fender.
8. Reinstall the turbo heat shield. Check along the exhaust and make sure all connections are tightened. Check along the whole length of the exhaust system to ensure that there is adequate clearance around the spare tire, fuel and brake lines or any wiring. If there is any interference detected relocate or adjust. See Figure 11.
