2017+ L5P Duramax Downpipe

Covers installation of PN: WCF100129

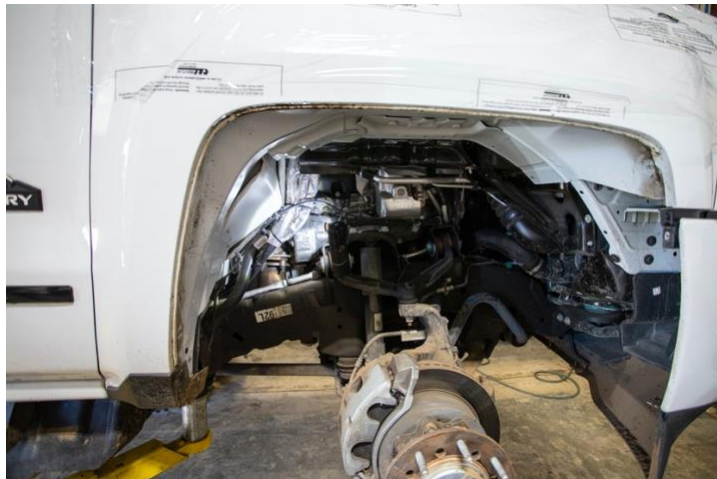
4. Remove the passenger side wheel and tire, inner fender liner.

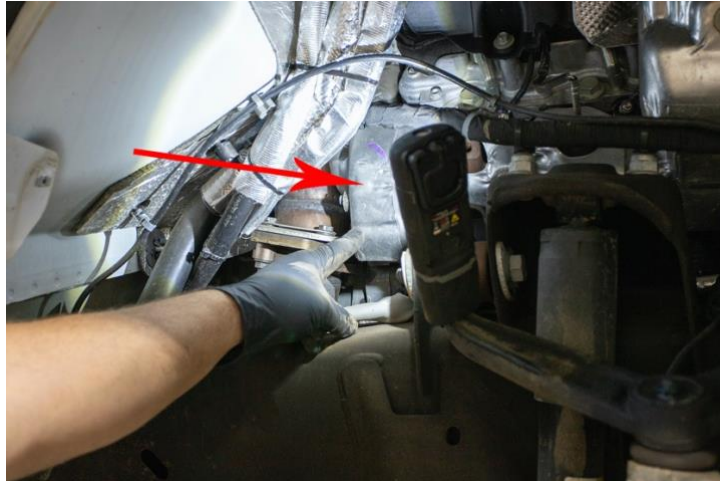
5. Remove rear heat shield on passenger side exhaust manifold (3x 10mm bolts)
6. Remove front pipe of exhaust from down pipe (4x 15mm bolts)

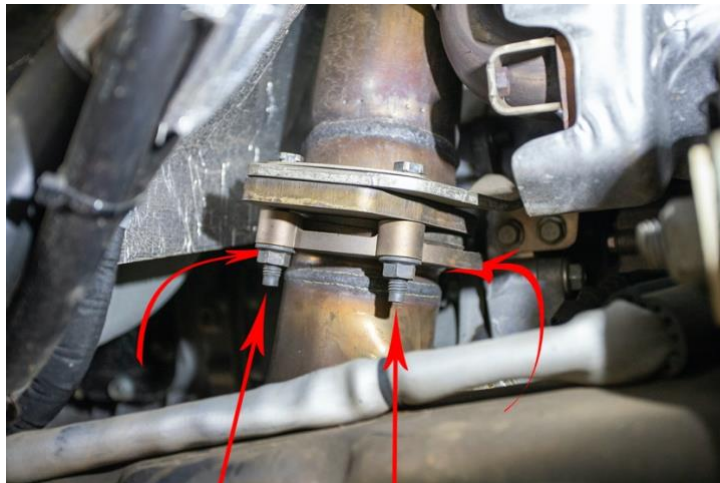
7. Remove lower down pipe support bracket near where down pipe connects to exhaust system.

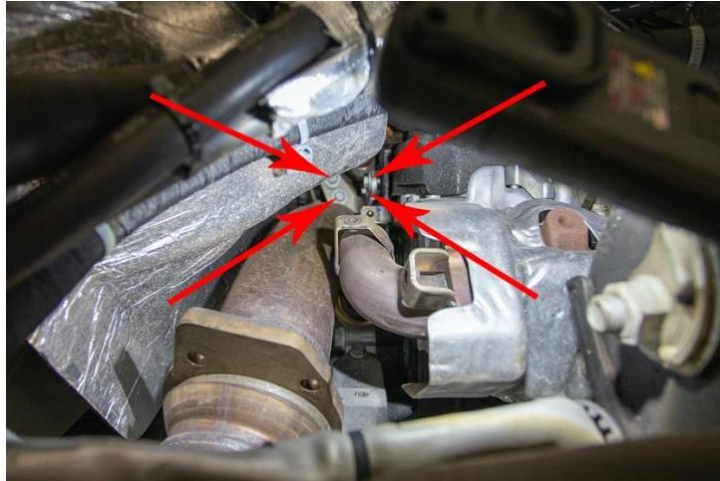
9. Remove upper down pipe support bracket which connects to the back of the cylinder head.

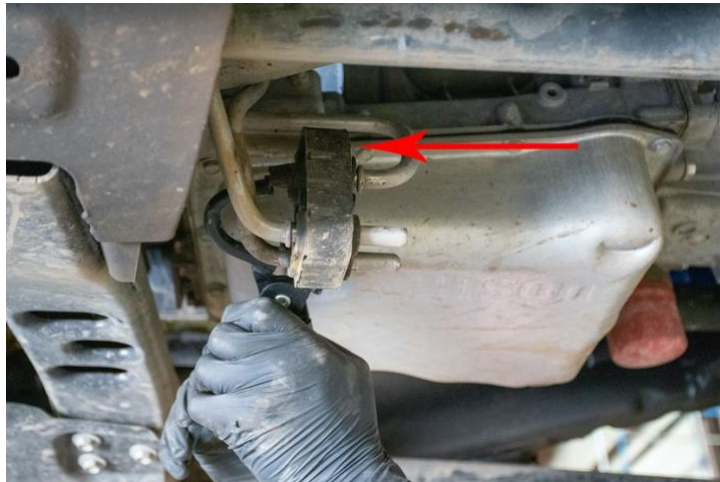
10. Remove front rubber exhaust hanger from exhaust system near transmission. This step allows the exhaust to drop to allow room for down pipe removal.

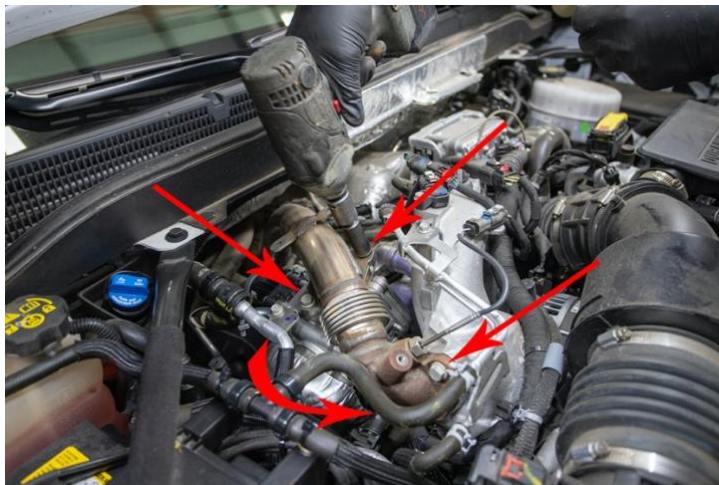
15. Remove EGR upper mounting bolts. There are two more bolts not visible in this picture where this pipe connects to the SCR under the cowl which also need to be taken out in order for the pipe to be completely free of the engine.

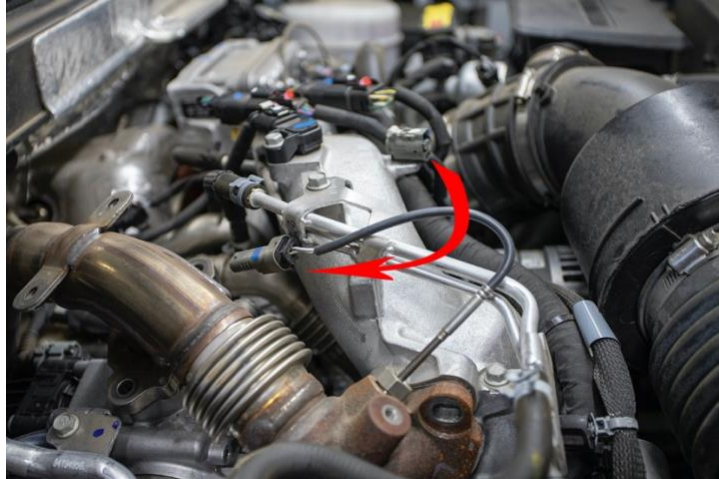
16. Unplug EGR Temp sensor.

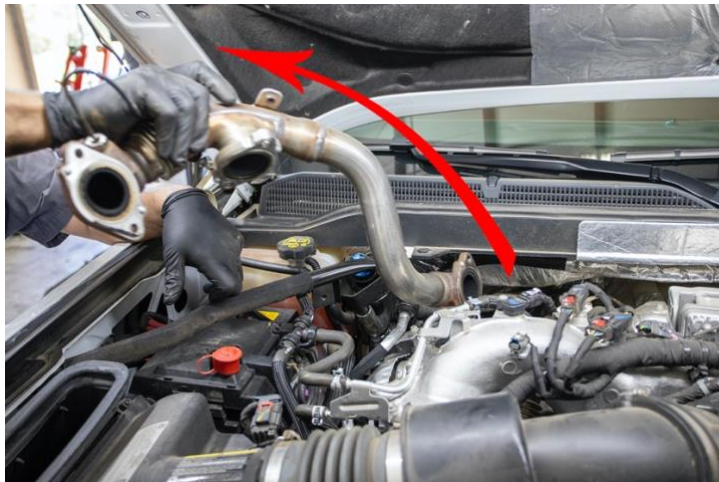
17. Remove EGR Pipe and set aside being careful not to damage riveted on gaskets which will be needed for reinstallation later.

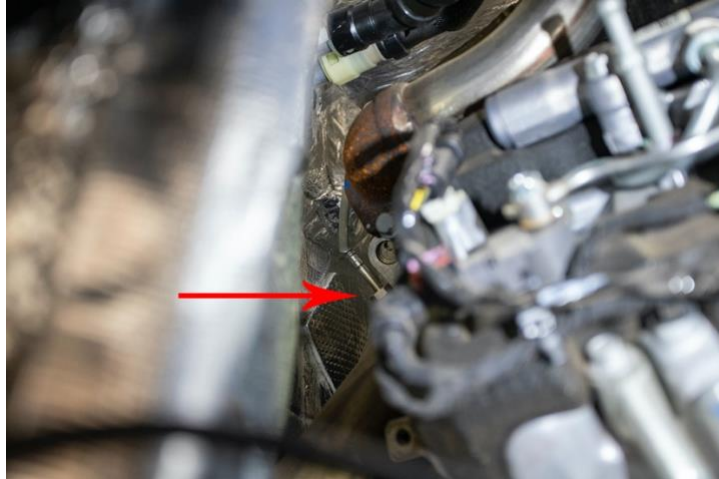
19. Now you have access to remove the temp sensor from the down pipe.

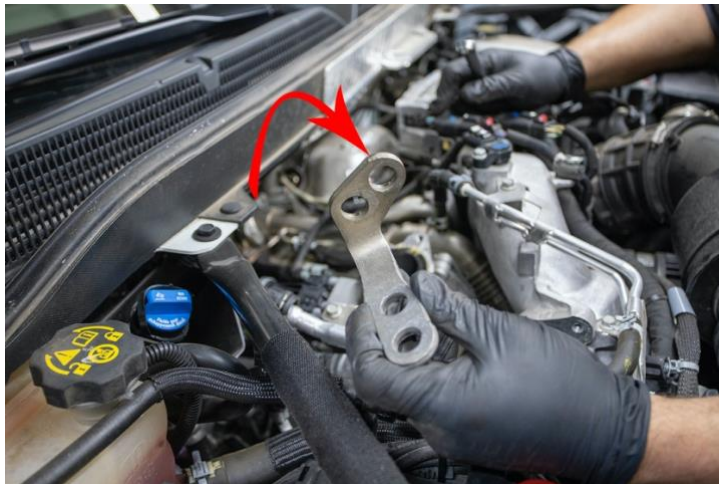
20. Remove top bracket from down pipe. There are no good sight lines to the bolts holding this part in but the items removed in the steps above will allow enough room for you to access this bracket through the passenger wheel opening and from the engine bay above.

21. Remove heat shield on SCR and temp sensor.

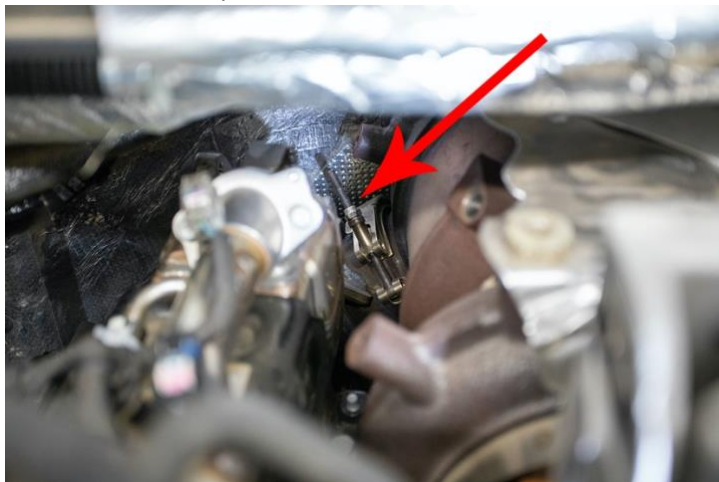
22. Loosen V-band clamp at inlet for downpipe. At this point your down pipe should be completely loose.

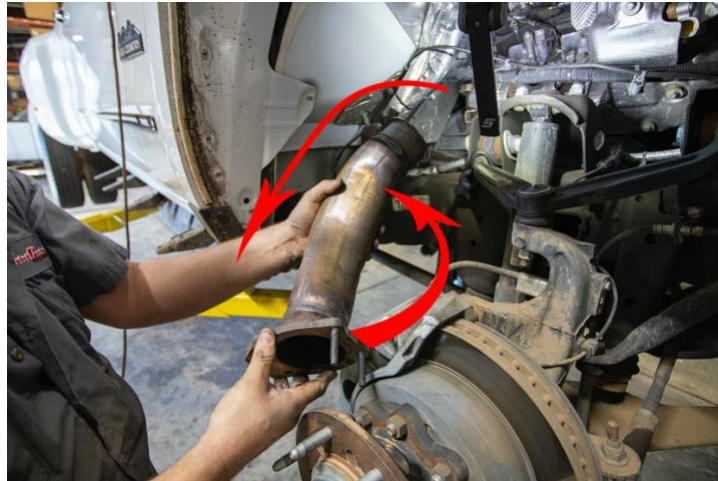
23. Rotate downpipe counter clockwise for removal out the passenger side.

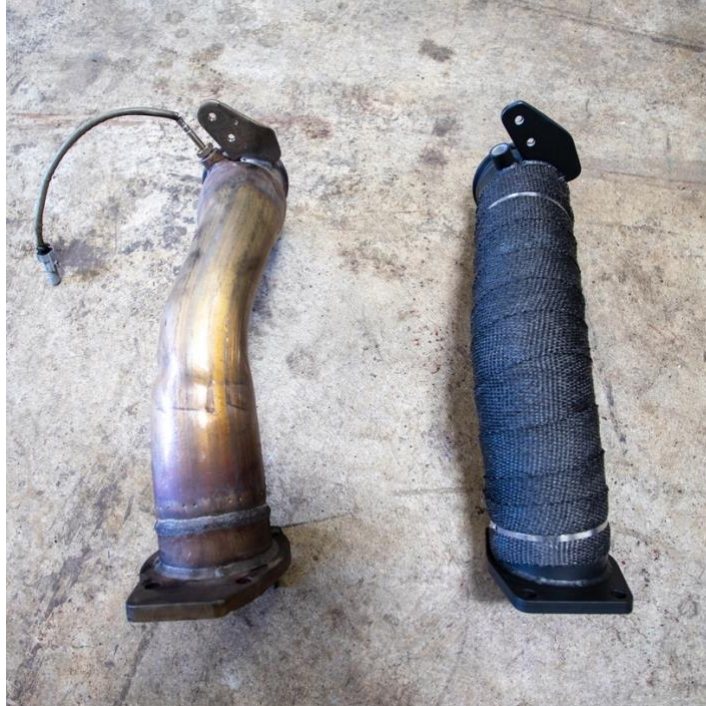
24. Reinstall downpipe temperature sensor taken from stock part.
25. Install new pipe back through the passenger side fenderwell.
26. Transfer saved exhaust 'donut' gasket from step 12 to allow your new down pipe to properly seal up to the rest of the exhaust system on re-assembly.

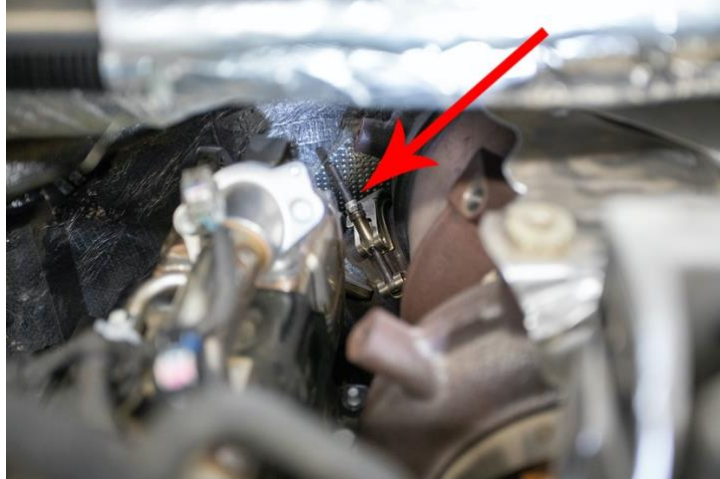
27. Tighten V-band clamp to hold pipe in place but do not fully tighten.

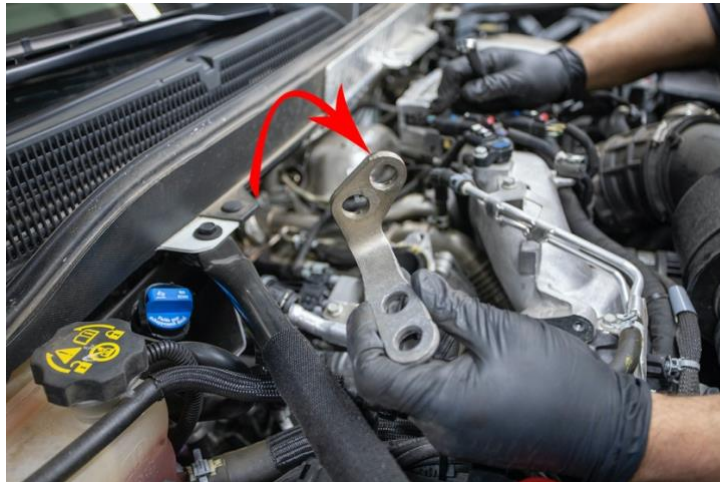
28. Reinstall upper downpipe bracket.

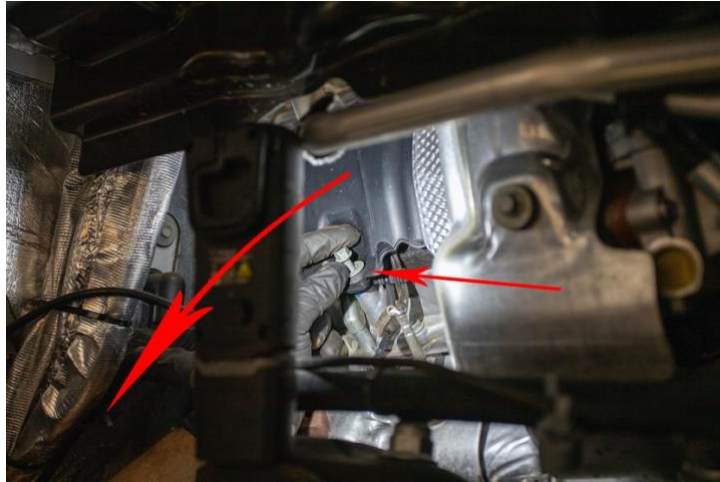
33. Reinstall sound shield on valve cover reversing step outlined above.

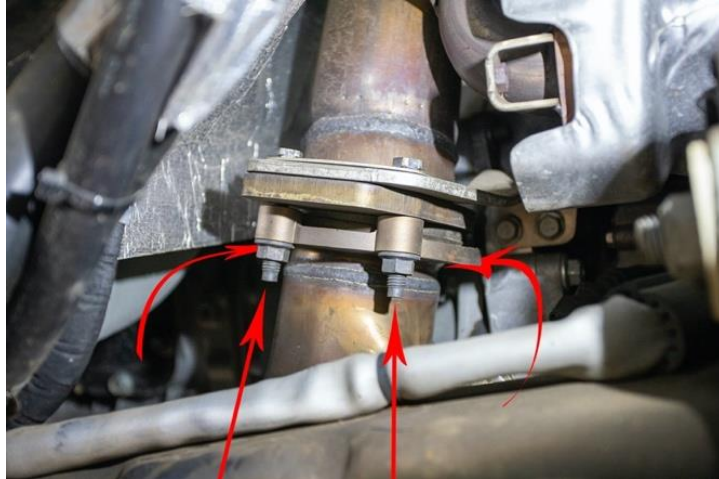
35. Reinstall lower v-band clamp to connect exhaust system to bottom of downpipe.
