## 2015-2019 HD Silverado Lower Valance Filler Panel

Covers installation of PN: WCF100425, WCF100427, WCF100426, WCF100428

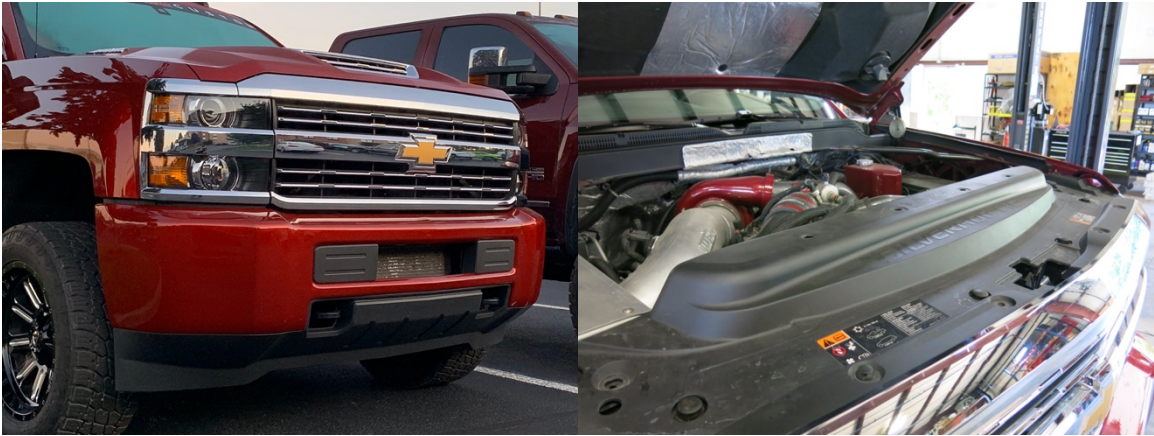
2. Remove plastic radiator cover under hood by removing twelve plastic pop rivets to reveal radiator stack.

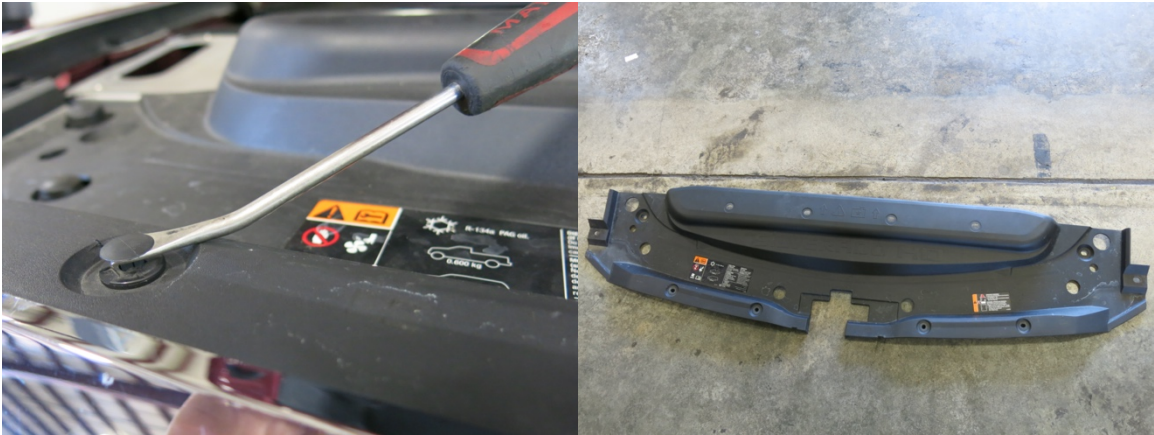
3. Remove grille. There are four bolts on top and push disconnects.

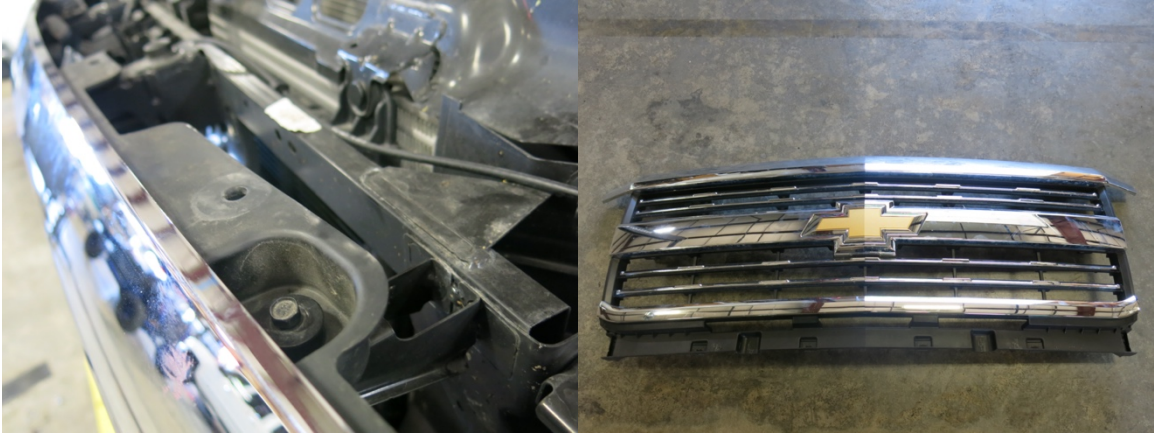
4. Remove front bumper. There are four bolts in the center and one on each end in front of the tires. Disconnect the wiring harness underneath the bumper towards the passenger side. The Bumper harness stays on the bumper for removal. Unplug fog lights if equipped. Lay bumper face down on cardboard or towel.

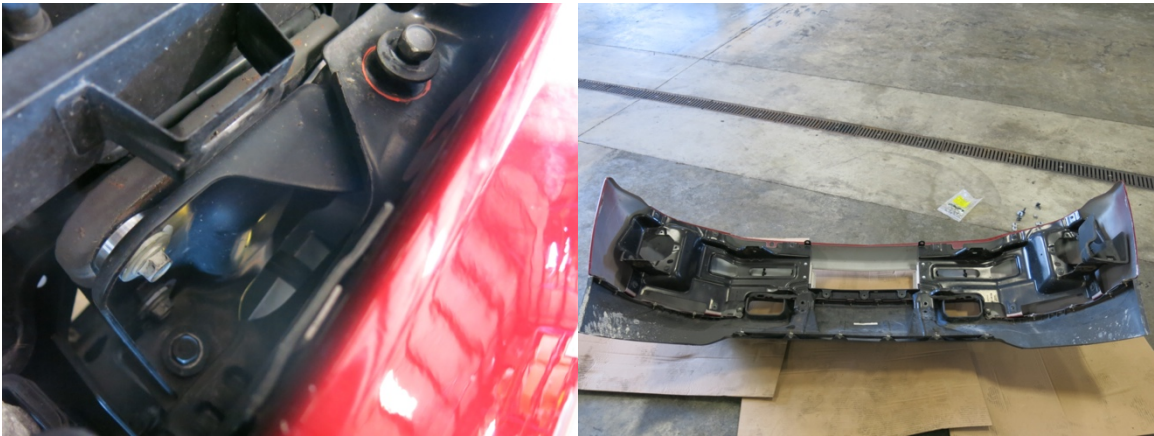
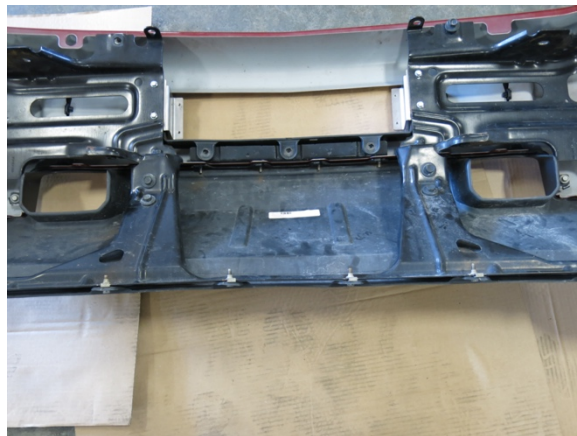
5. Remove lower valance metal support. There are six upper 15mm bolts and six lower 10 mm bolts.

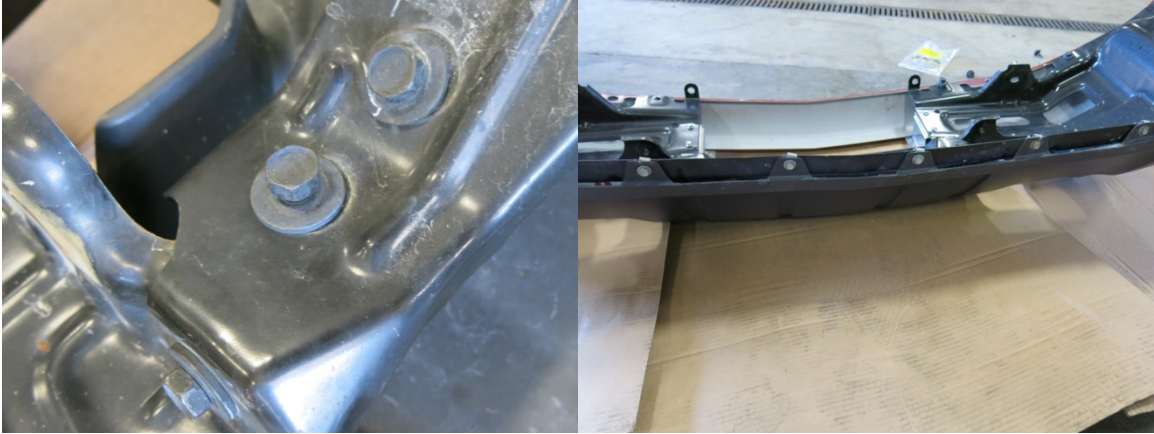
6. Remove both bumper support brackets and fog lights from each side of the bumper. There are five 15 mm bolts on each side.

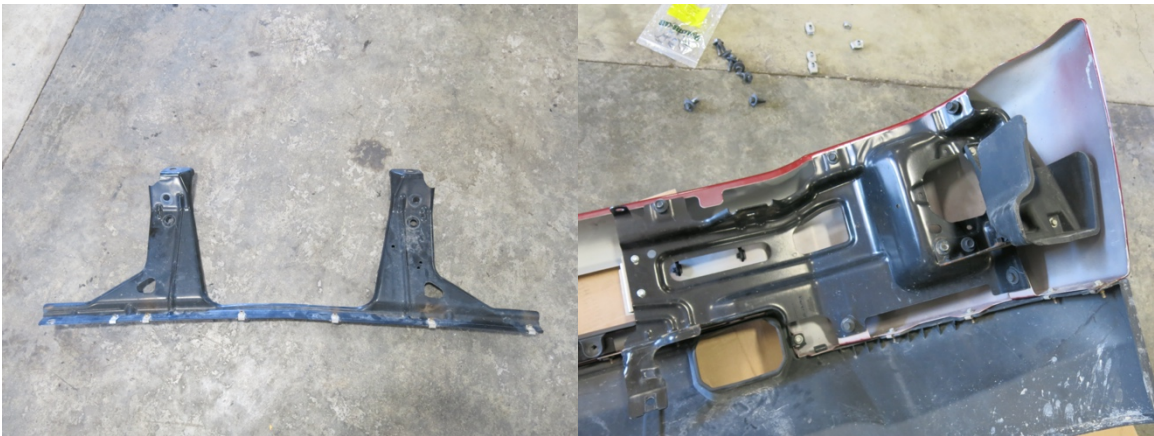
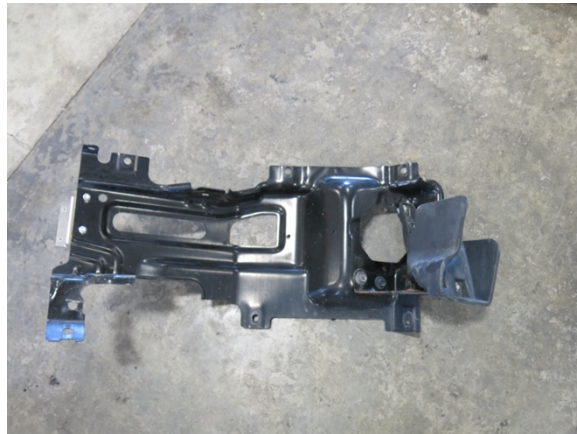
7. Unclip fog light and park sensor wiring harness.

8. Remove eight plastic clips and three 10 mm bolts from transmission cooler duct plastic. Remove park sensor if applicable. This removes from the front of the bumper. It needs to be removed so that you can access the lower valance bolts.

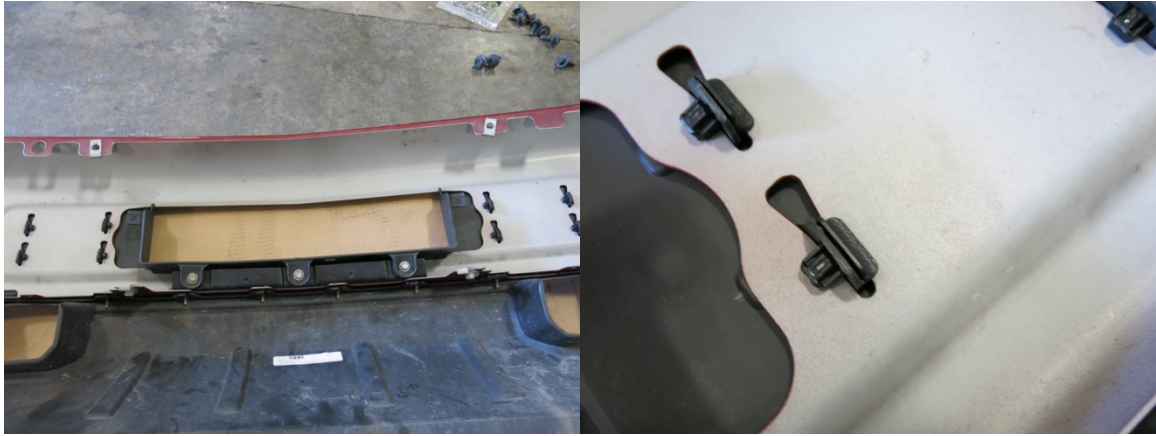
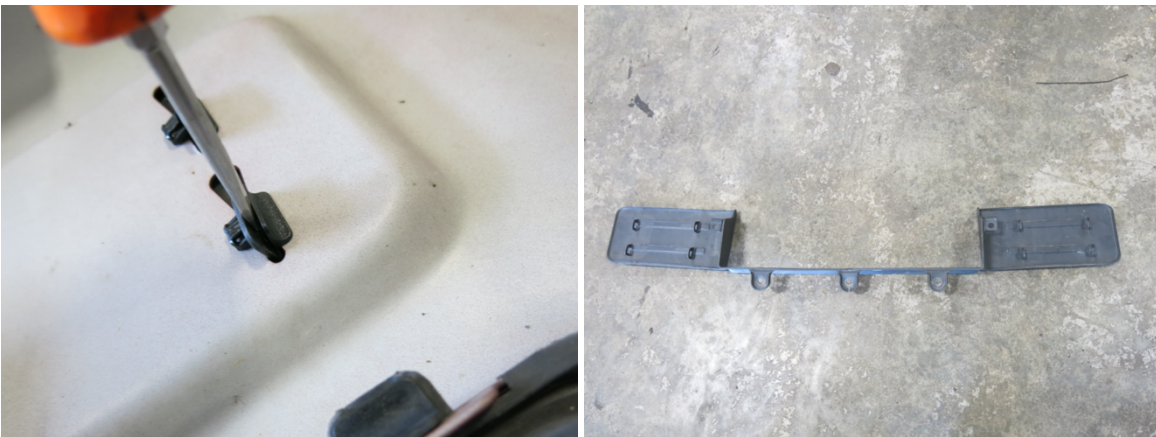
9. Remove the lower valance. There are 10 mm bolts across the bumper.
10. Transfer spring nuts to new valance and install eight 10 mm bolts to attach new valance.

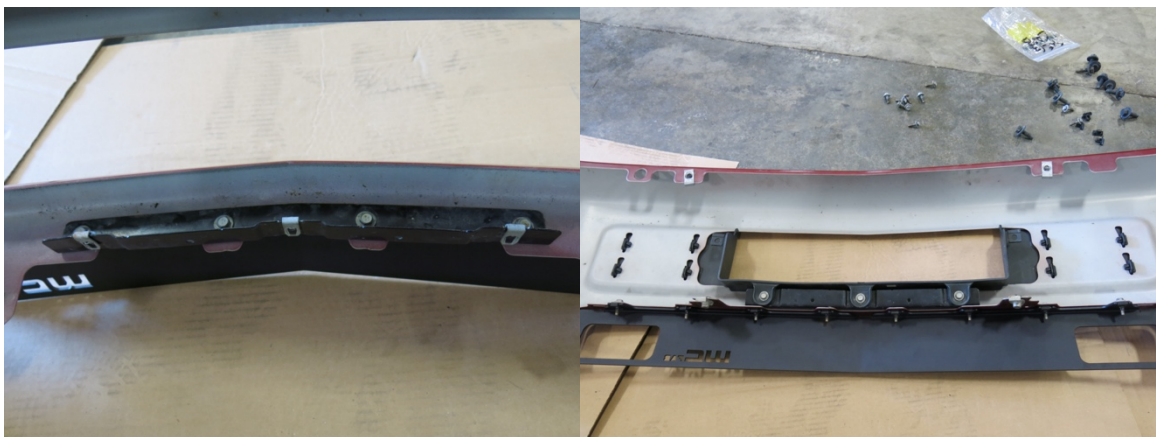
11. Reassemble in reverse order.
