Revision 1 February 2020

Safety Recall W03 / NHTSA 20V-043 Transmission Valve Body

**2019 - 2020 (DJ) Ram 2500 Pickup
(D2) Ram 3500 Pickup**

NOTE: This recall applies only to the above vehicles equipped with a 6-Speed Automatic 68RFE Transmission (sales code DG7).

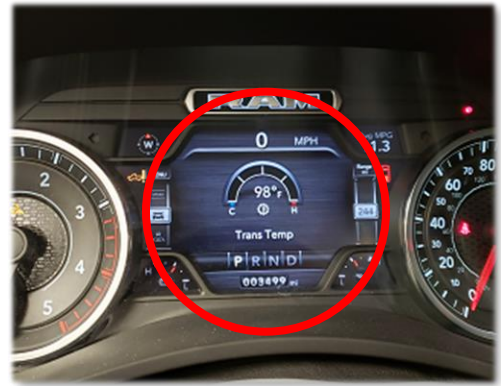
2. While driving, frequently monitor the transmission temperature while in operation using the gauges available on the instrument cluster.

If transmission temperature exceeds 210°F, immediately proceed to a safe location to park the vehicle and allow the transmission temperature to cool to less than 190°F.
