68 RFE PROTECT 68 PLATE KIT

| Part #: | 1030373 | 2007-2016 |

Valve Body Installation

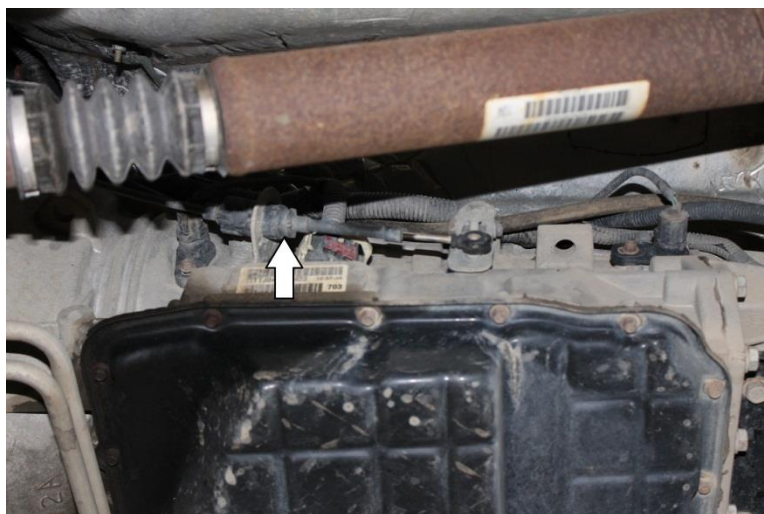
5. Remove shifter cable from transmission for better access to the main electrical connector.

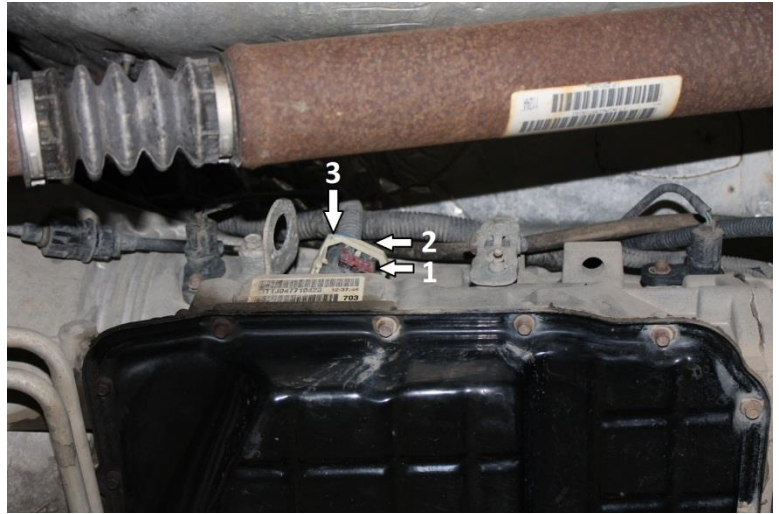
6. To remove connector, push red tab (1) downwards. Then, press the black tab (2) which will allow the white handle (3) to be rotated downwards, releasing the connector from the transmission.

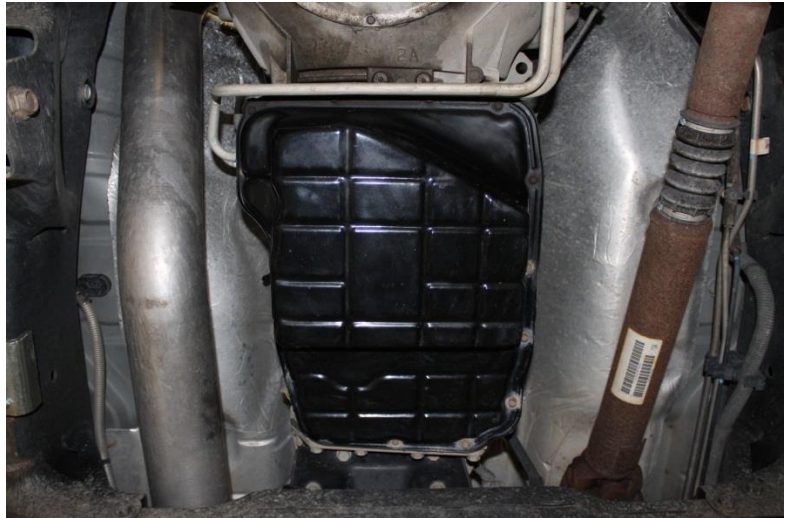
8. Remove 14 of the 15 transmission pan bolts (8mm). Loosen the remaining bolt but leave in place to keep the pan from falling. The transmission cooler lines may need to be moved to access some of the bolts, gently pry them out of the way.

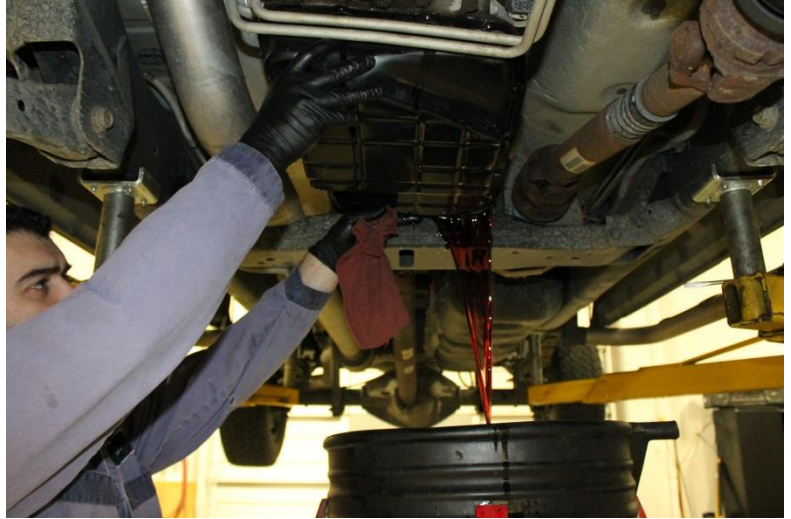
9. Tap pan with a mallet to break the silicone gasket seal. Allow fluid to drain. Remove last screw and drain remainder of fluid.

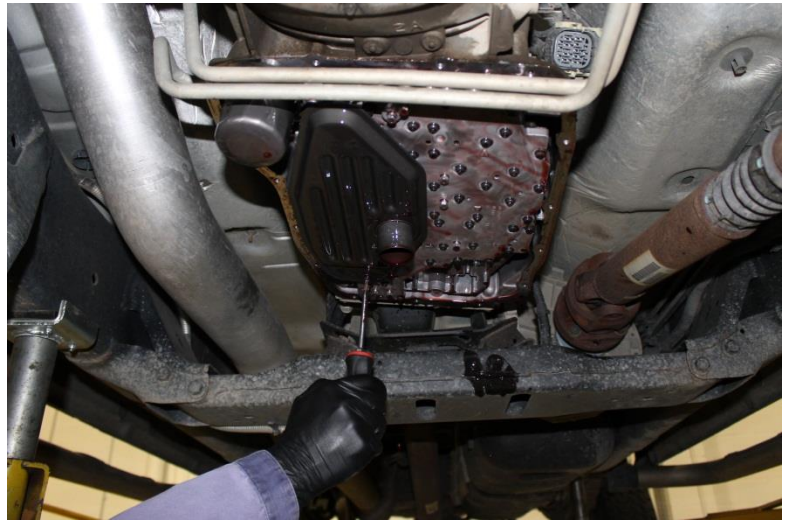
10. Remove transmission filter by removing the one T25 Torx screw.

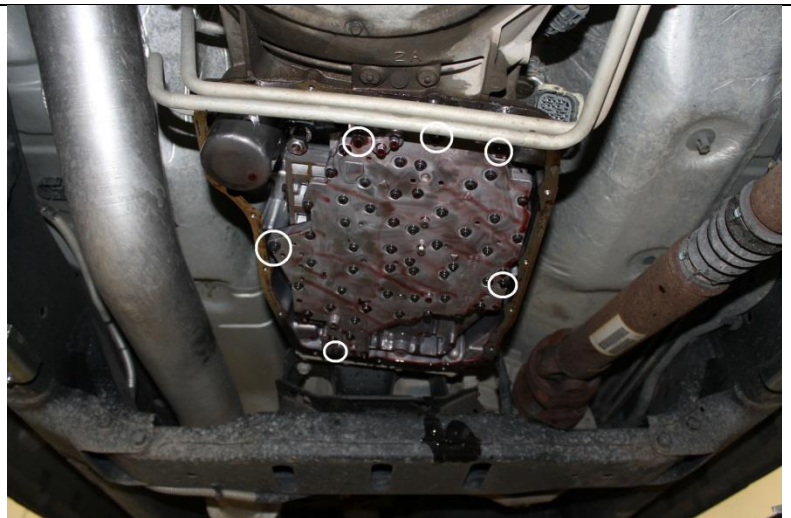
11. Remove the six 8mm bolts securing the valve body to the transmission. Drain valve body of fluid. To remove valve body from transmission, wiggle it while pulling downwards to work the electrical connector through the case.

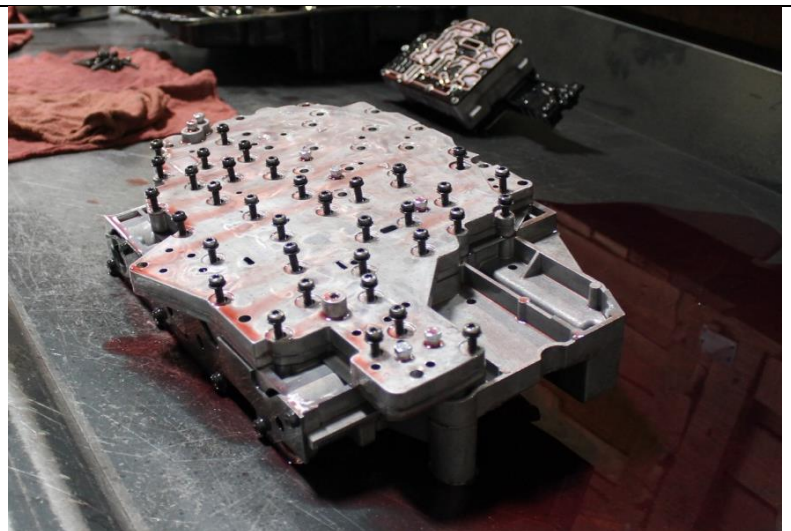
14. Remove remaining thirty five T25 Torx screws securing the valve body halves.

Note: All bolts are the same length.

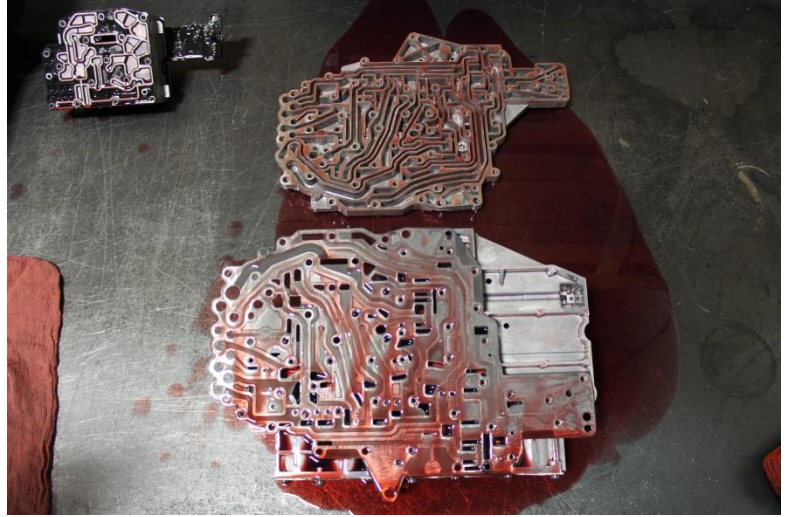
15. Carefully separate the two halves of the valve body. Separate as shown in pictures – *do not invert the larger (top) portion as it contains plastic check balls*. The two halves will have to be wiggled apart as the alignment dowels will be holding them together.

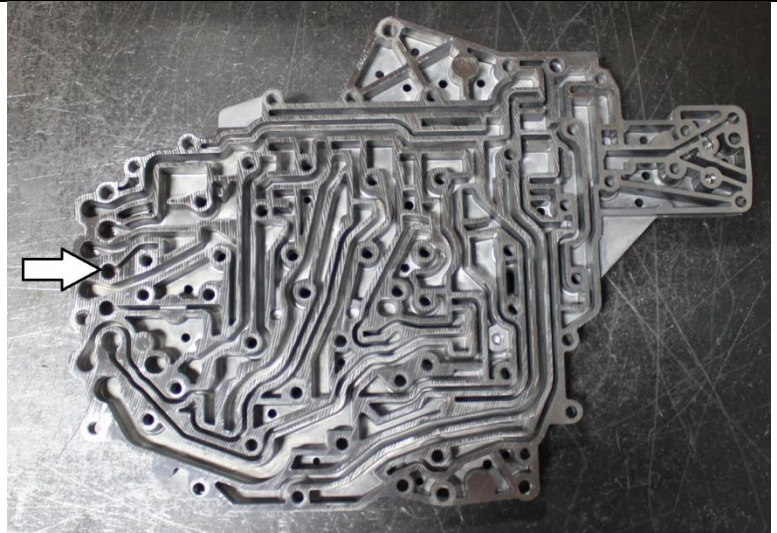
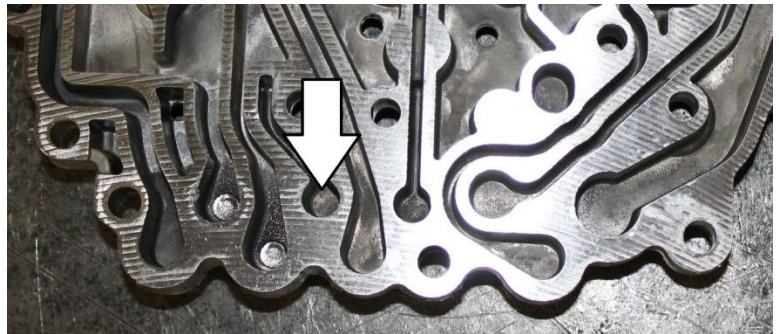
17. Thoroughly clean the bottom (smaller) half of the valve body. Locate the passage to be drilled.

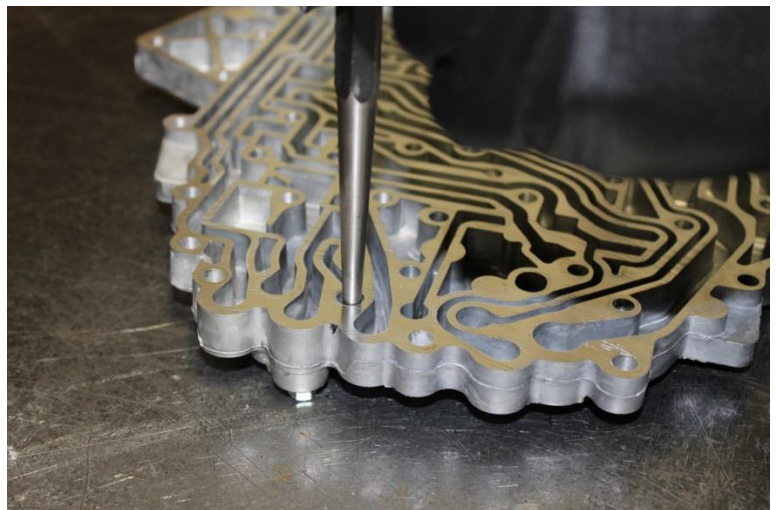
18. Punch center of hole using a center punch.

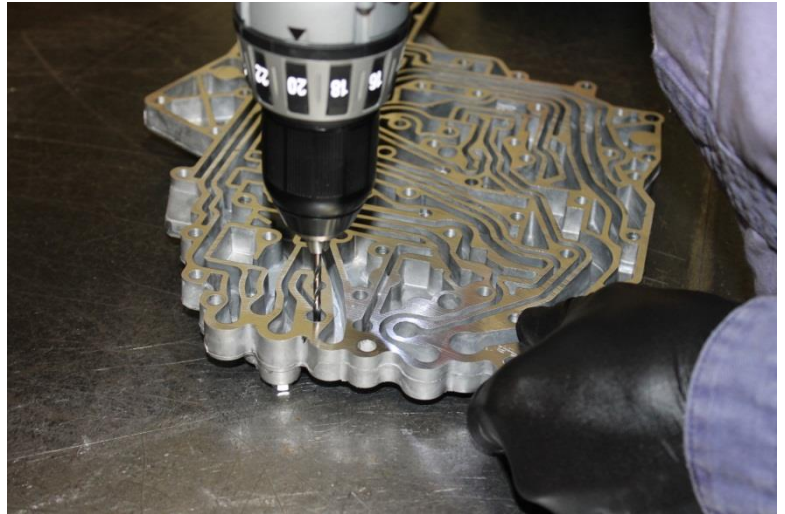
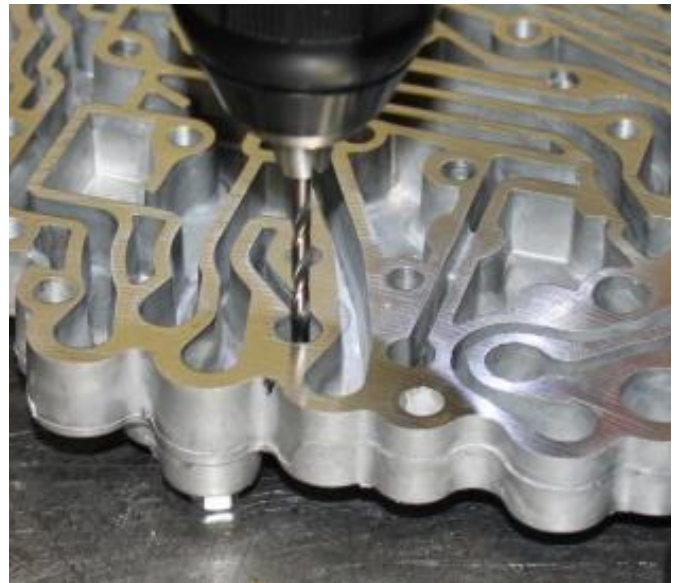
19. Drill hole with 1/8" drill bit.

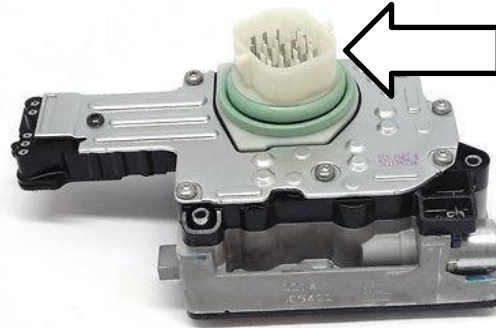
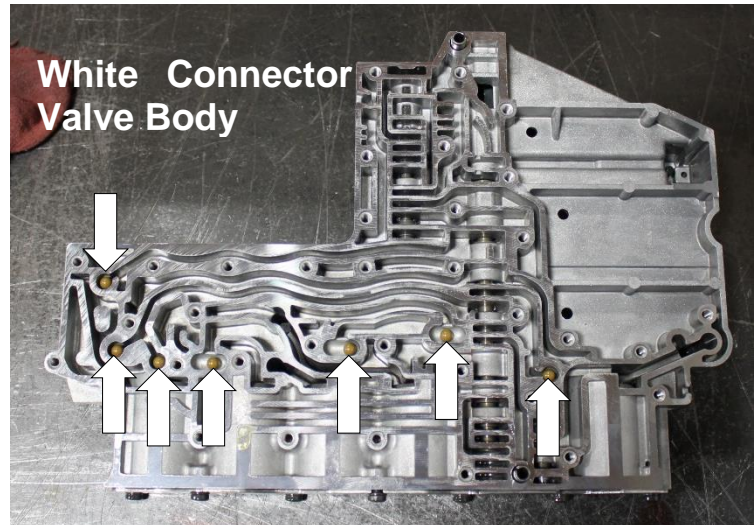
21. **IMPORTANT!** Ensure that all the check balls are in the locations shown.

If the electrical connector on the valve body is white make sure you have all seven check balls installed.

Discard any extra check balls.

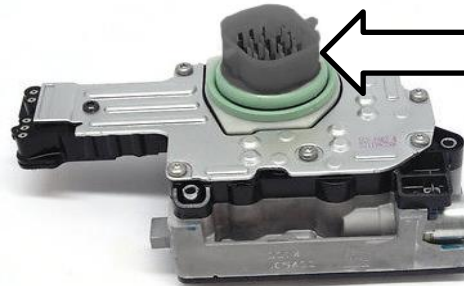
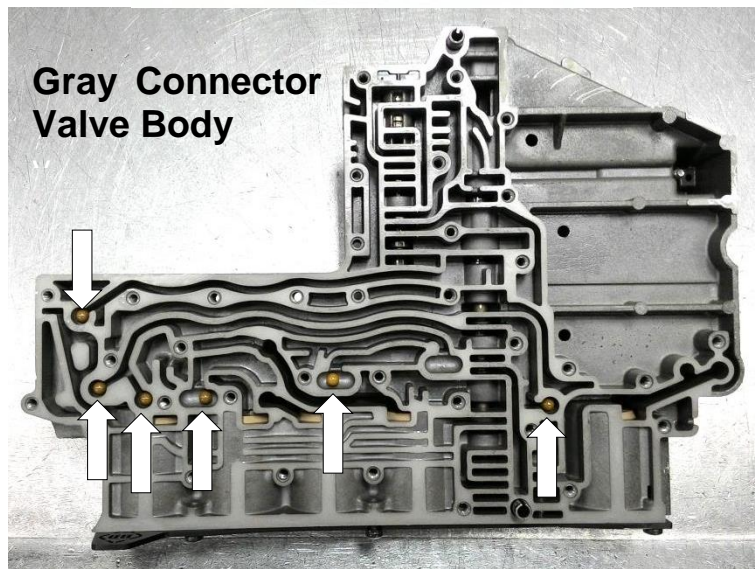
22. **IMPORTANT!** Ensure that all the check balls are in the locations shown.

If the electrical connector on the valve body is gray you will install six check balls rather than the five that were originally installed.

Use the supplied extra check ball included in this kit for this. Refer to the diagram on the right.

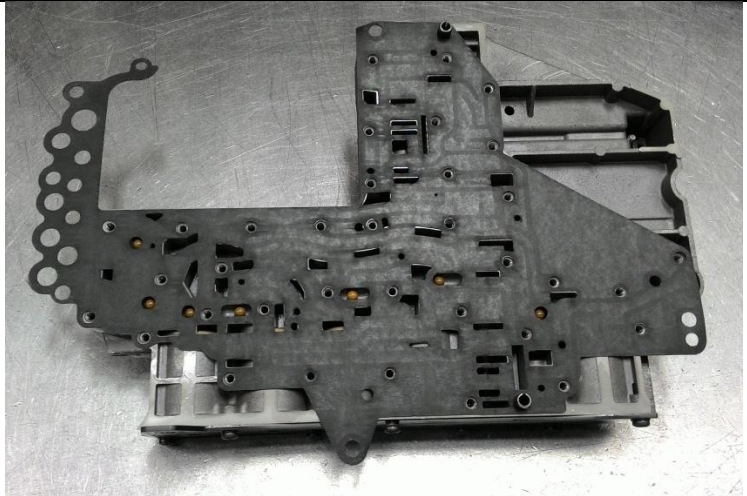
23. Install BD valve body gasket part number 1600186-1 on to the valve body, lining it up with the dowels.

Be careful not to tear or damage the gasket.

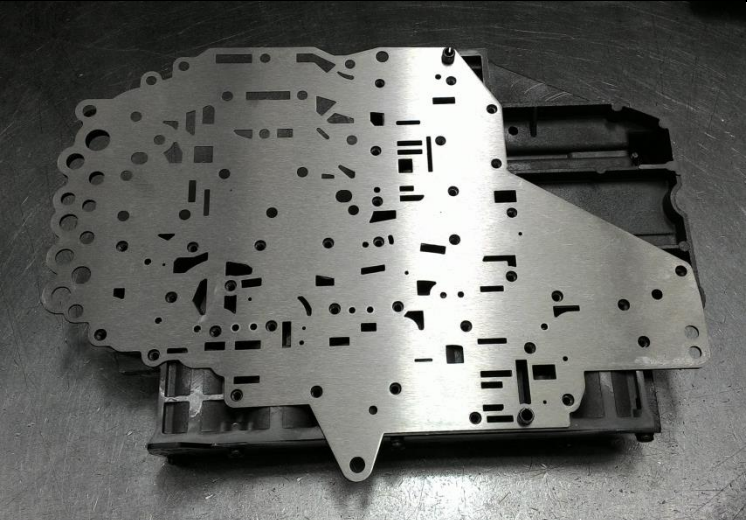
24. Install BD separator plate. Ensure it fits flat on the valve body.

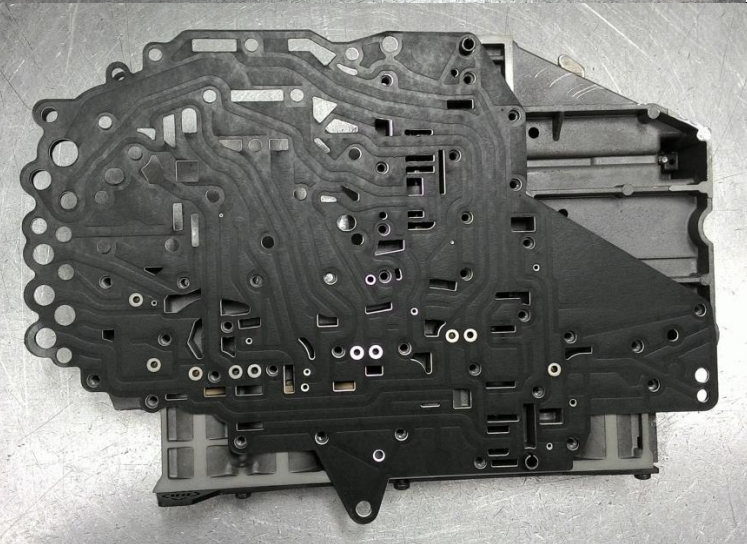
25. Install the second BD valve body gasket part number 1600186-2 on the separator plate, lining it up with the dowels.

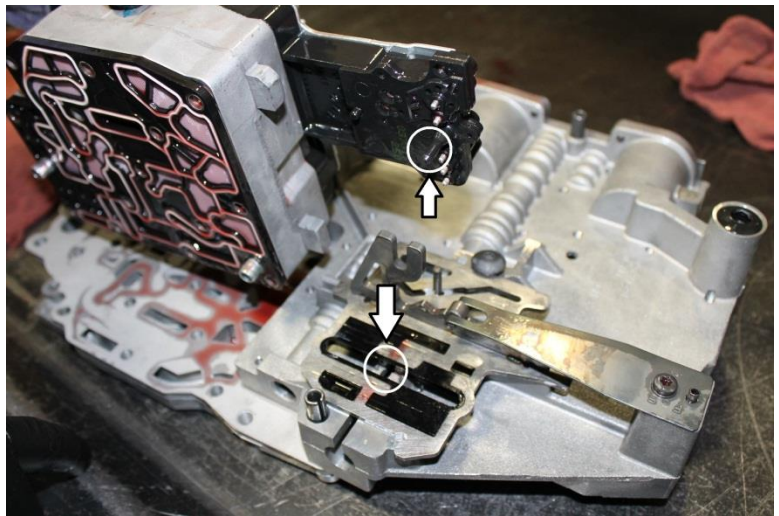
27. Re-install solenoid pack onto valve body. Be sure to properly align the pin on the solenoid pack with the slot on the valve body. Due to the alignment dowels, the valve body may need to be wiggled down into position. Install solenoid pack attaching screws. Install remaining Torx screws to fasten the solenoid pack to the valve body.

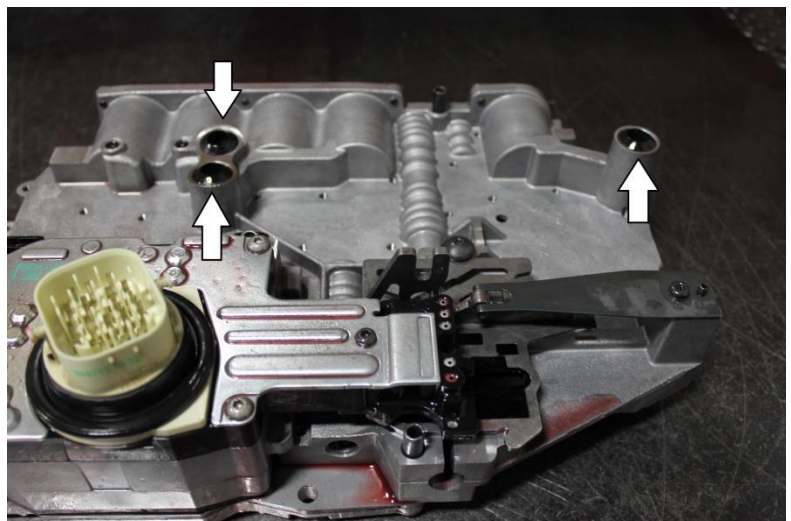
29. Inspect the three rubber seals on the top of the valve body, replace with supplied seals if they are nicked or otherwise damaged. Ensure the seal mating surface on the transmission is clean.

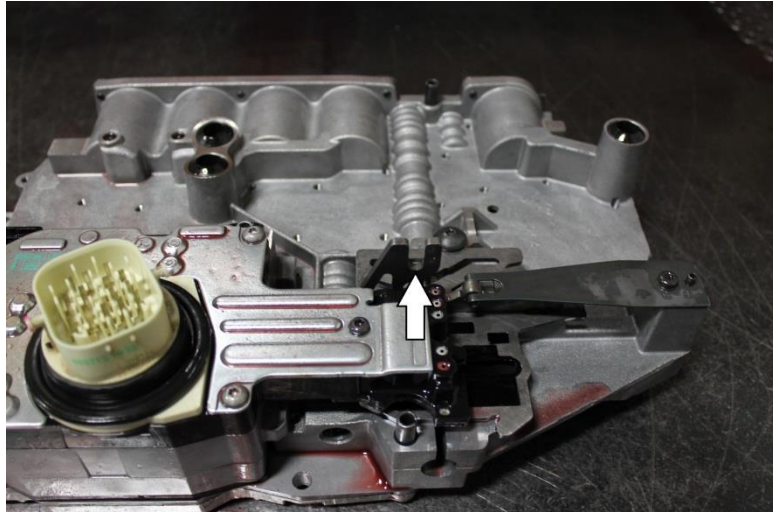
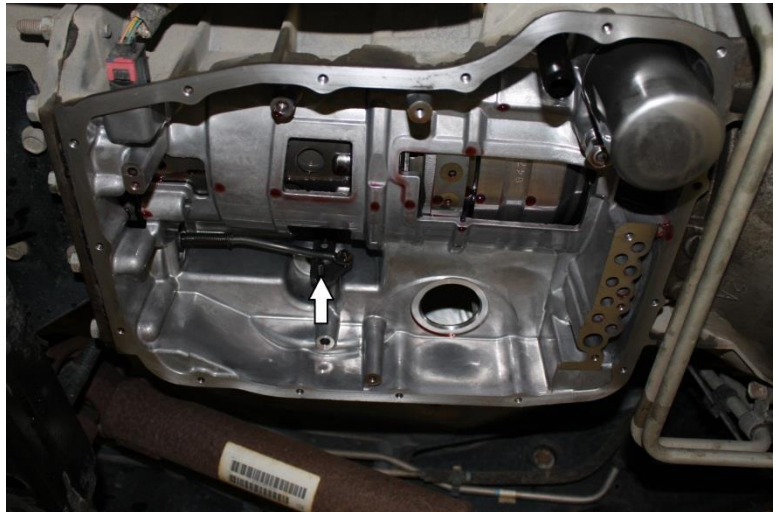
31. Check that the shift lever on the valve body lines up with the shift lever on the transmission and lift the valve body back into the transmission. Start the 8mm screws by hand, do not tighten yet. Work the shift lever on the outside of the transmission case by hand to ensure that the lever is making contact with the valve body correctly.

IMPORTANT: Use great care when reinstalling the valve body, the gasket that mates with the front of the case must line up correctly. Do not fold or pinch during installation.

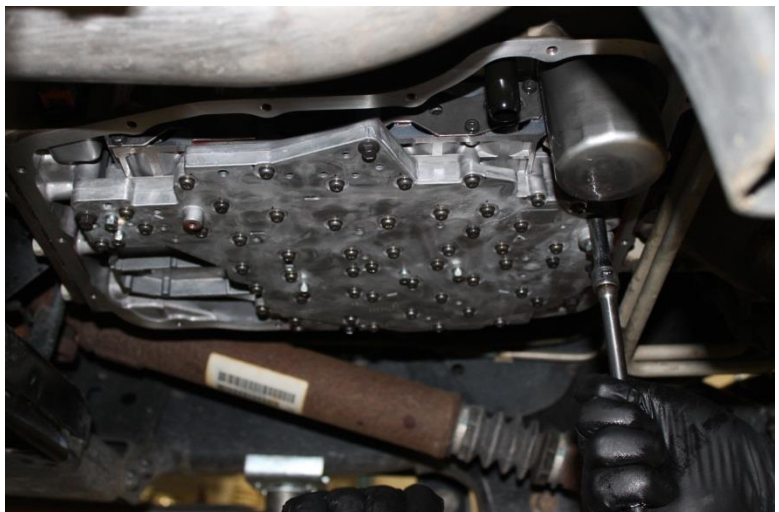
32. Torque the valve body attaching bolts to 105 in/lbs.

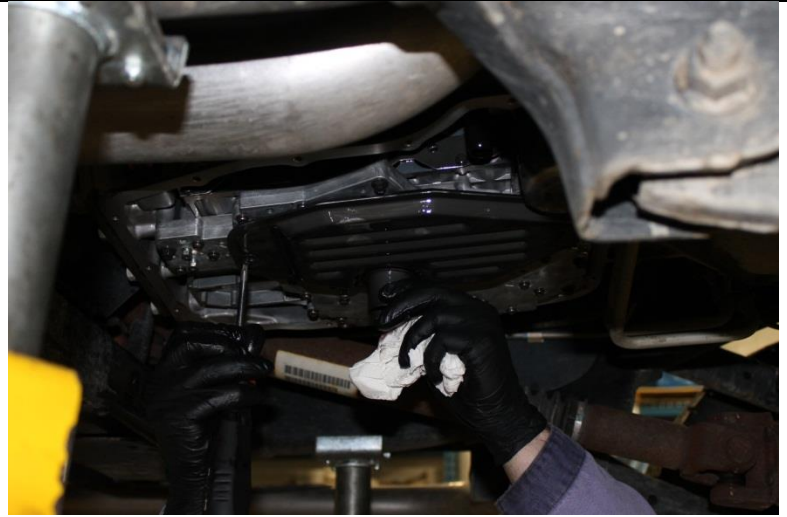
33. If desired, install new filter(s). Otherwise, reinstall the filter/pickup assembly. Torque to 50 in/lbs.

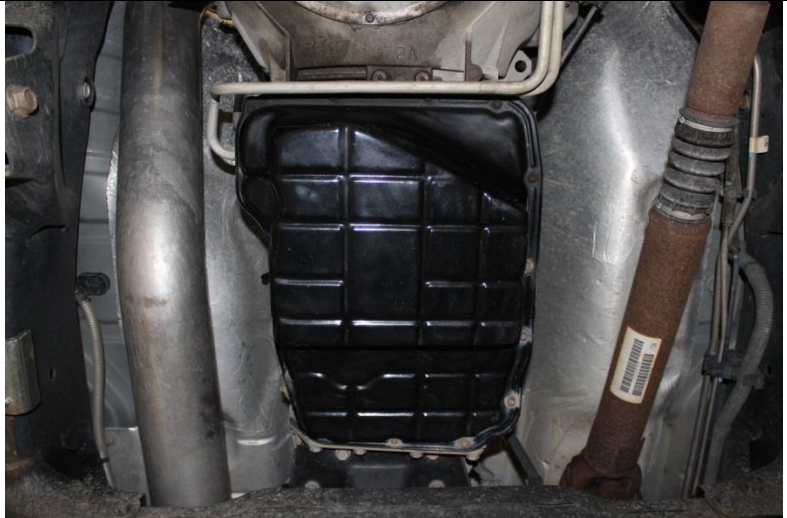
34. Place the supplied gasket on the transmission pan. Hold pan below transmission and install attaching screws. Torque the pan screws to 105 in/lbs.

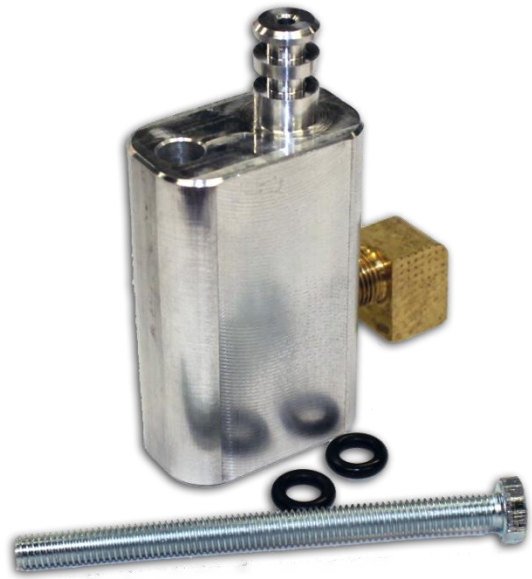
ADAPTER KIT BD# 1061529

41. Note. If you would like to verify the increases in line pressure, use adapter kit (BD 1061529) in conjunction with a 300psi gauge. Pressures at wide open throttle should be between 240 – 260 PSI with a mechanical gauge.

Use this kit with a 300 psi gauge.
