ATS or BD.....you decide.

The products that I'll be discussing are two competing sets of compound turbos, both installed on 2006 Dodge Ram's with Cummins Turbo Diesel engines. One set was from ATS, which included the Aurora 3000 and Aurora 5000 turbos and the other was from BD Power, which included the SuperB and R700 turbos. Both are advertised as towing / race setups.

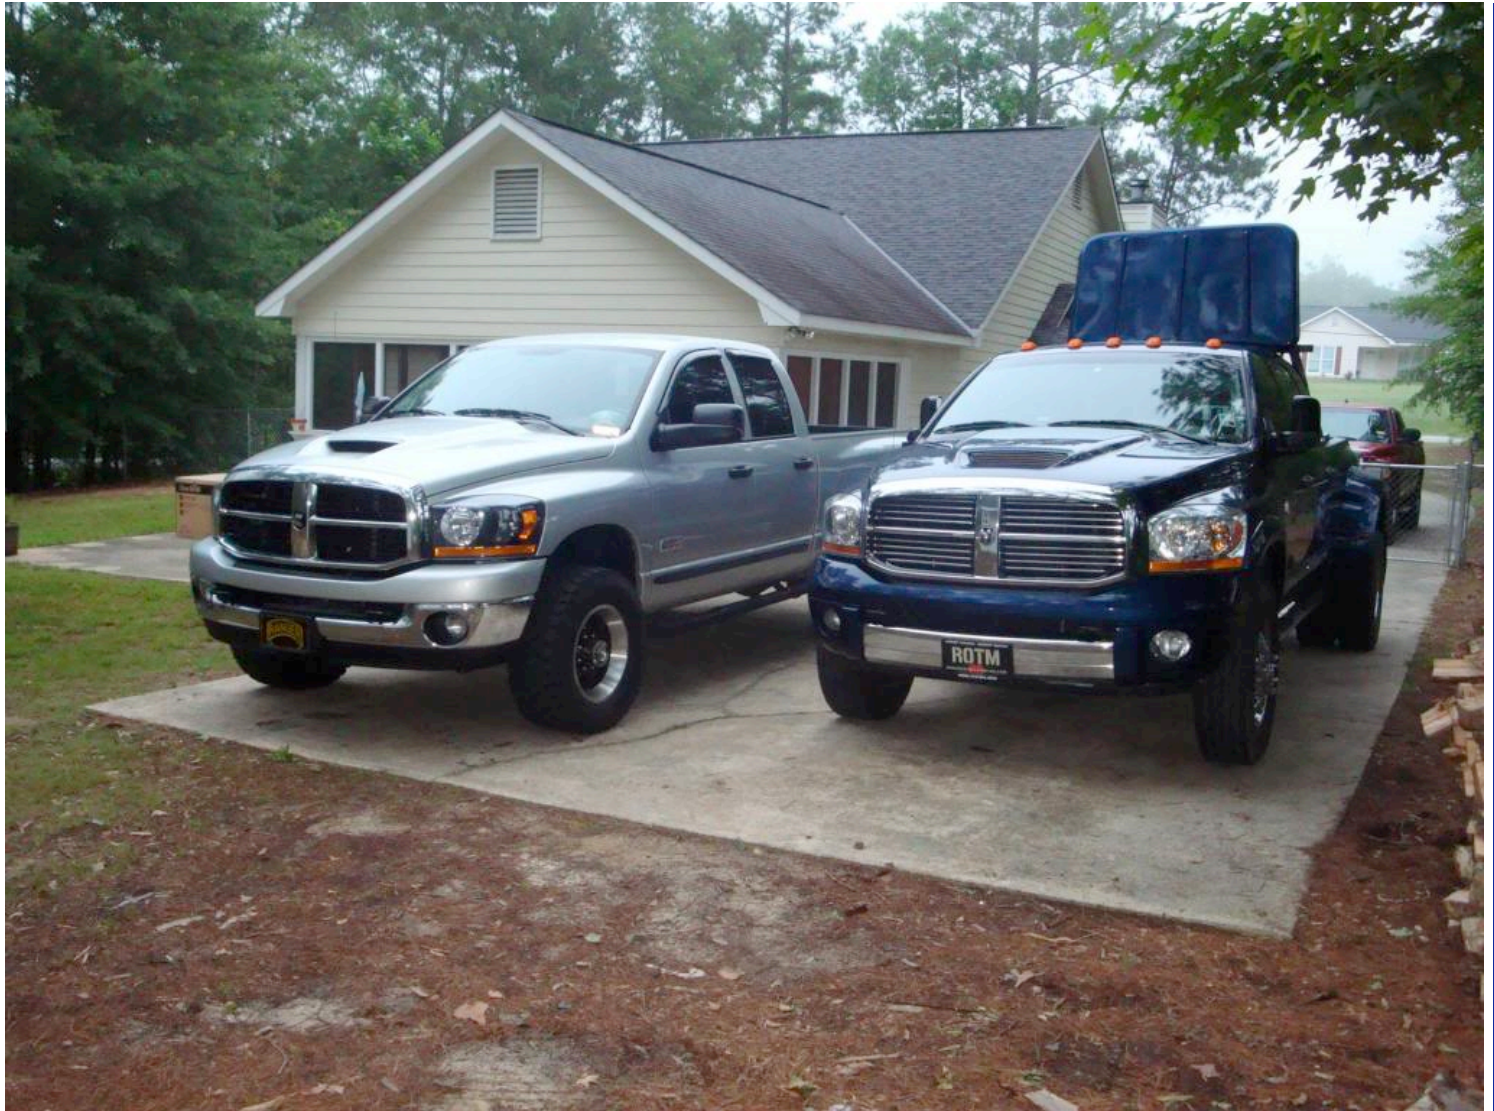
The two vehicles that the products were installed on:

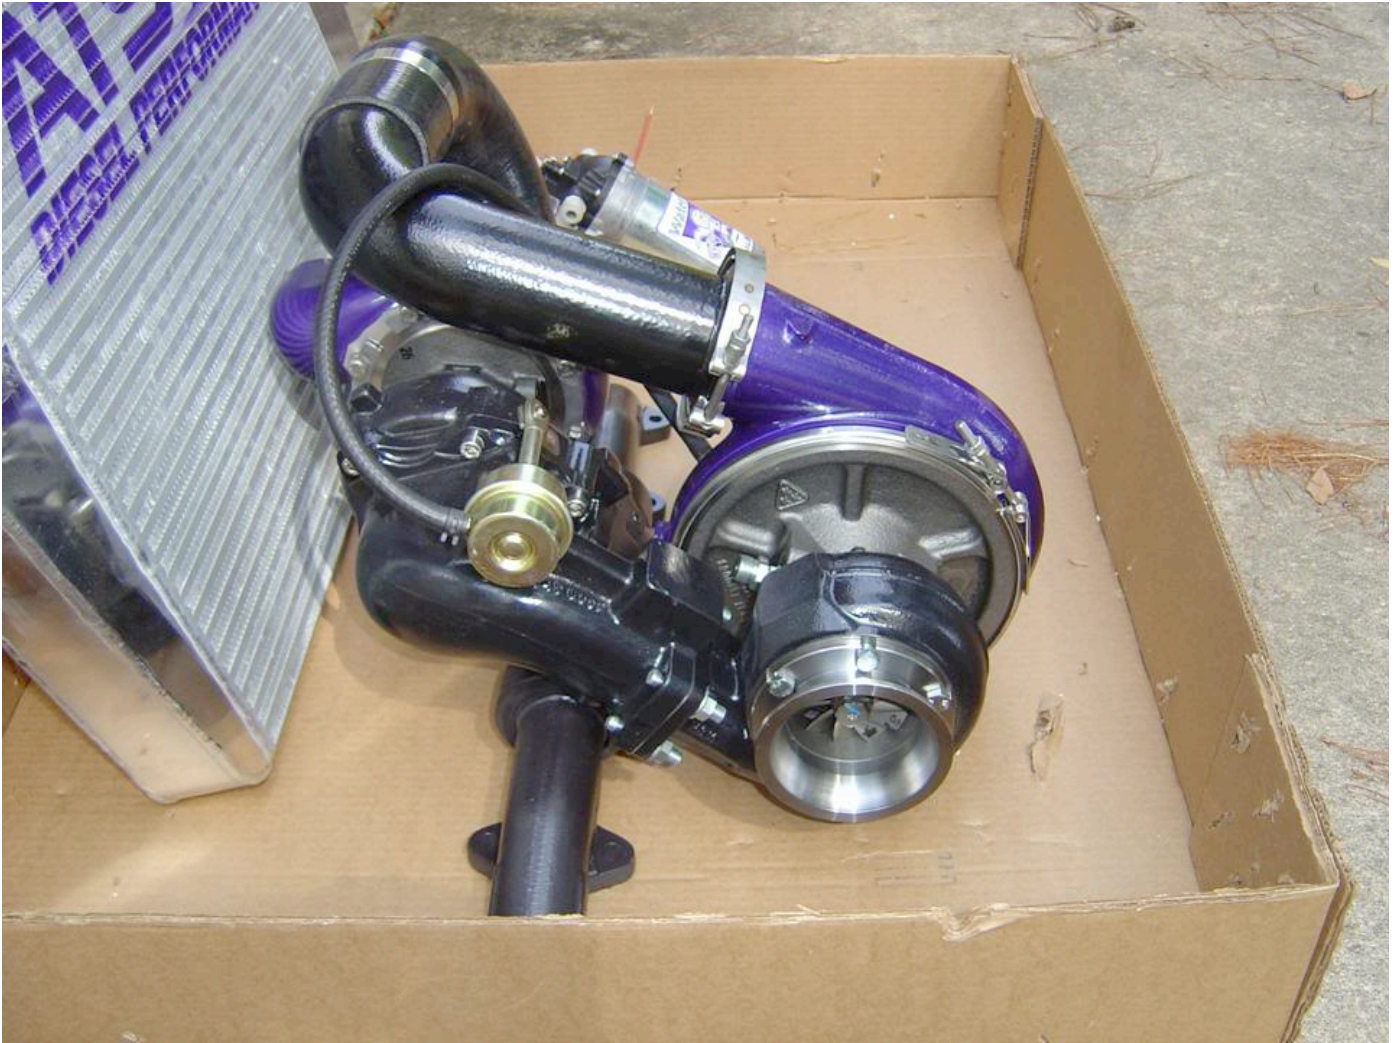
When the parts arrived, they were in very different conditions from each other. The ATS kit came completely assembled and made for a very easy install. You had the finished product to look at prior to installation.

The parts arrived complete, free of rust and corrosion and clocked correctly for the application.

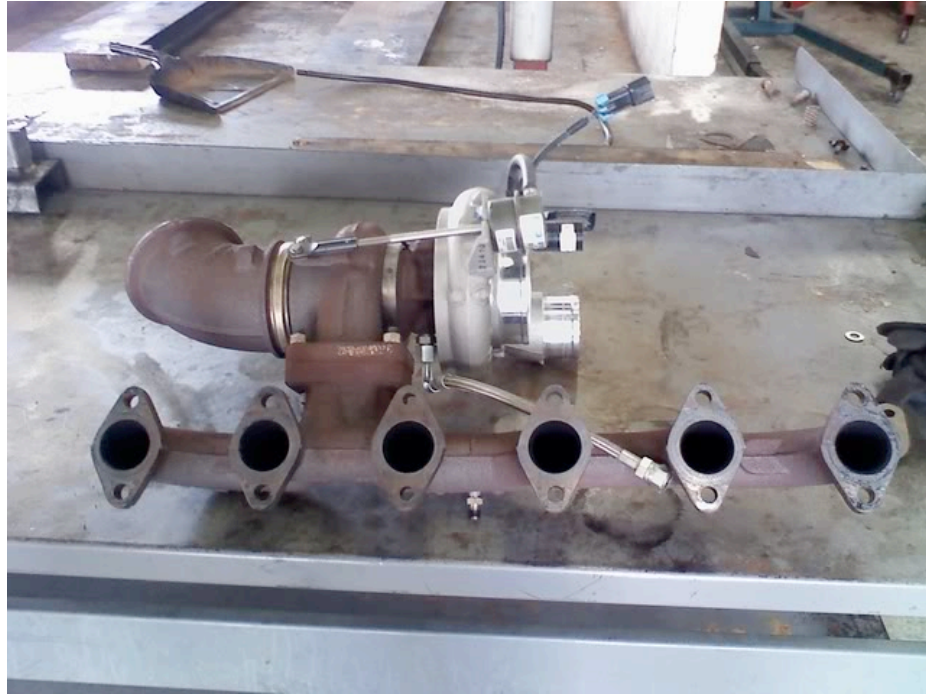
Silver 2500:

To begin, obviously all the original parts had to be removed. Both of the trucks had OEM manifolds and turbos, both had AFE Stage II intakes, both had 5" exhausts installed. The blue 3500 had a Pac-Brake that had already been disconnected and posed no additional labor to remove.

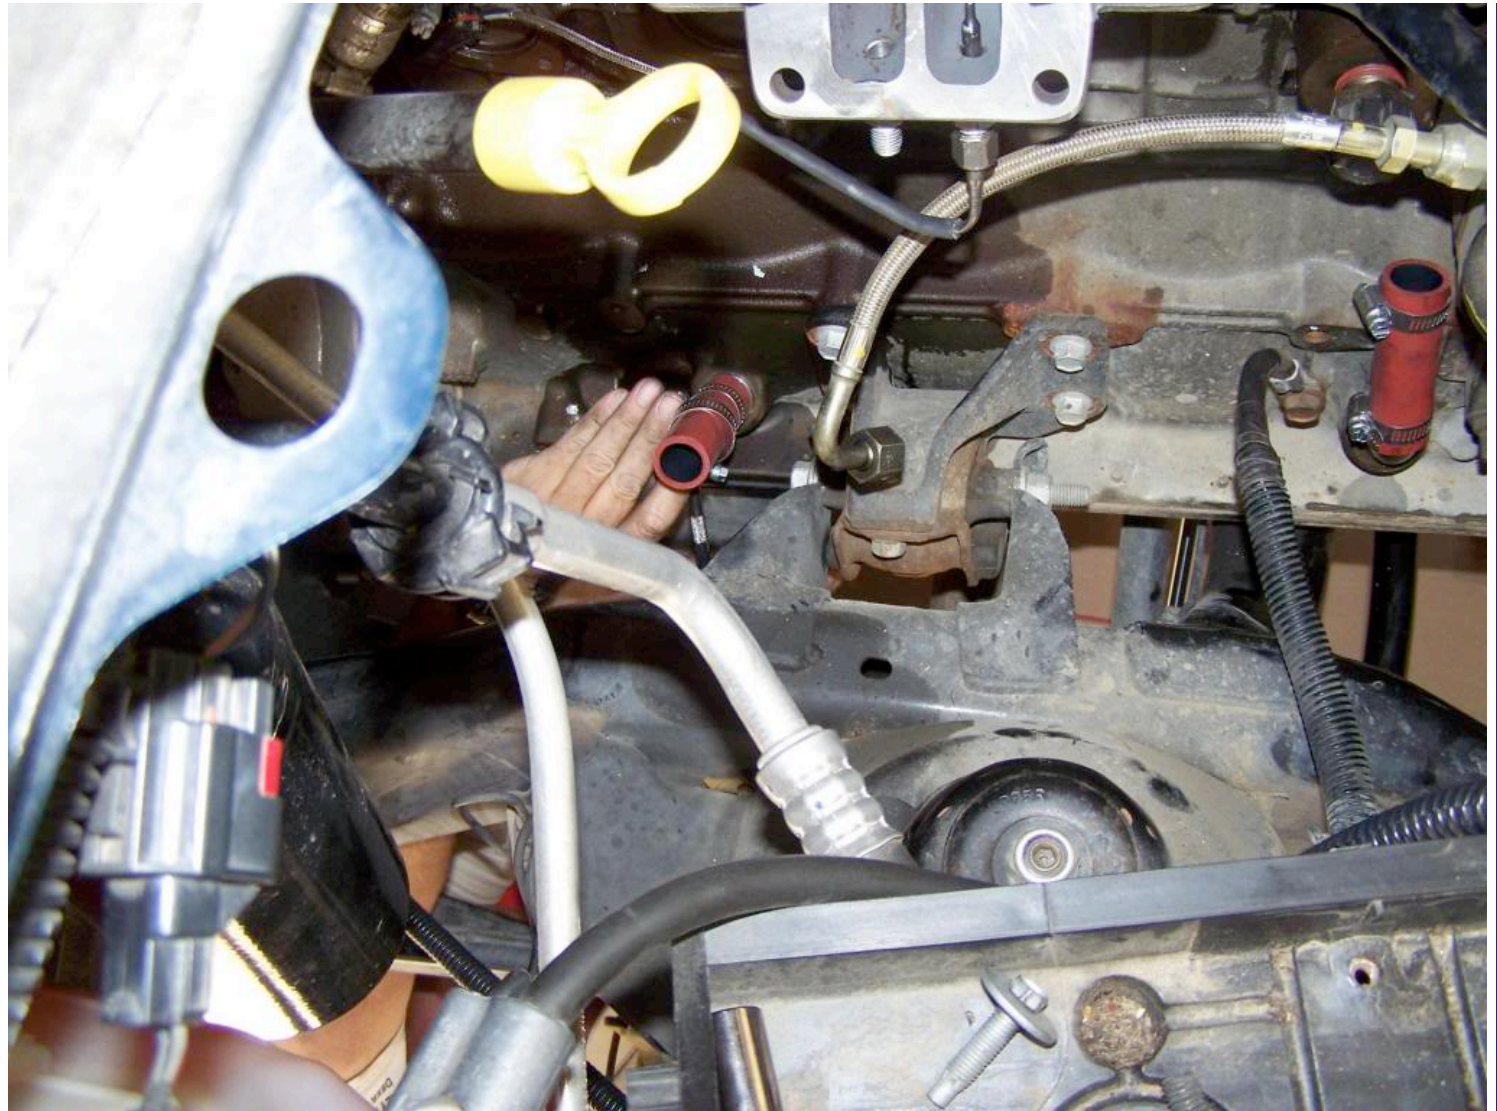
The picture below shows where the OEM return is (rear of engine) and the new secondary drain is located (front of engine)

Once the old intakes, manifolds, turbo's and passenger side batteries were removed, we can now start doing a few things were common to both kits, but became uncommon very quickly. Both kits require pulling out a frost plug leading to the oil pan for the drain on the secondary charger.

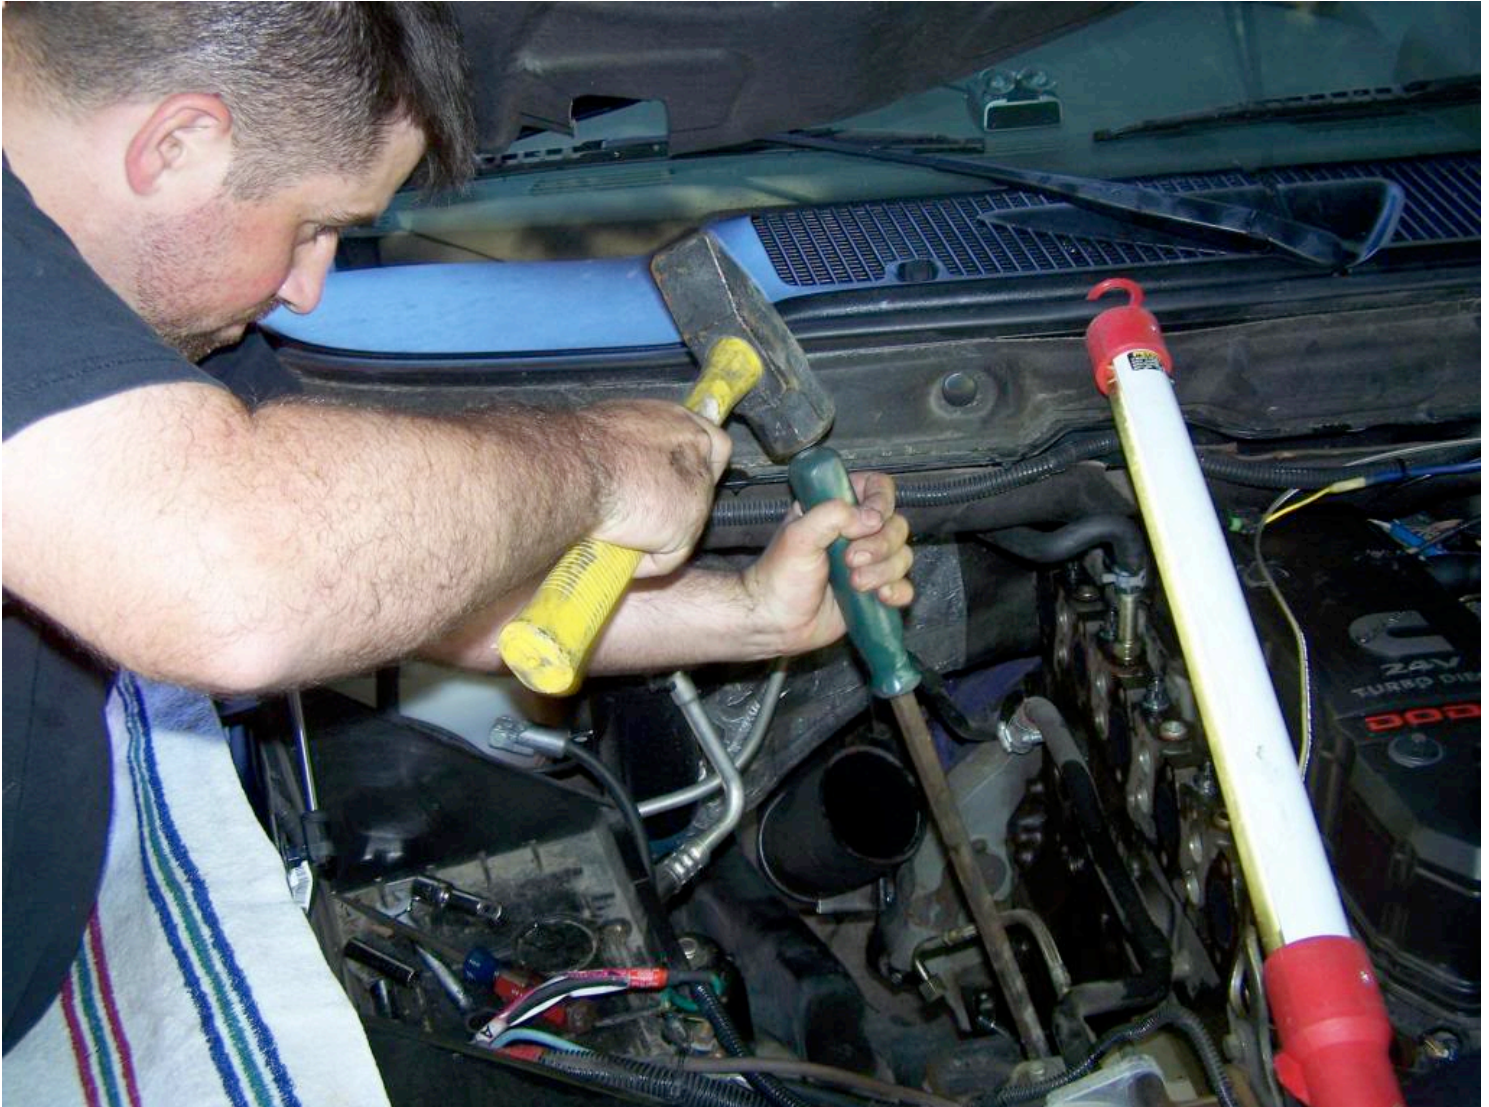
The secondary turbo also required a steel adapter to go in the frost plug hole. This adapter did not fit. The instructions said that you may have to use a punch to get it to fit....this was a mild understatement.

I tried brass and steel punches, using a reasonable amount of force and it would not even seat. I ended up need to use a pry bar and a mallet to mark the adapter where it was oversized so it could be re-sized with a die grinder.

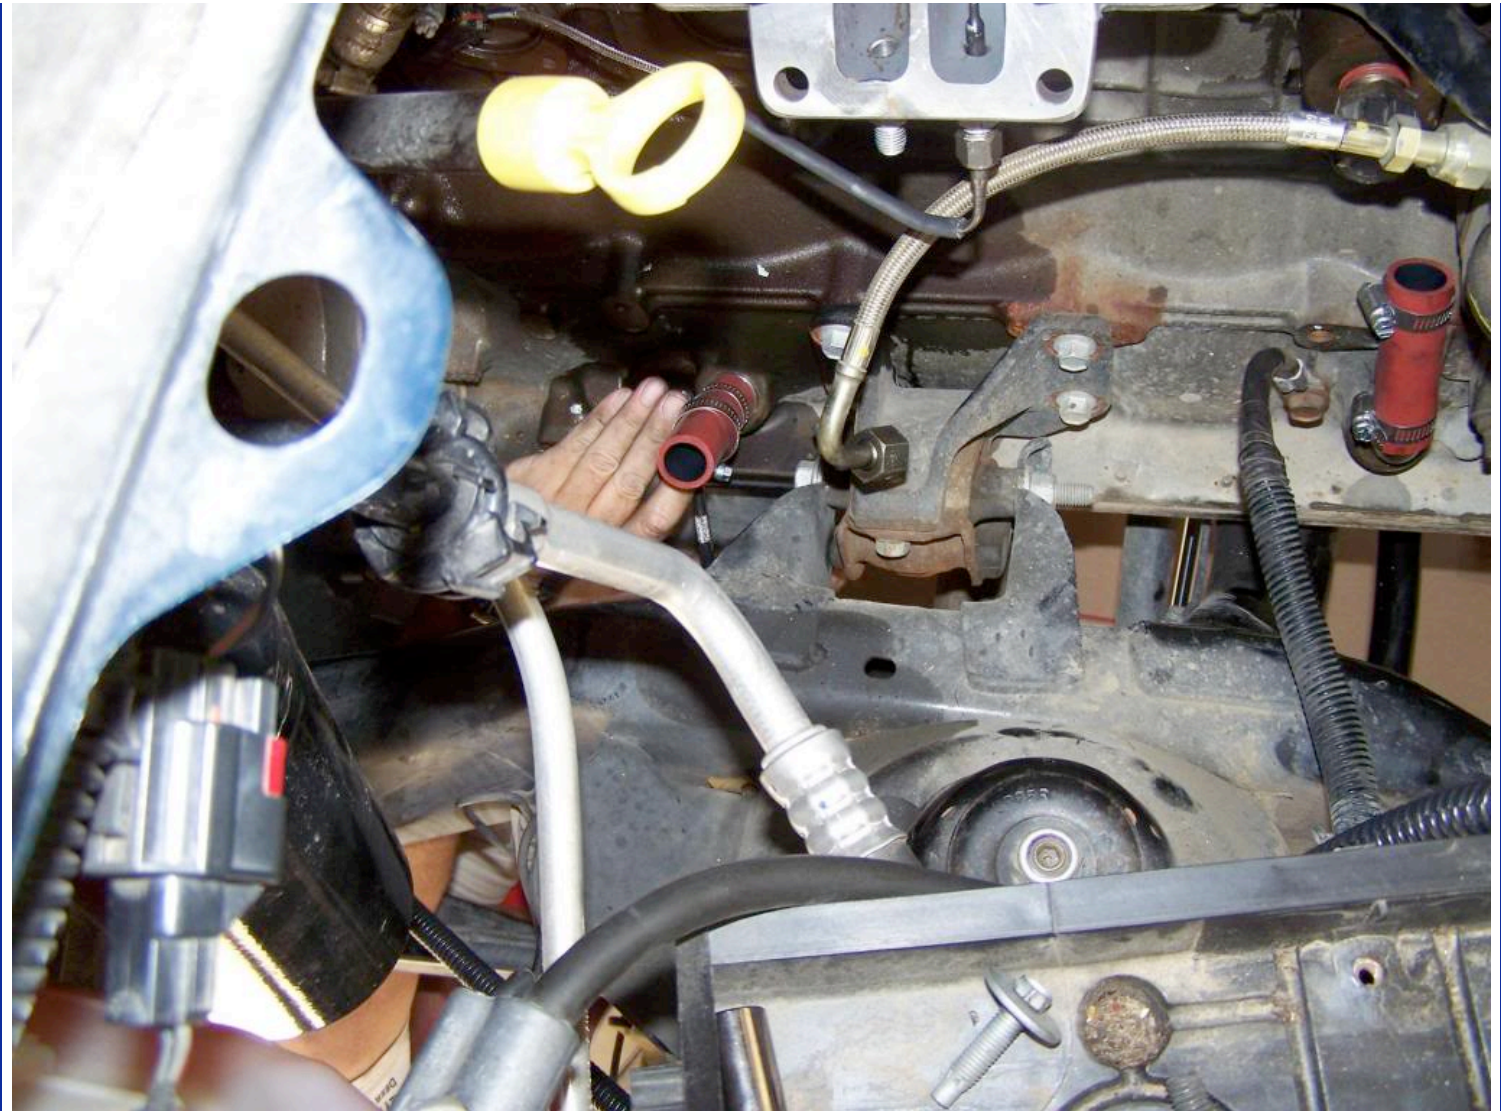
Once it was chamfered and resized, the secondary adapter was installed. The picture below is of those two components and their associated hoses and clamps installed.

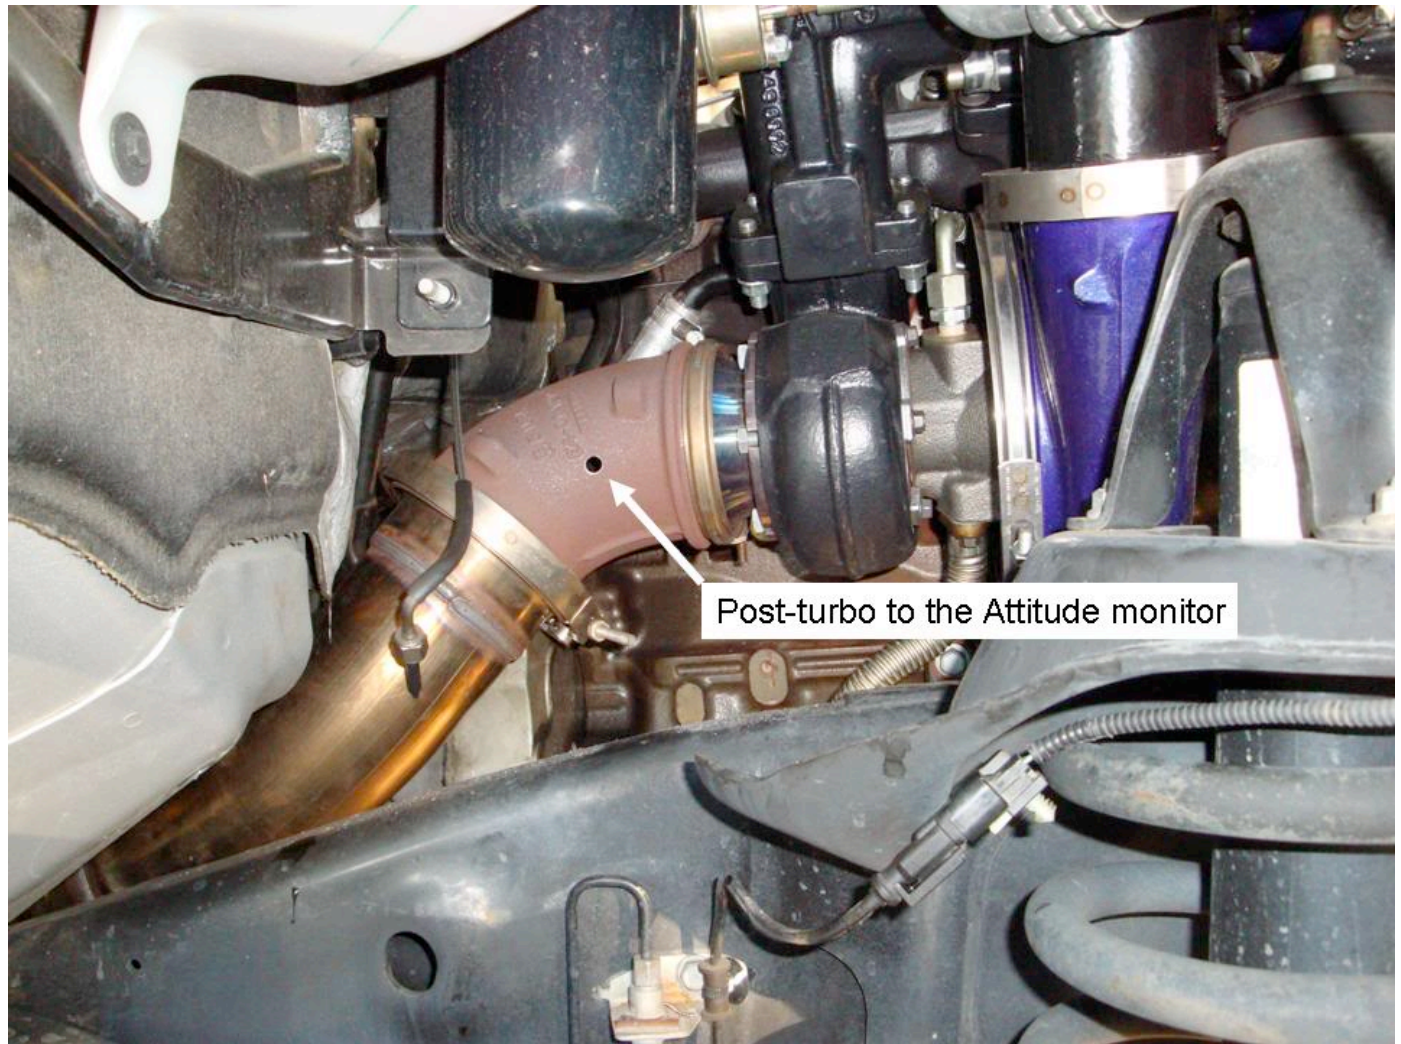
Now, from here, the ATS primary was attached the OEM exhaust elbow by removing the locator roll pins in the elbow and loosely attaching it to the existing down pipe for alignment and attachment to the secondary.

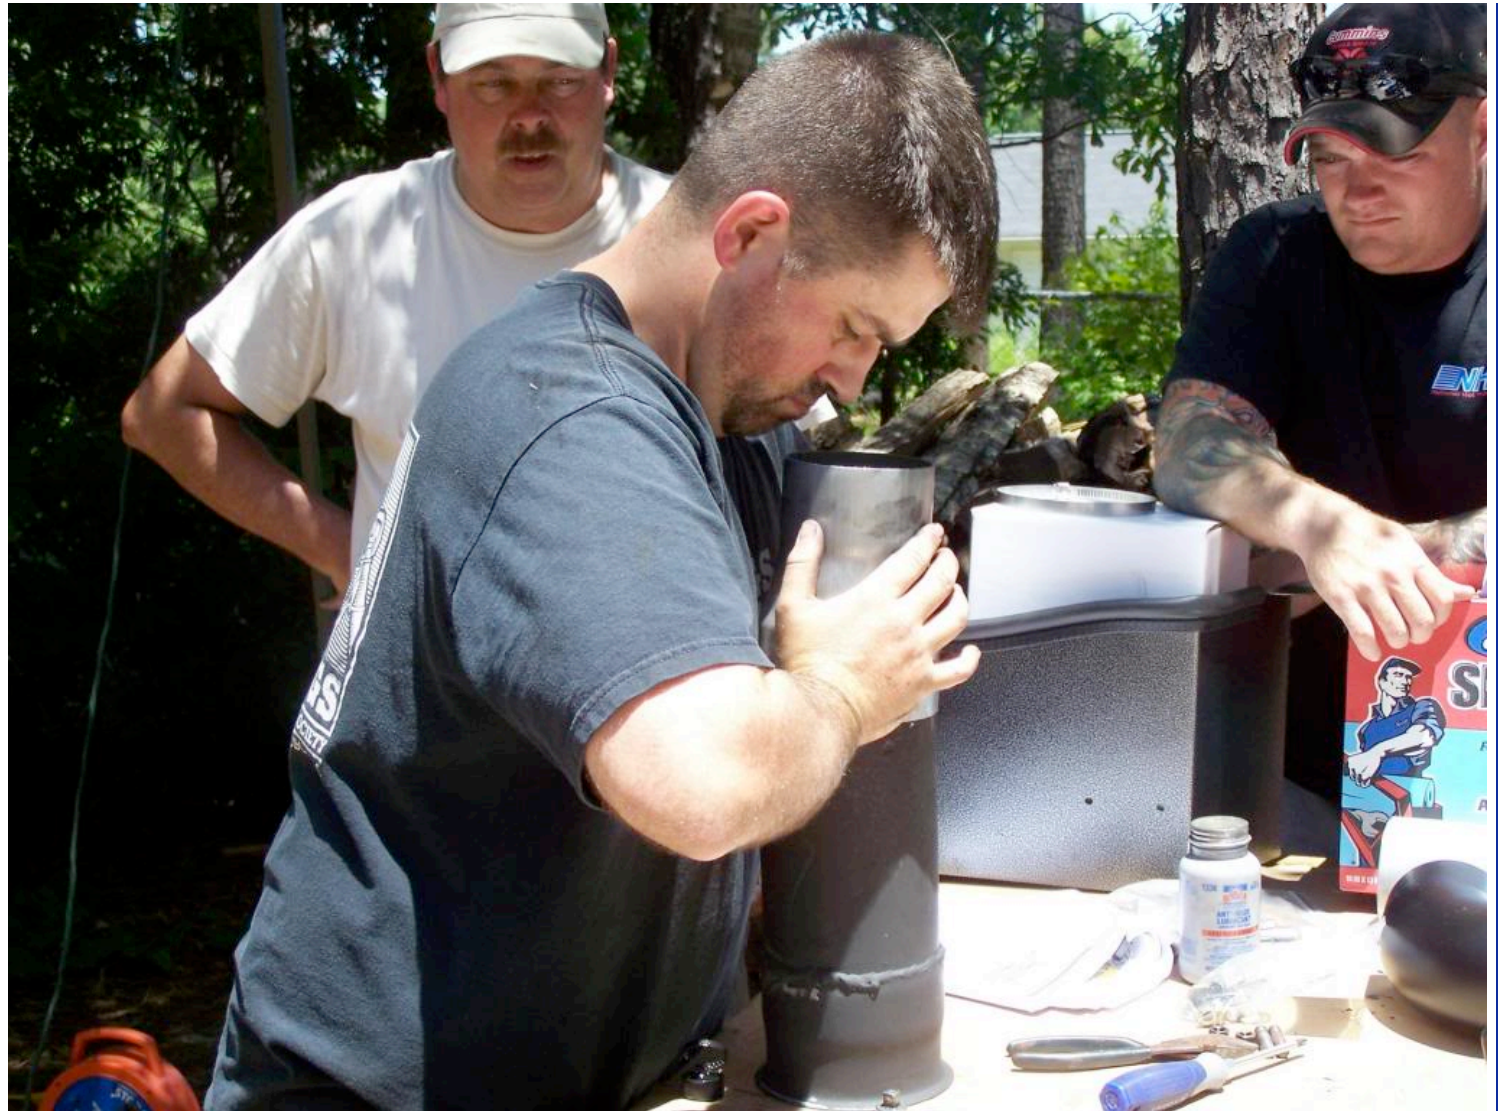
The BD kit does not sit in the OEM location and cannot reuse the existing elbow or down pipe. This presented a problem as both trucks had 5" exhausts and the BD downpipe that comes with the kit is 4", which required getting an adapter to mate the two. This also eliminated the possibility of using the existing exhaust elbow and the post-turbo pyrometer used to monitor the exhaust brake.

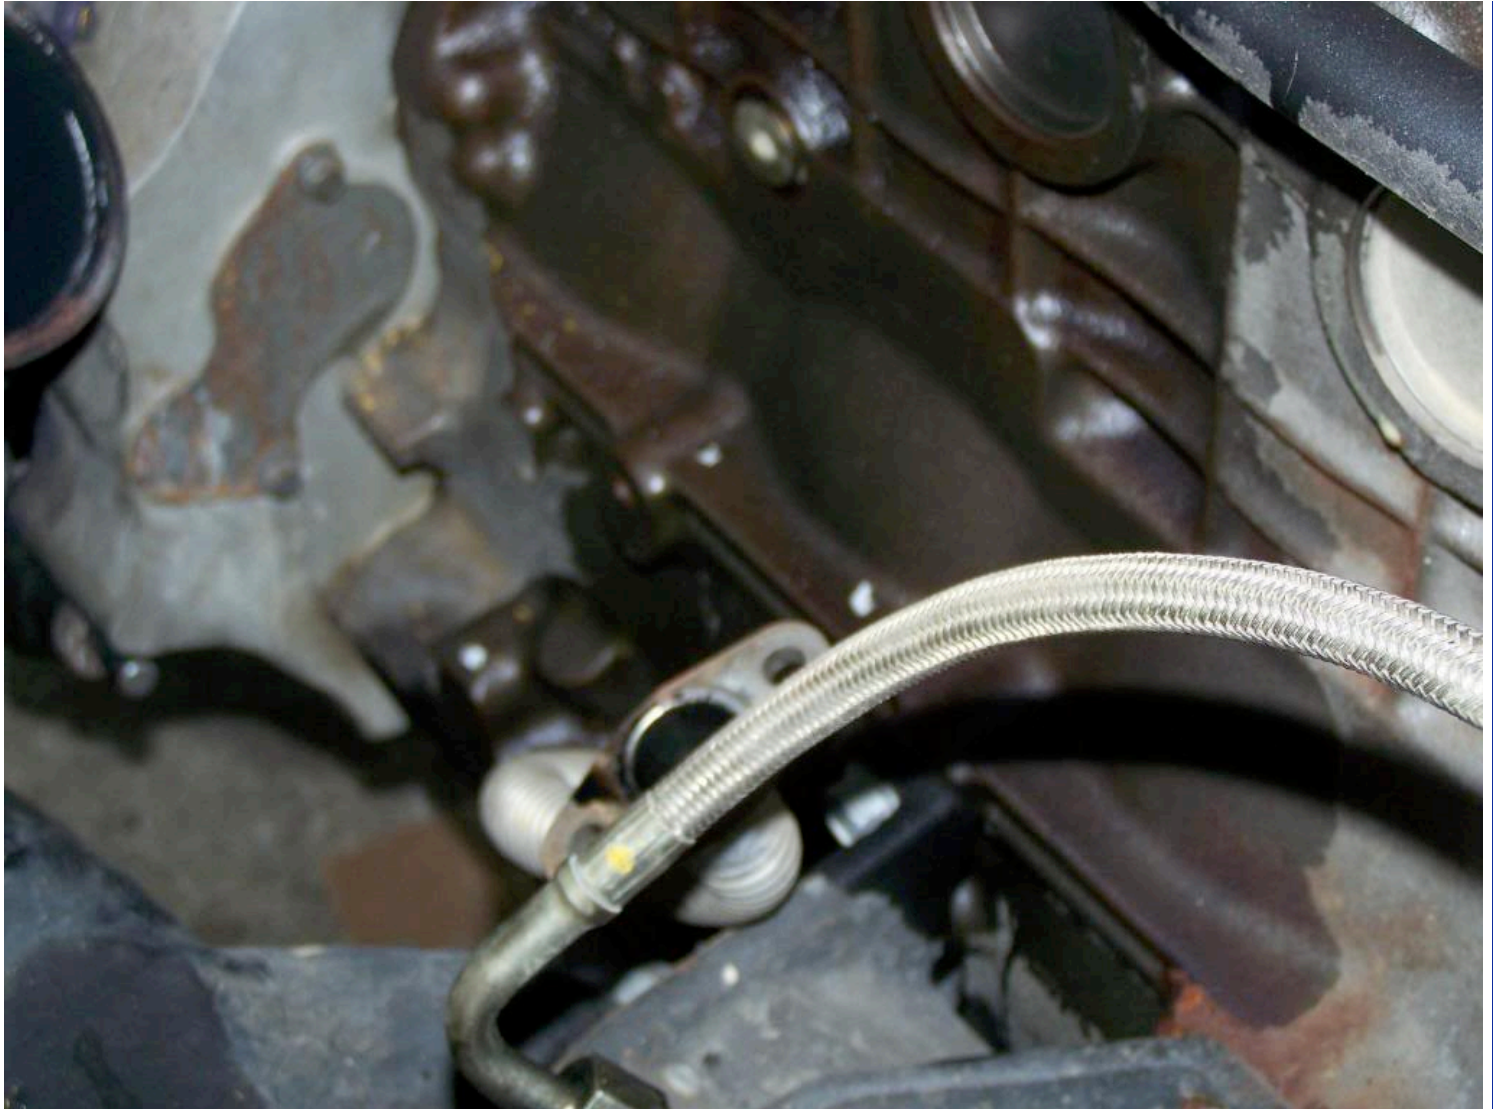
Once this modification was made, the BD kit required draining approx 3 gals of coolant from the system. This was necessary because you had to cut the tube on the steel coolant line that runs near the bottom of the engine block. This was to install an adapter that bolted to existing bungs in the block. The kit came with a 90* adapter for this cut, but it was larger than the existing pipe and would not clear the bracket. We ended up fabricating a soft coolant line from the bottom of the engine to the heater core supply fitting. This still presented a problem as the edges of the supplied bracket are very sharp and would have cut the hose quickly. We omitted using the bracket at this point.

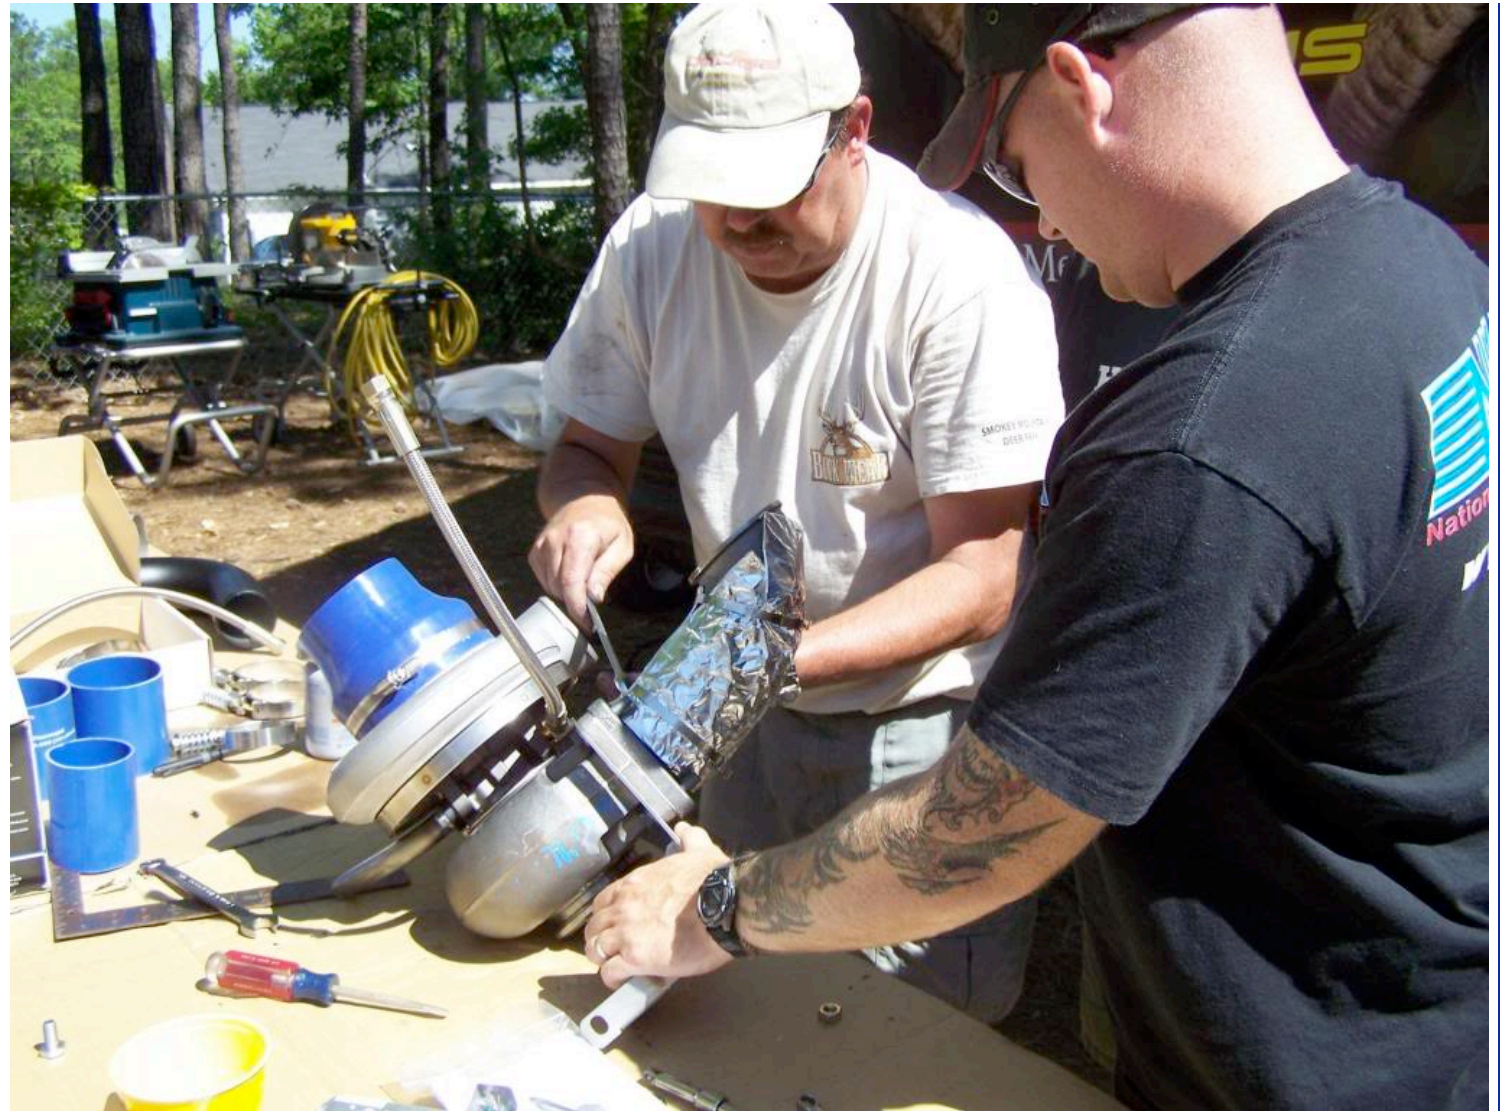
From here, you must fit the exhaust adapter from the secondary to the primary on the BD compound. This again presented a problem. The studs supplied with the kit were incorrect in thread pitch, count and coarseness. We had to run to the hardware store to get fasteners of the correct type to bolt the adapter to the primary.

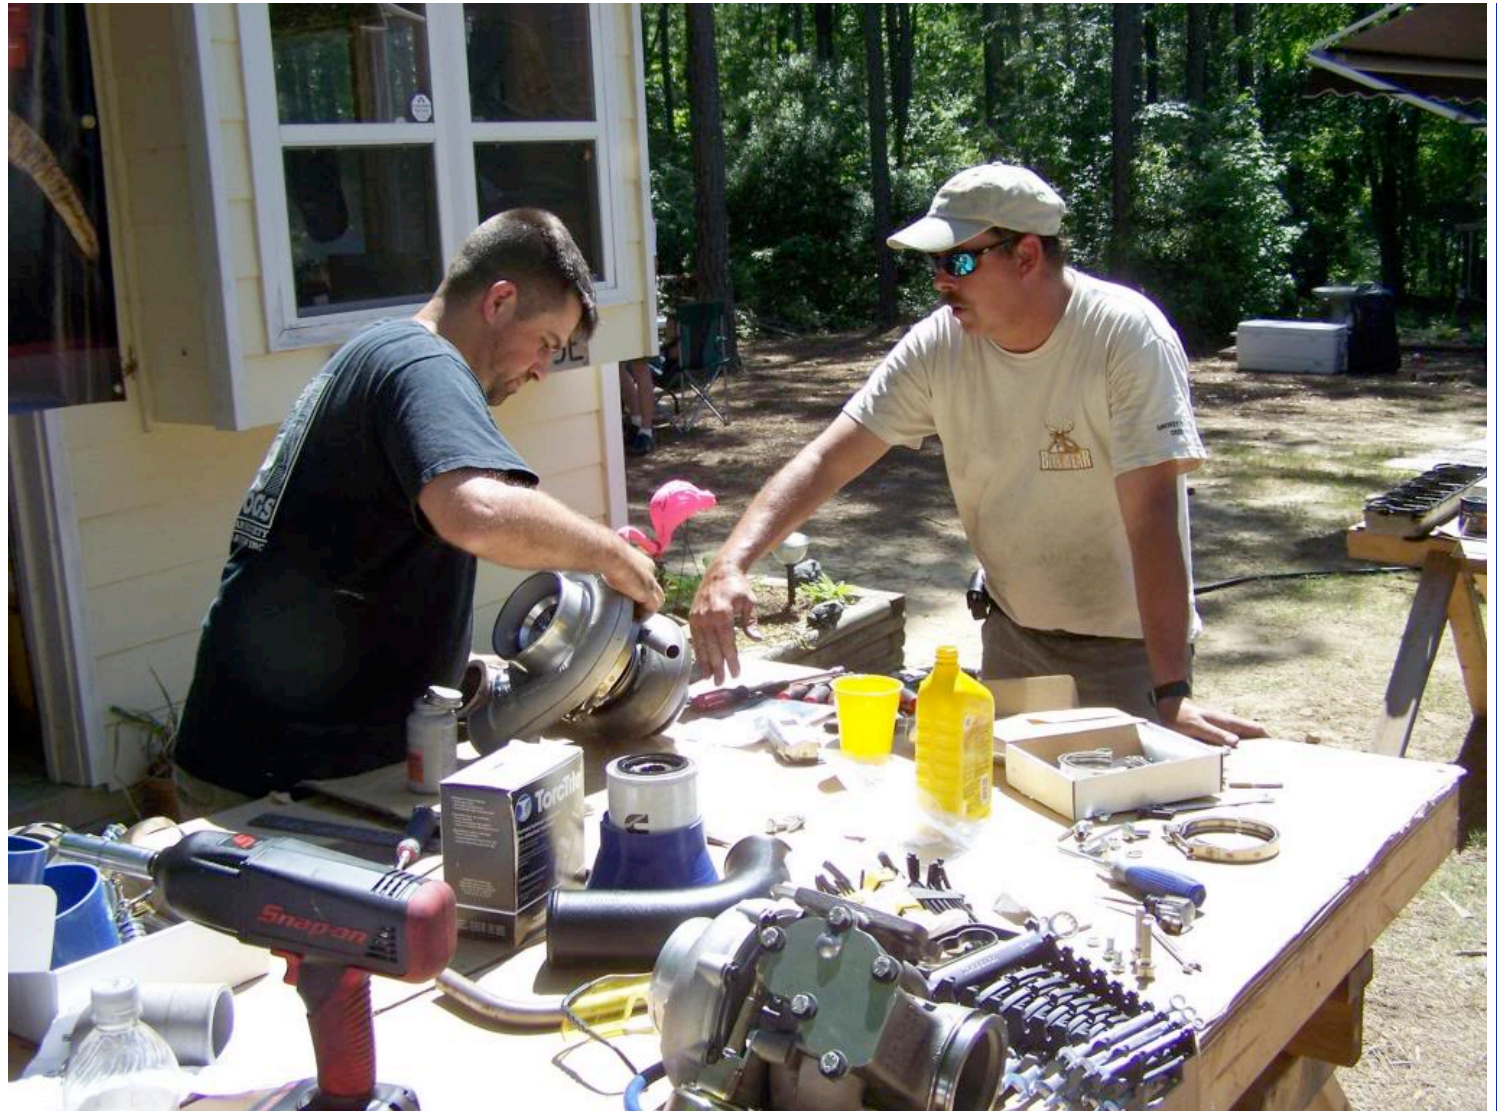
Once the primaries were positioned, we found the clocking that was called for in the BD directions was incorrect, so this was adjusted.

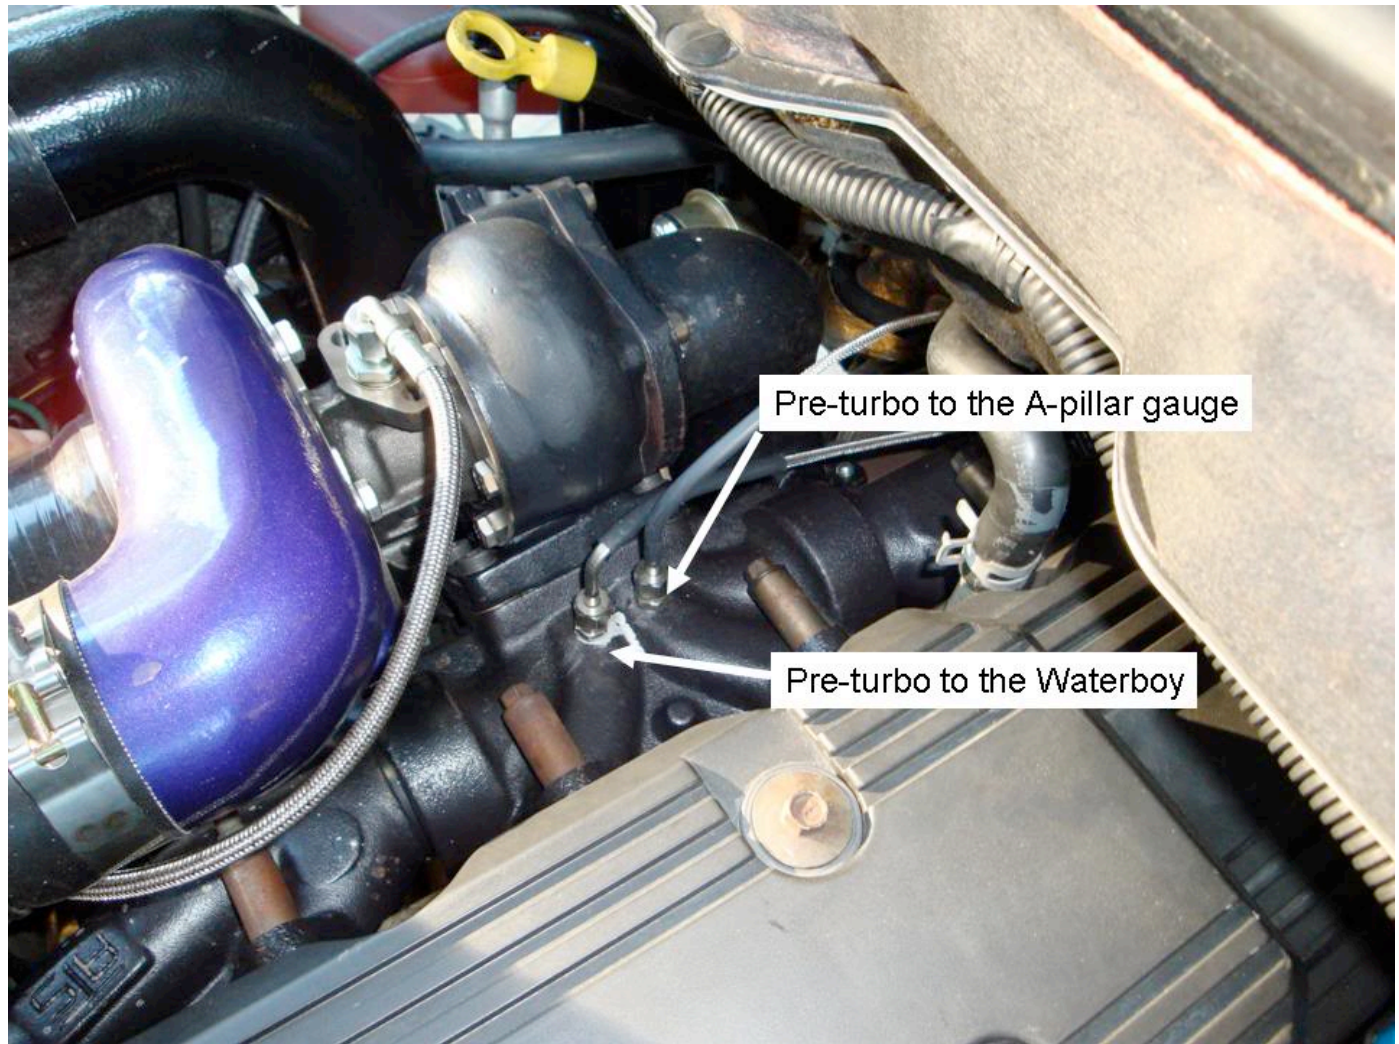
The ATS manifold came pre-drilled and tapped with four 1/8 NPT ports. Two on top and two on the bottom. These ports were in the correct locations for the application and were correctly tapped.

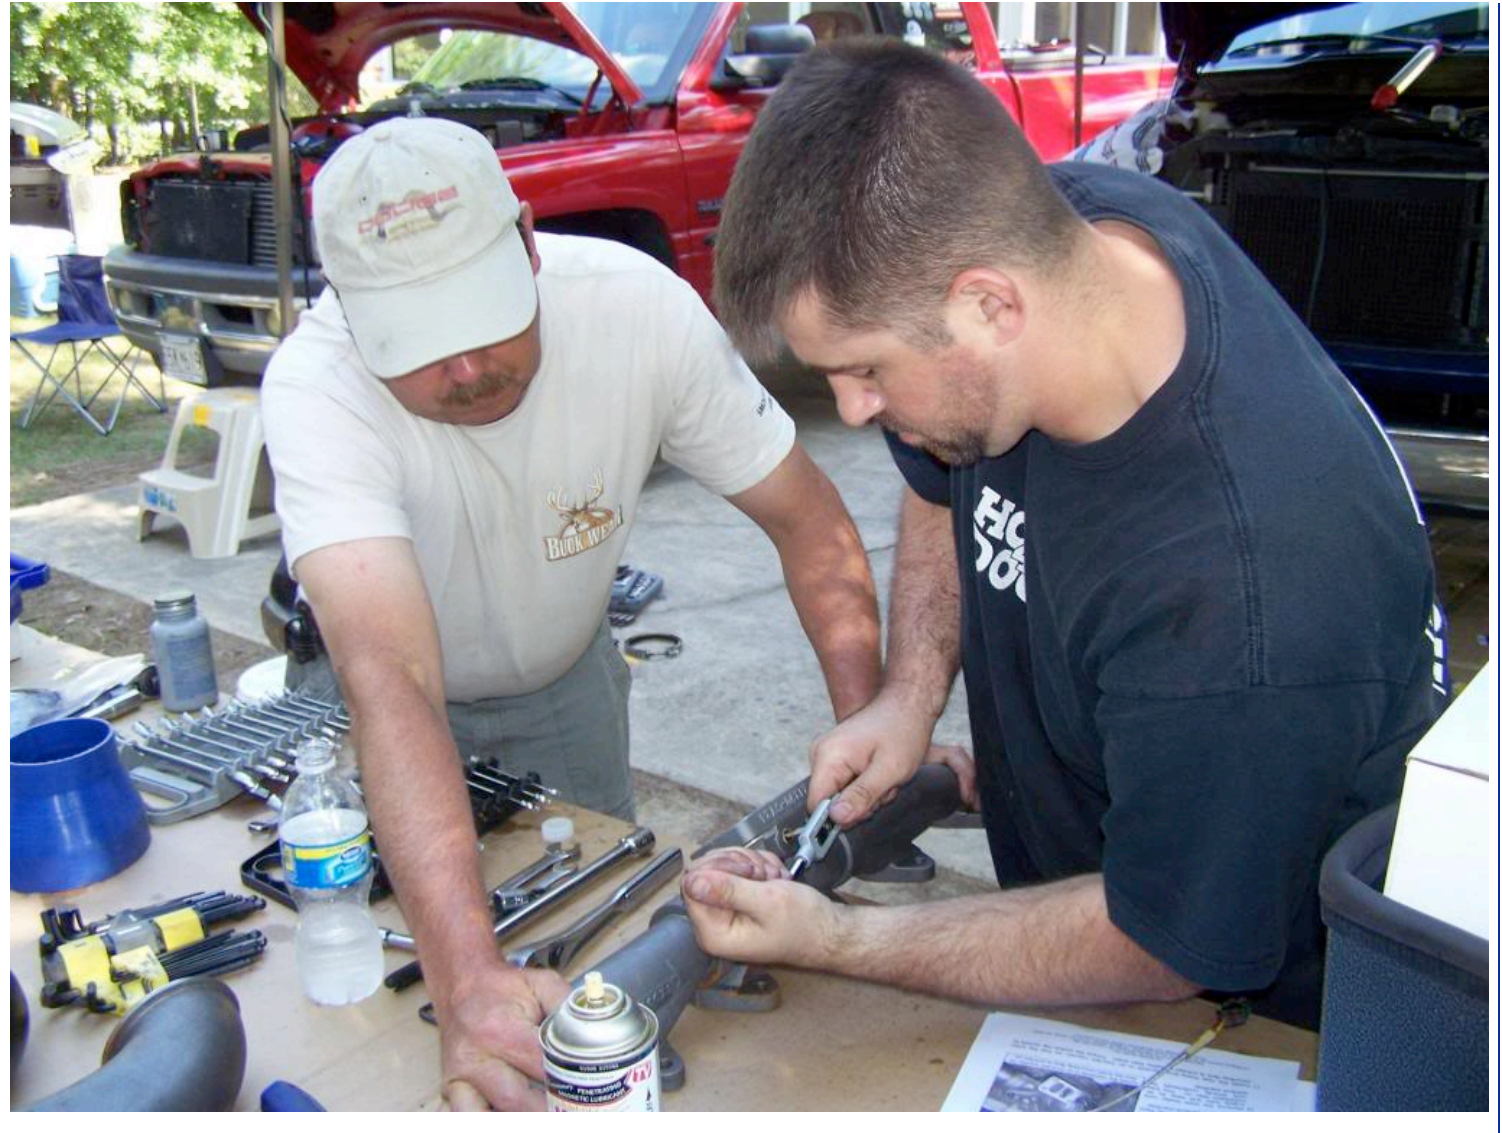
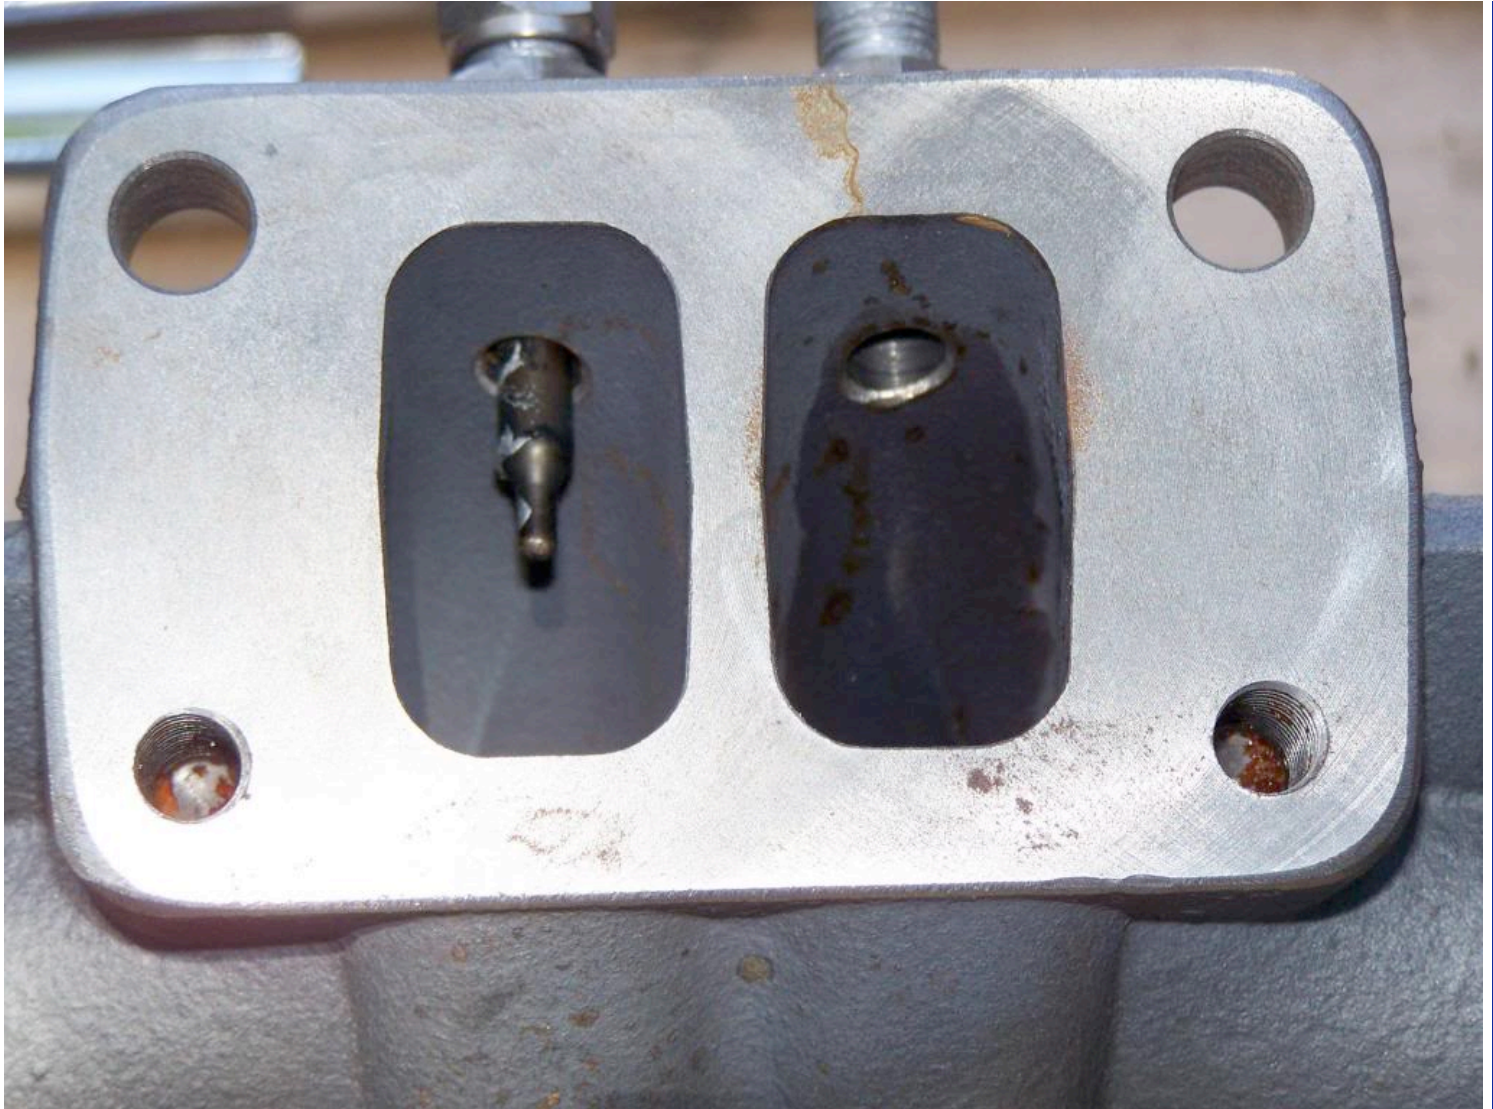
The BD kit came with two pre-drilled and tapped ports. The ports, as the manifold was to be installed, were located on the bottom of the manifold. They were also not tapped deep enough to properly seat a 1/8 NPT fitting. We could only get 2 threads of the probe fitting in before it stopped. This required tapping the manifold further to allow proper EGT probe function.
