ATS or BD.....you decide.

The products that I'll be discussing are two competing sets of compound turbos, both installed on 2006 Dodge Ram's with Cummins Turbo Diesel engines. One set was from ATS, which included the Aurora 3000 and Aurora 5000 turbos and the other was from BD Power, which included the SuperB and R700 turbos. Both are advertised as towing / race setups.

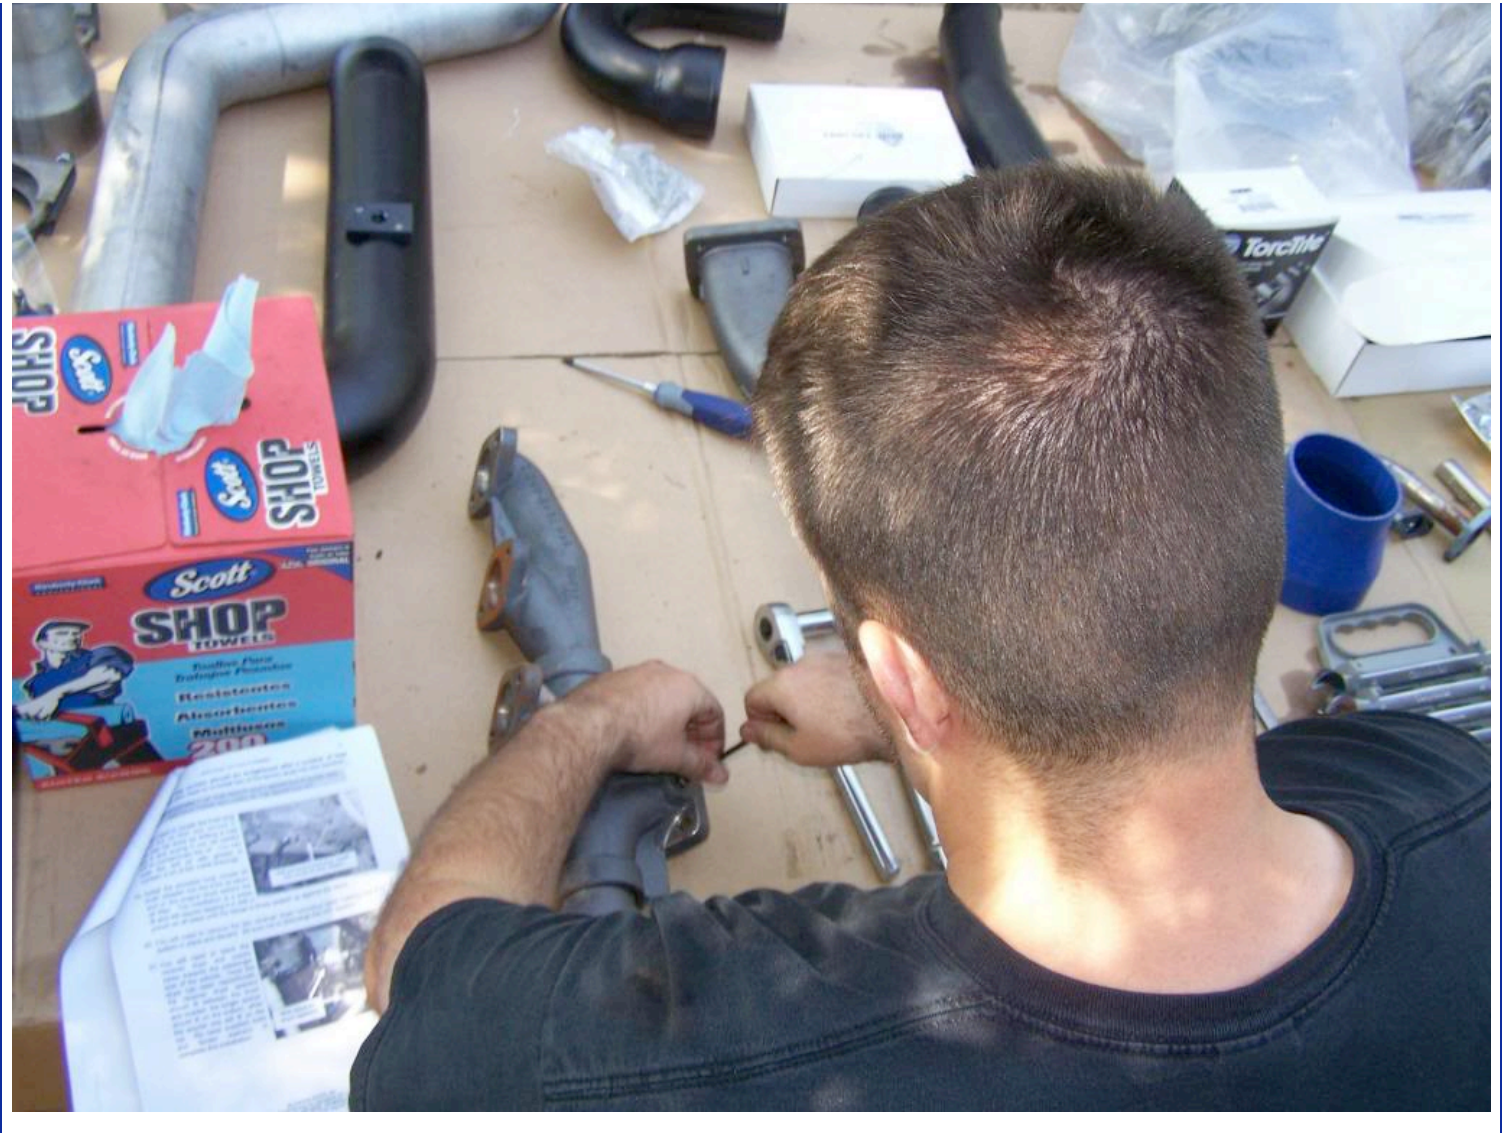
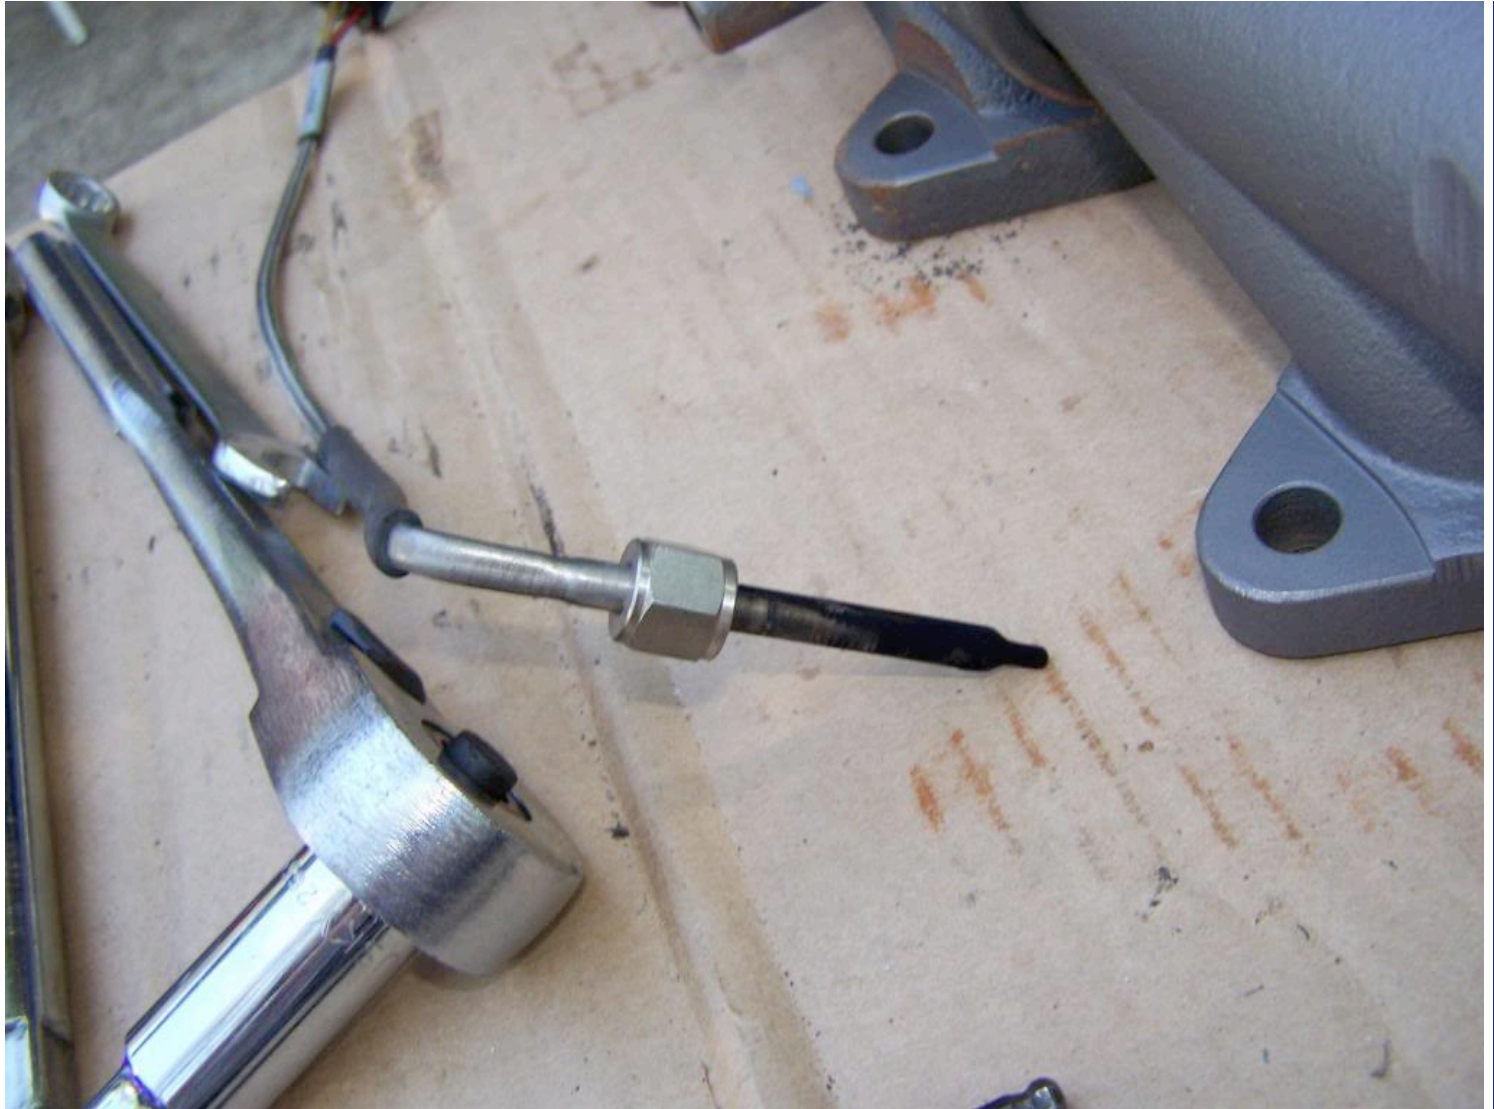
Once this was done, we installed the EGT probes and found another problem. The location of the ports on the bottom of the BD manifold did not allow enough clearance for straight type EGT probes. The probes ran directly into the side of the SuperB compressor housing. We ended up taking two 90* probes off of another truck to make them fit.

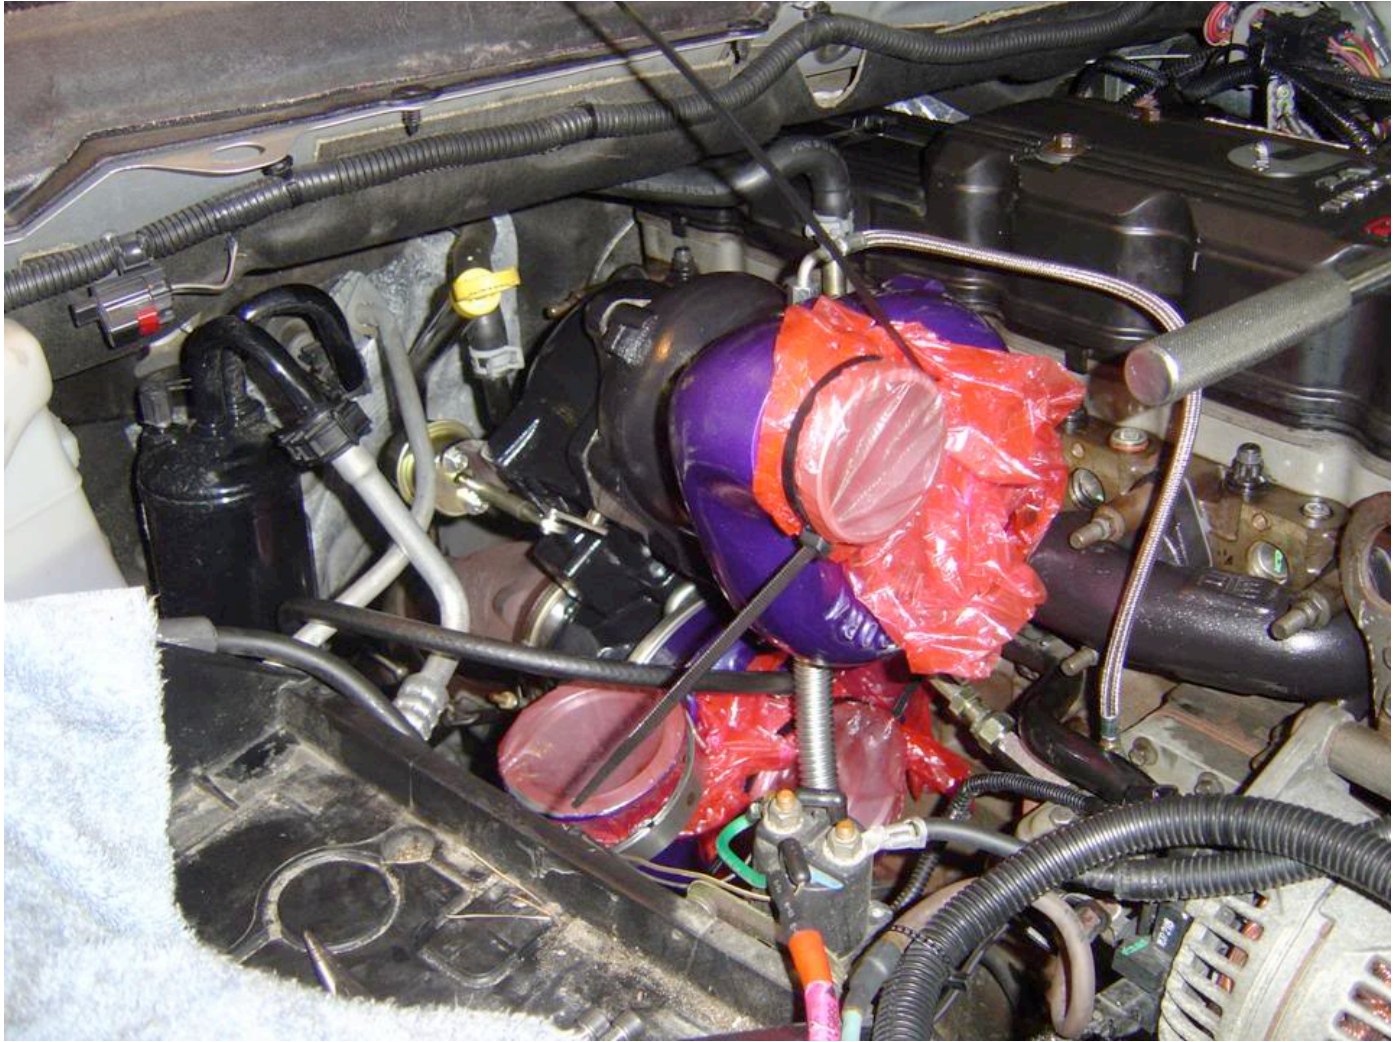
Once this was done, we were able to attach the secondary to the exhaust manifold. From here we saw another problem. The alignment of the compressor, cartridge and turbine housing's on the BD kit were incorrect as called for in the directions. This was changed to get the proper alignment of the oil supply and return lines.

This led to another problem. The flanges on the nuts for attaching the secondary to the exhaust manifold were too large and made contact with the secondary oil drain. These had to be removed, filed down and re-installed.

The ATS kit already had the secondary attached to the manifold, so all I had to do was check for proper torque specs on the fasteners.

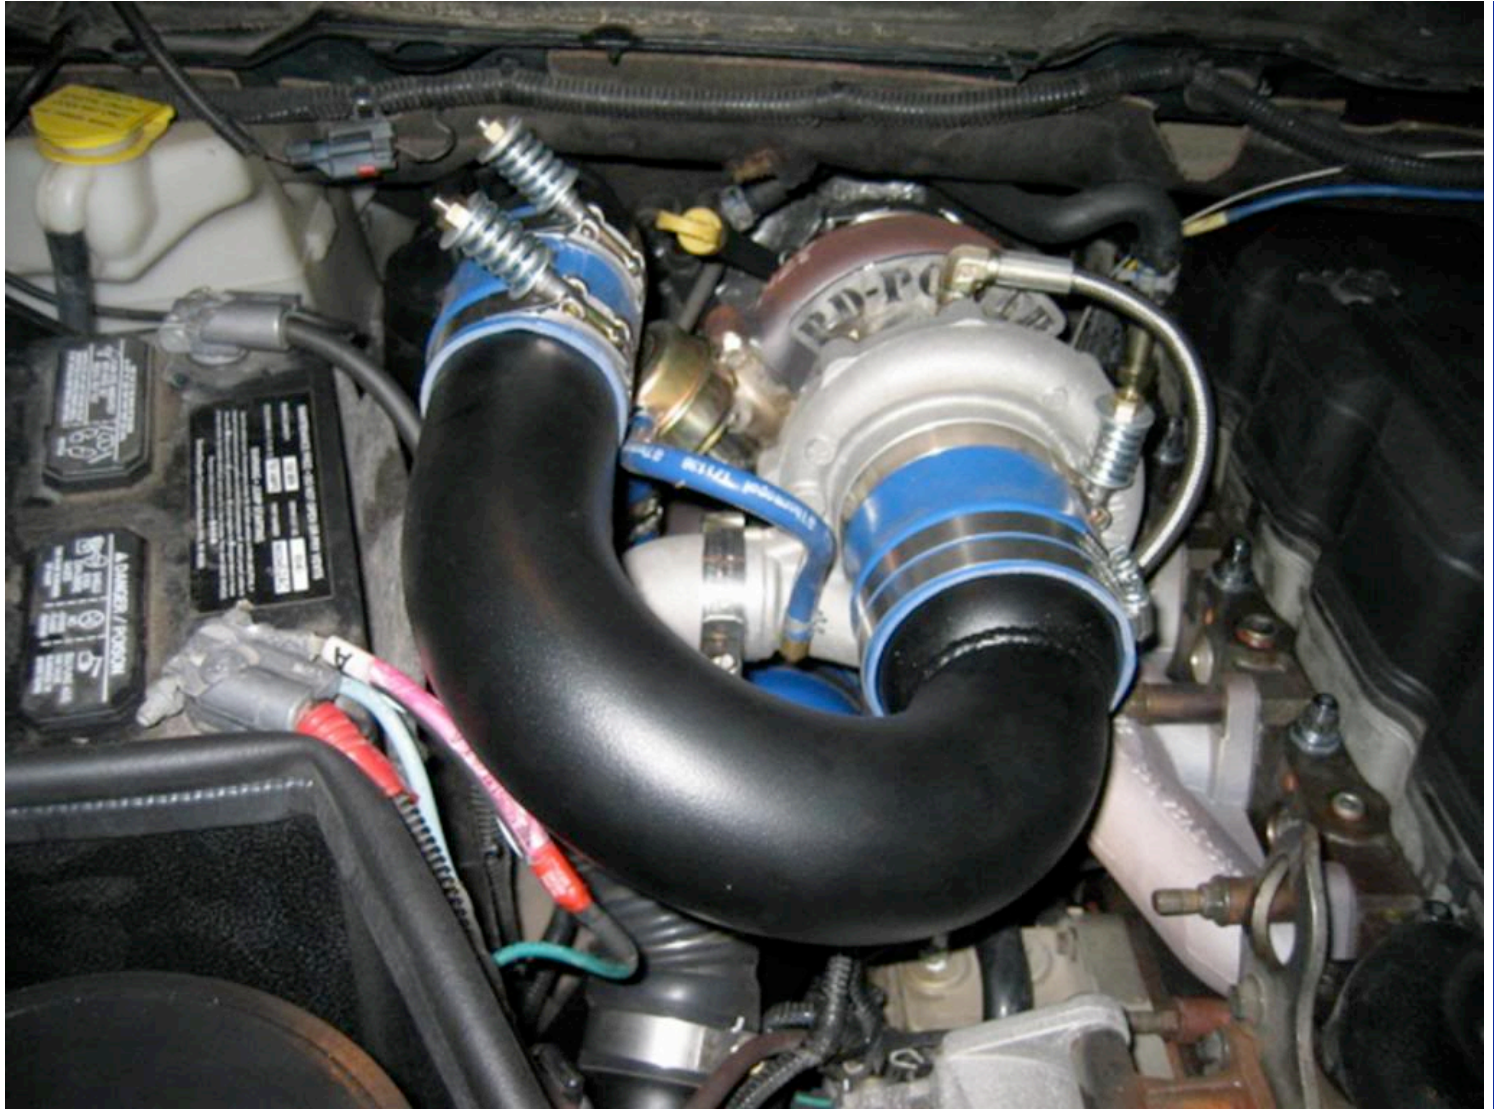
The ATS kit called for re-using the stock exhaust manifold studs, with the exception of two cap head bolts that were used where the turbo/manifold flange was. These were used due to the clearance issue that would have been presented by the OEM studs.

The BD kit called for new cap head bolts all the way around. These were supposed to be included in the kit, but were not, so the OEM studs were re-used. This caused another trip to the hardware store for cap head bolts to fit behind the manifold.

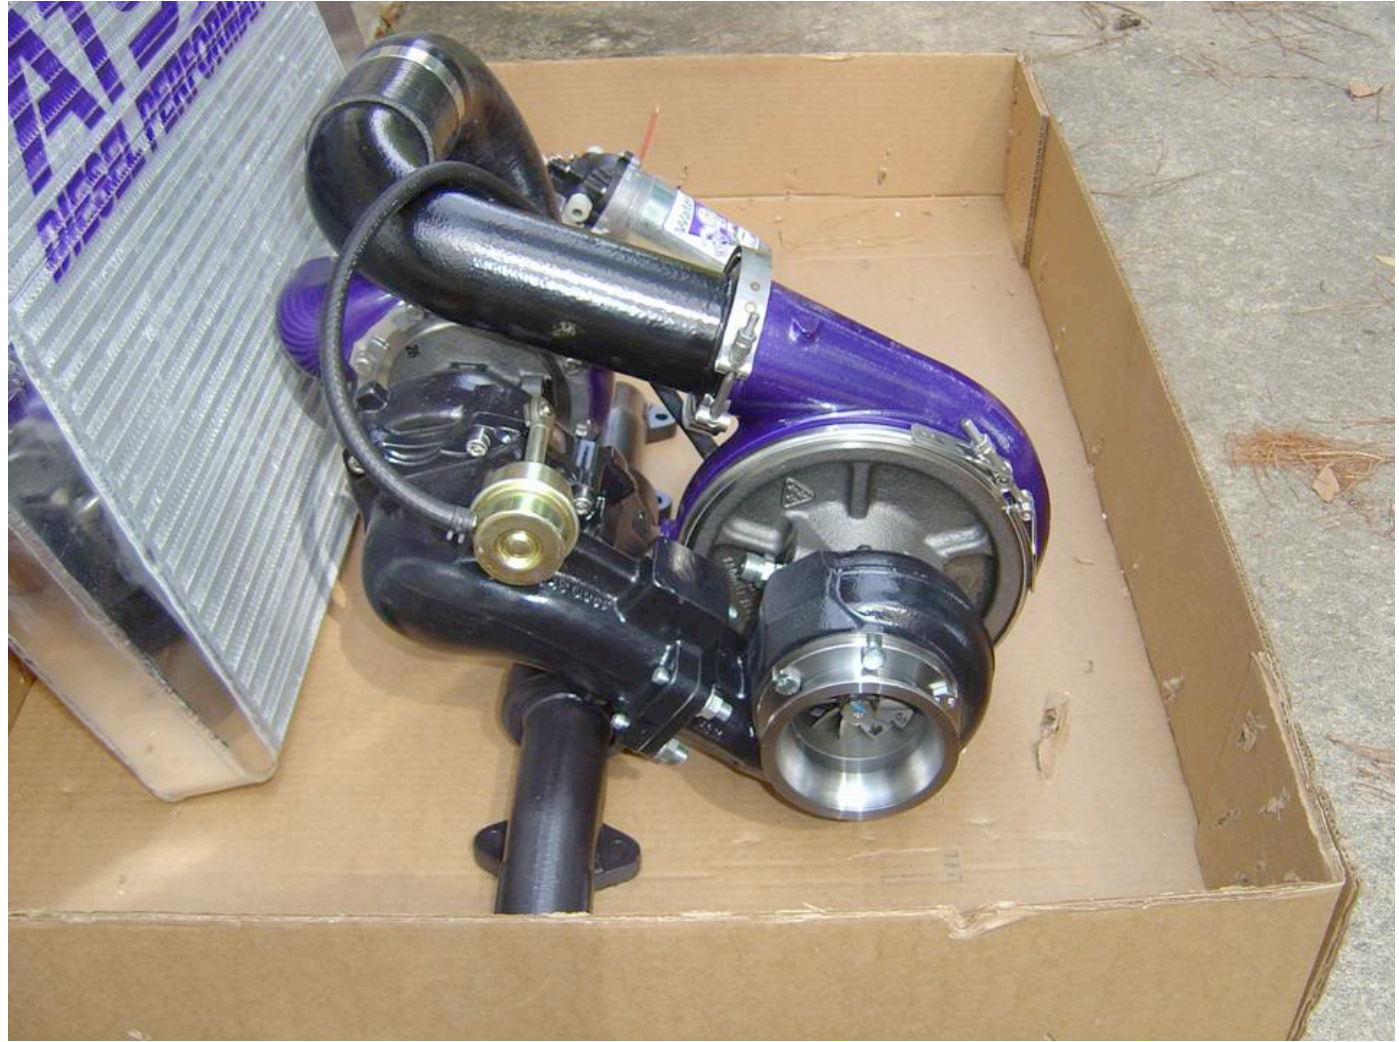
From here, the ATS kit requires attaching the exhaust adapter to the turbine housing of the secondary. This was simply a matter of lining up the holes and attaching the bolts. Using a ratchet wrench is essential here, otherwise you'll be making minute turns on two of the hard to reach bolts. The picture below shows the ATS exhaust adapter and where it fits to the secondary.

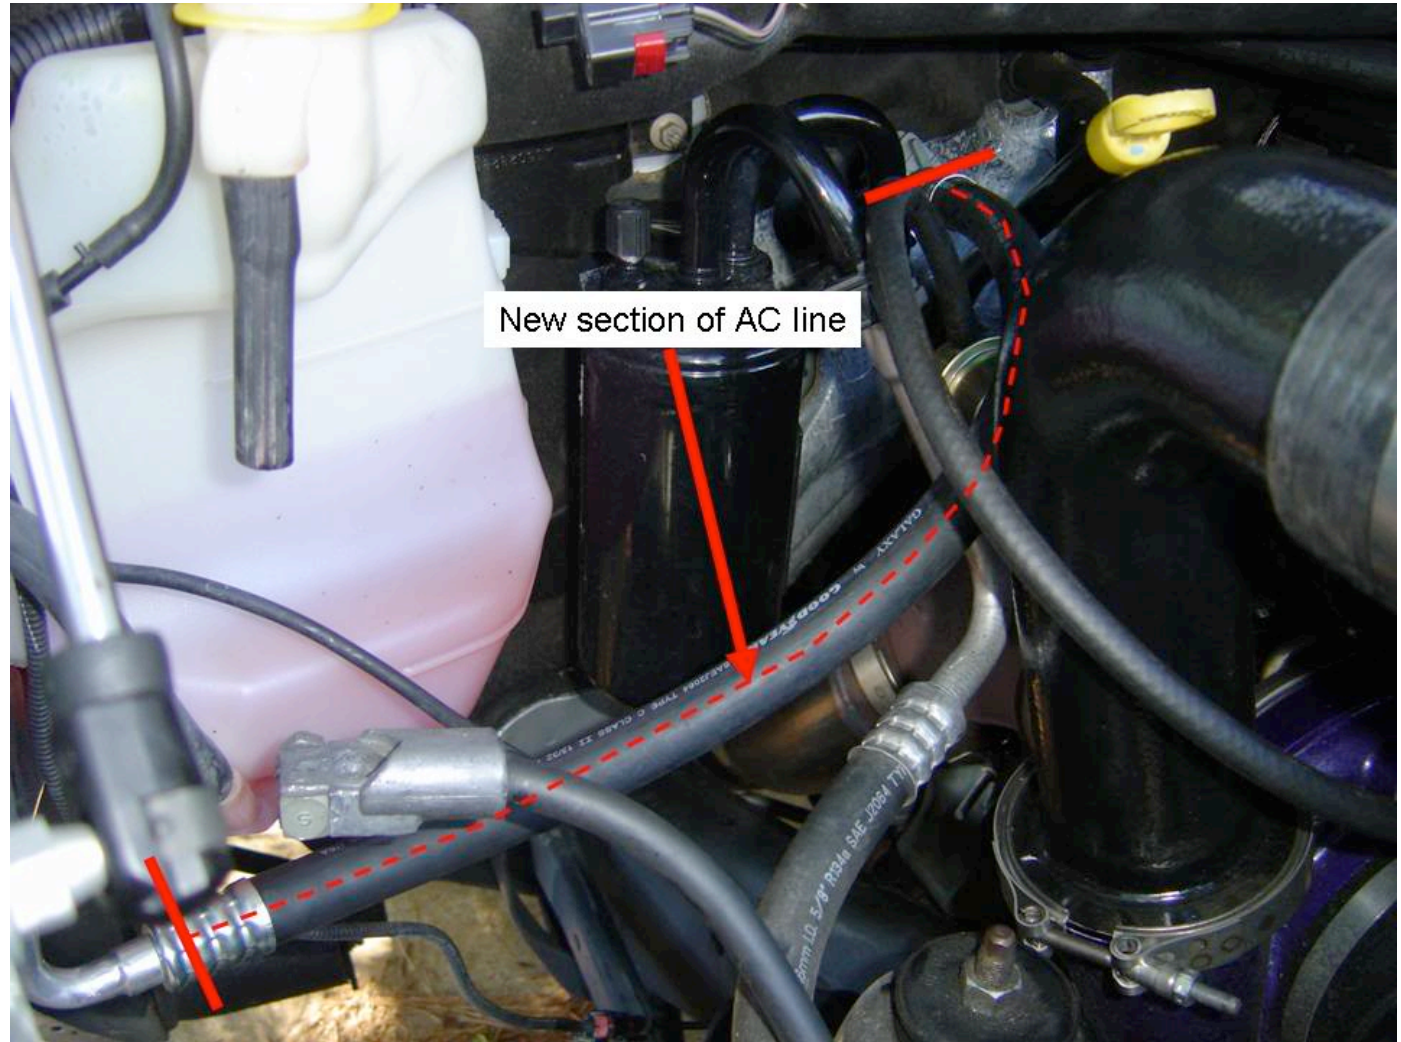
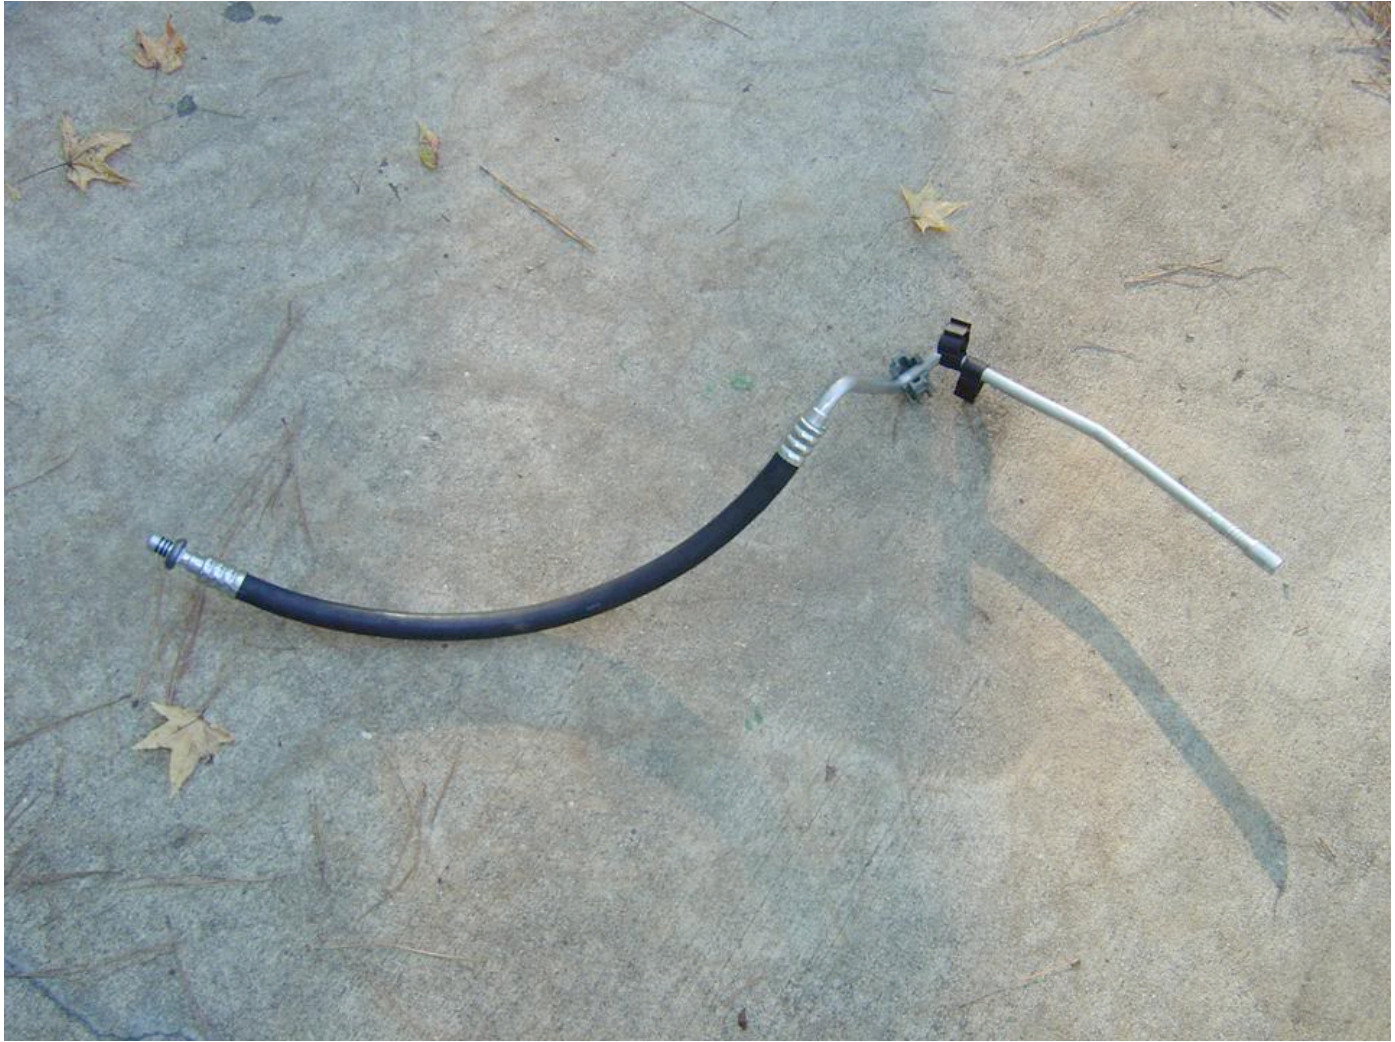
Now this is where we ran into a problem with the ATS setup. The location of the wastegate head was trying to occupy the same space as one of the AC lines. This required evacuating the AC system and removing the AC line until I could get a custom one made at a local shop. Here is the line I had to remove and the one I had had made to clear the wastegate head.

I contacted ATS regarding this, sent them the pictures and was reimbursed the \$45 that it cost me to have a new AC line made.

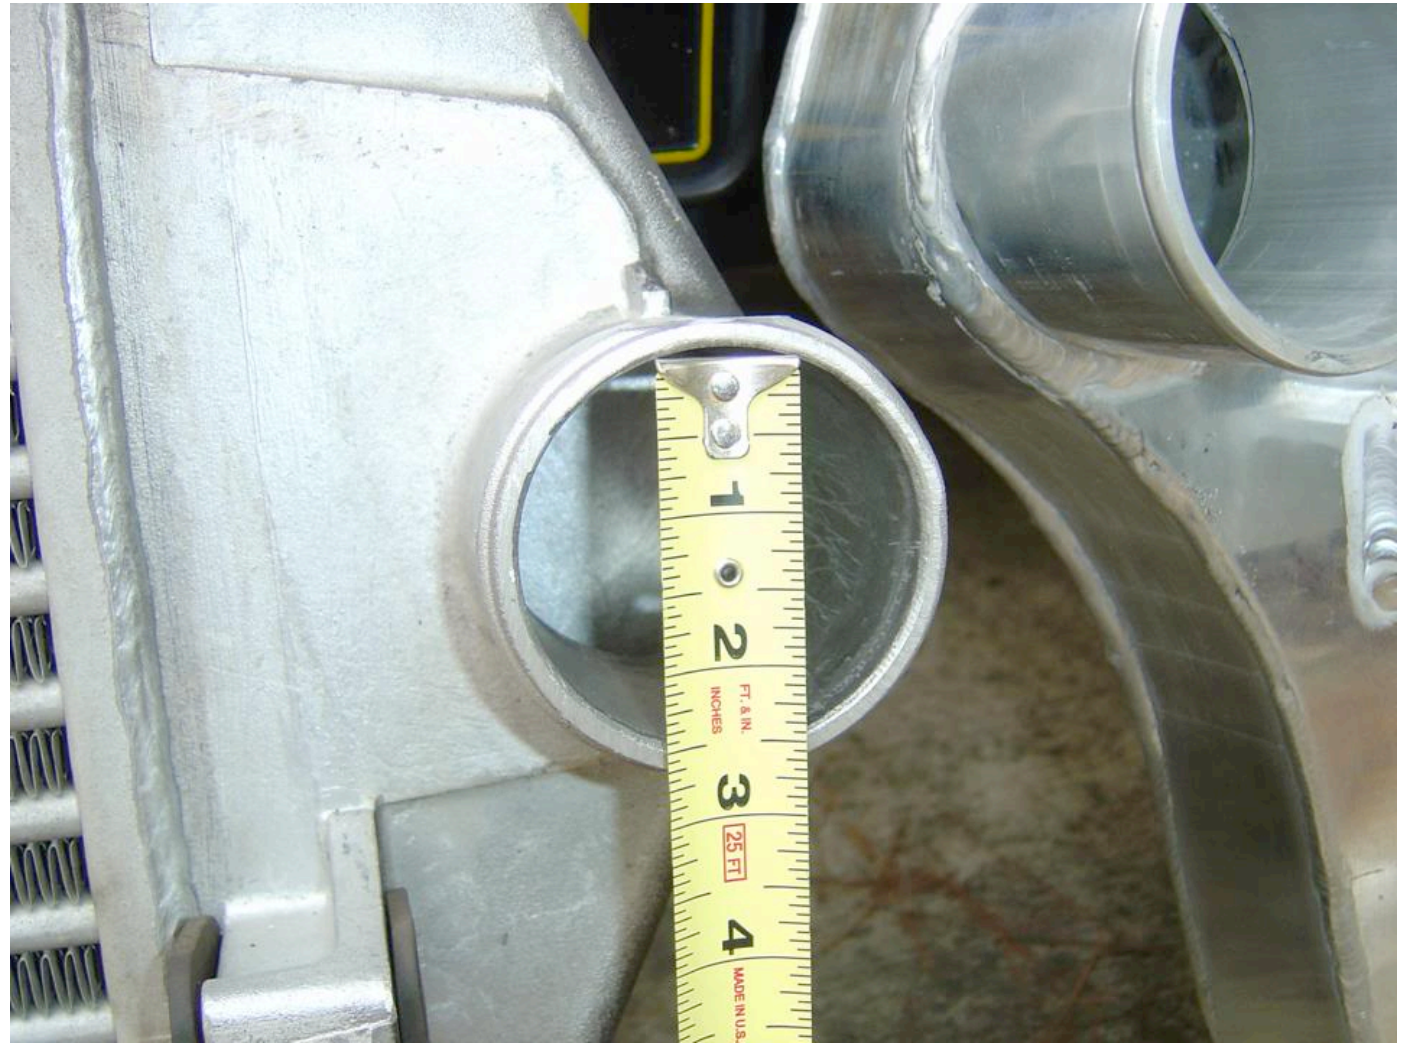
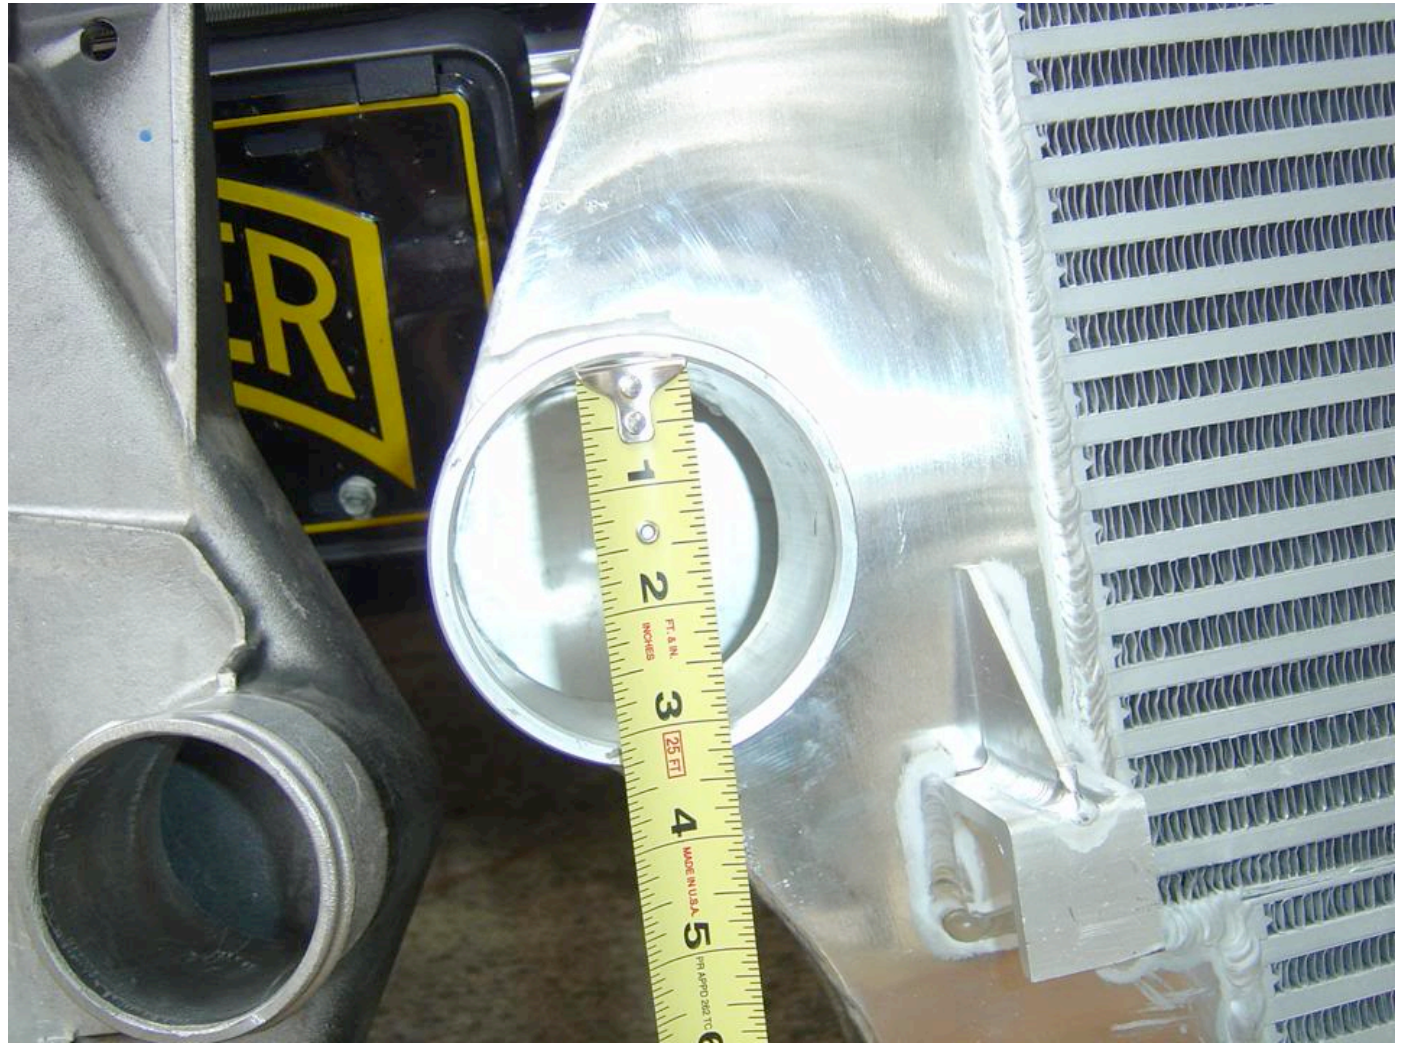
The ATS kit presented me with one final problem here. The kit comes with a 90* boost boot to go from the secondary boost tube to the intercooler opening. This boot is sized for a stock intercooler and I had the ATS intercooler that had a larger opening.

This required removing the ATS intercooler and re-installing the stock intercooler until the new one from ATS showed up, which was sent overnight.

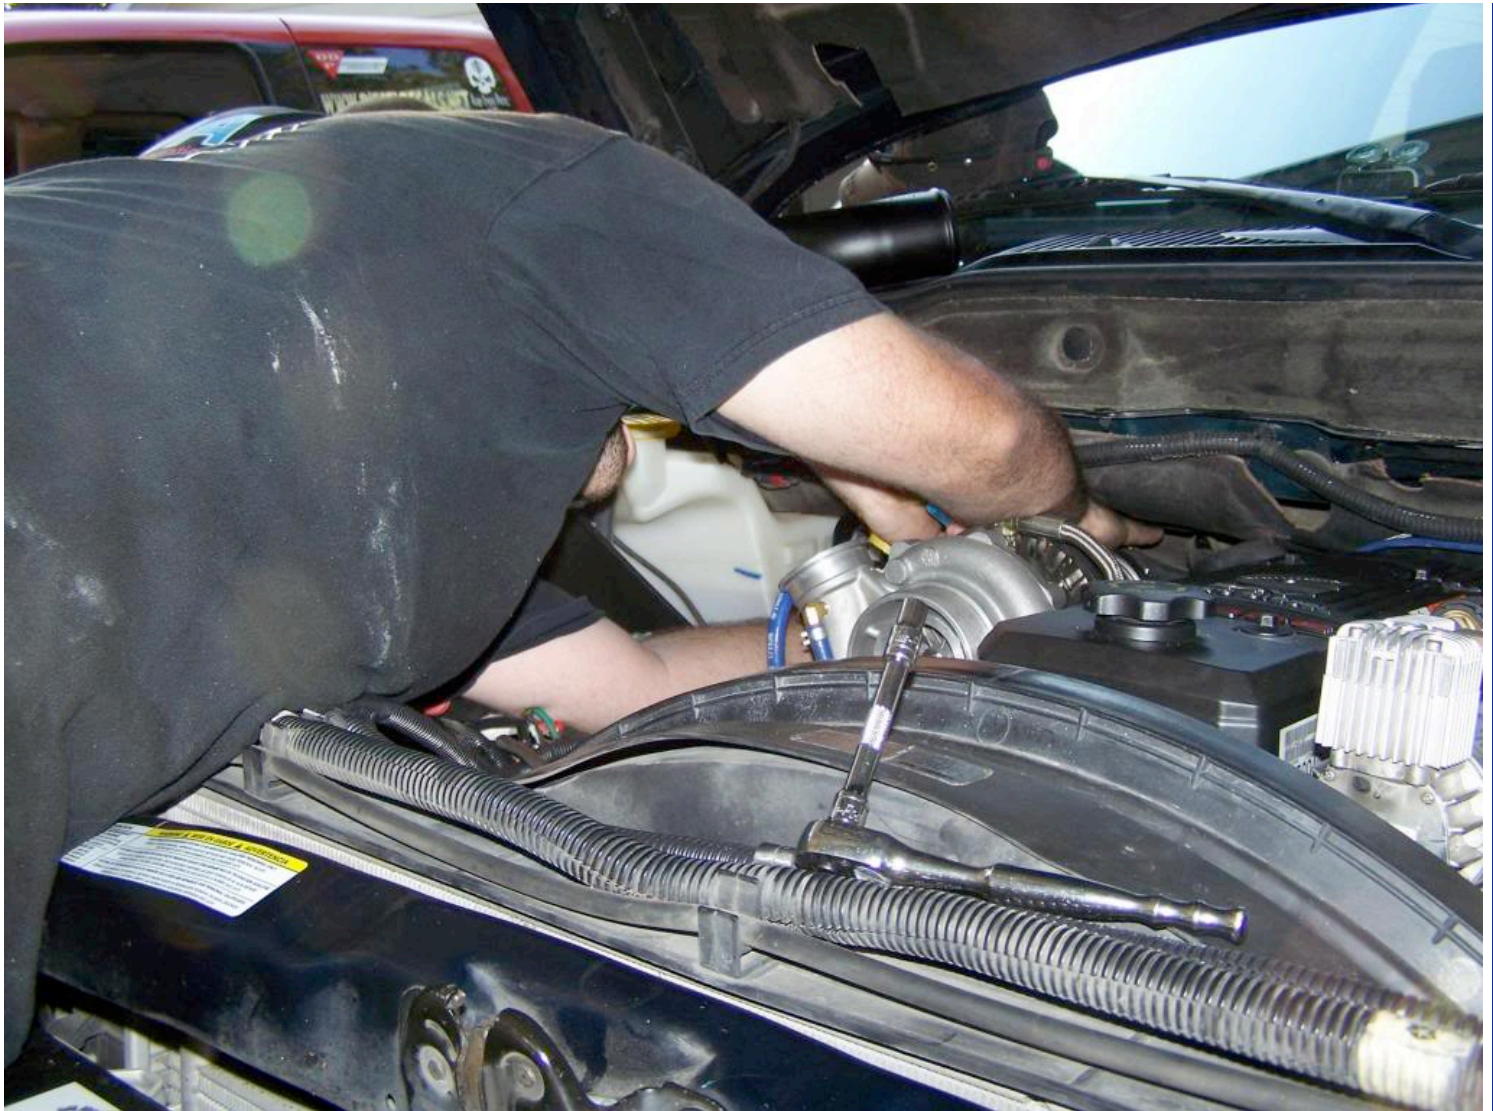
As we began routing the piping, we found that the compressor outlets still needed some tweaking to line up. Other than it being a pain to reach all the hold down bolts at this point, we found that the location of the wastegate head made it impossible to turn the compressor outlet to the correct position. You could go toward the engine, as it would hit the manifold and you couldn't go toward the battery as you hit the wastegate head. So, we had to remove the wastegate head, clock the compressor housing and then re-install the head. Now, the location to the wastegate head and it's 3 bolts make this a task for a contortionist. This took us a little while and increased our vulgarities count significantly.
