Dynatrac Service Bulletin

Dynatrac HD Replacement Ball Joints

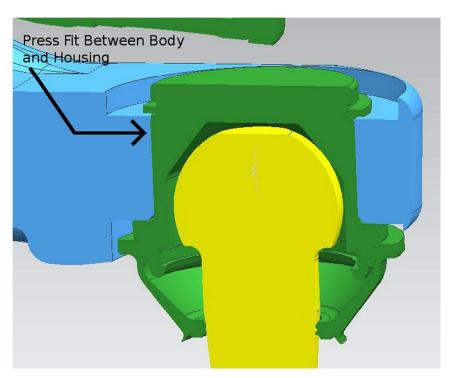
Tech Bulletin: Some customers have reported that the Dynatrac ball joints are loose in the housing bore when they are installed. There should be a press fit between the housing and the ball joint body when installing the ball joints. If the ball joints are loose in the housing, this can create an unsafe situation. If you ordered the Dynatrac ball joints and they are not installing properly, call the tech department for assistance ((714) 596 4461 ext. 202).

Why this Happens: There are a couple of reasons the axle housing bores may be affected. In some cases, the ball joints have been replaced multiple times which can wear the bore diameter. Some non-OEM replacement ball joints have a knurled body which will damage the bore of the axle housing, affecting the press fit.

The Fix: Dynatrac is currently working on a solution to knurl the body of the ball joints to create a press fit. Dynatrac will keep a few of the knurled parts in stock for customers that encounter problems. This will not be a production change because the knurl will damage the ball joint bore, which could affect future replacements.
